PRELIMINARY
KNKT.16.05.14.04

Aircraft Serious Incident Investigation Report

**Hong Kong Airlines
Airbus 330-223; B-LNE
Near Banjarmasin
Republic of Indonesia
6 May 2016**

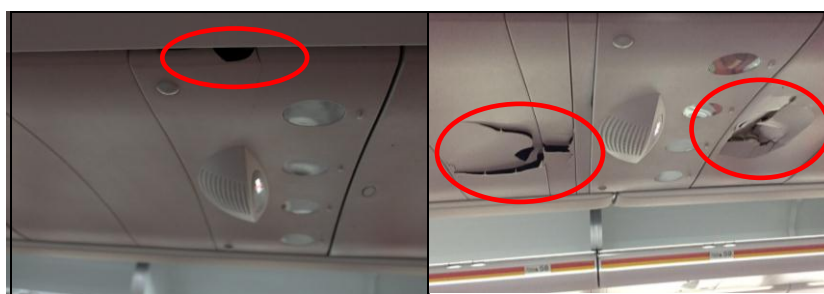
The aircraft had cracks on the several passenger service units and aft galley ceiling. The damaged passenger service units were found on passenger seat number 11A, 11C, 46C, 57E, 58F, 58G, 59F and 59G.

Figure 3: Several cracks on passenger service units

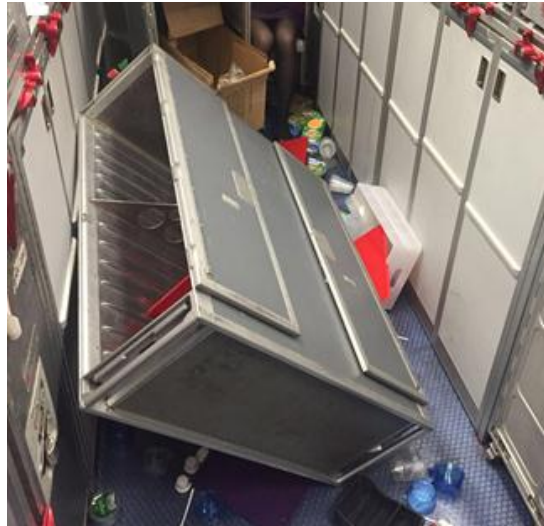
There were some damages on the ceiling cause by impact to occupants and two food carts that lifted and hit the ceiling then fall back on the floor.

Figure 9: The aft galley condition a few minute after turbulence

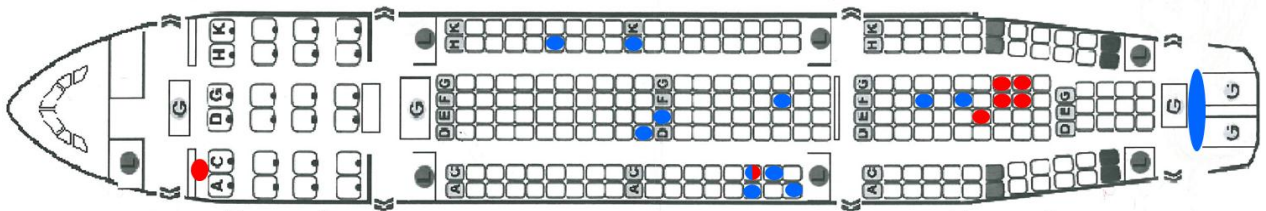
Figure 10: Damage (red) and injury (blue) distribution
