**KOMITE NASIONAL KESELAMATAN TRANSPORTASI
REPUBLIC OF INDONESIA**

KNKT16.05.14.04

Aircraft Serious Incident Investigation Report

**Hong Kong Airlines
Airbus 330-223; B-LNE
Near Banjarmasin
Republic of Indonesia
6 May 2016**

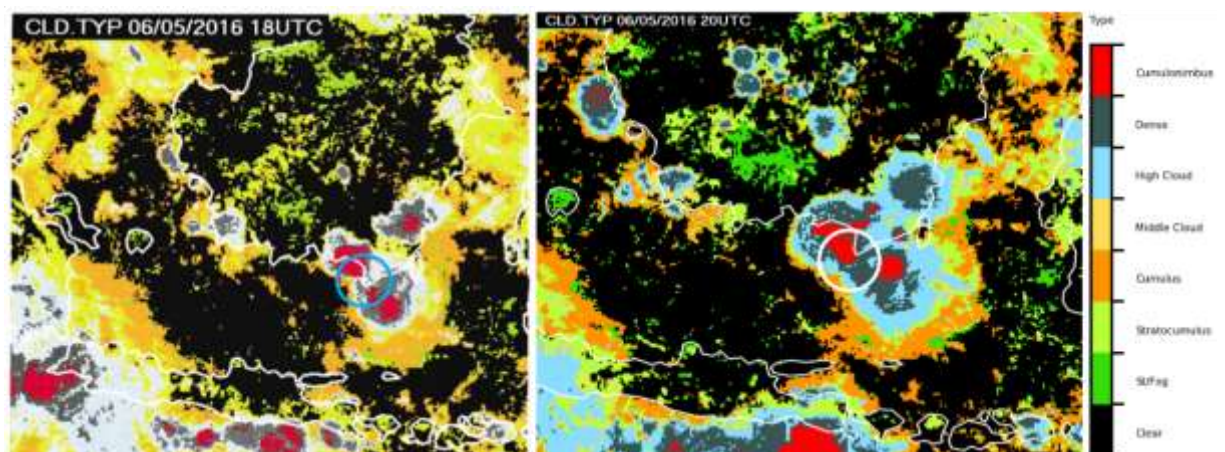
Figure 3: Clouds type satellite imagery on occurrence area at 1800 UTC (blue circle) and at 2000 UTC (white circle)

The satellite image of clouds type at 1800 UTC indicated two buildup cumulonimbus clouds at the occurrence location and the distance between the buildup cumulonimbus clouds was about 25 Nm. At 2000 UTC, the satellite image also indicated two buildup cumulonimbus clouds and the distance between the buildup cumulonimbus clouds was about 30 Nm

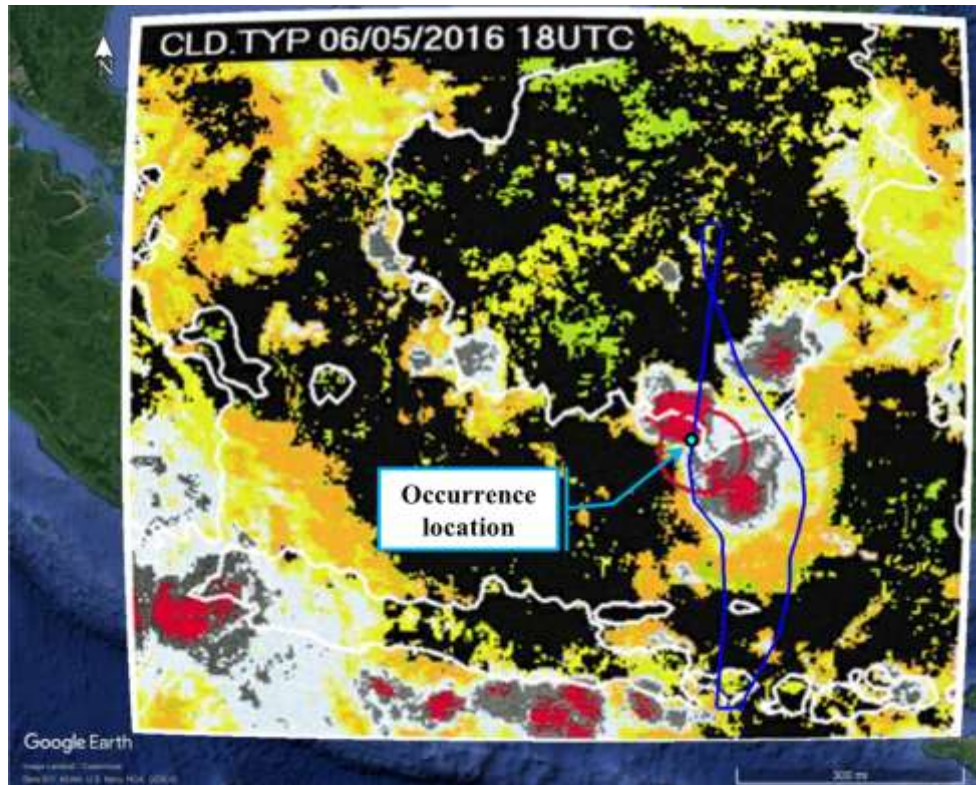
Figure 8: Aircraft flight track superimposed with satellite image at 1800 UTC

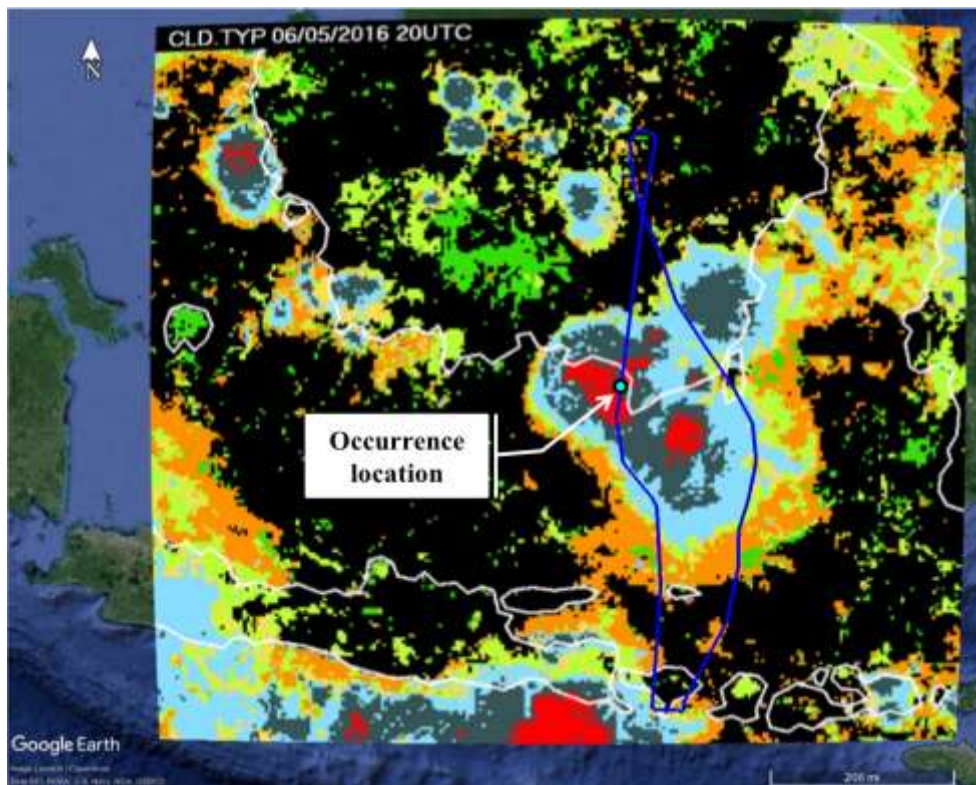
Figure 9: Aircraft flight track superimposed with satellite image at 2000 UTC

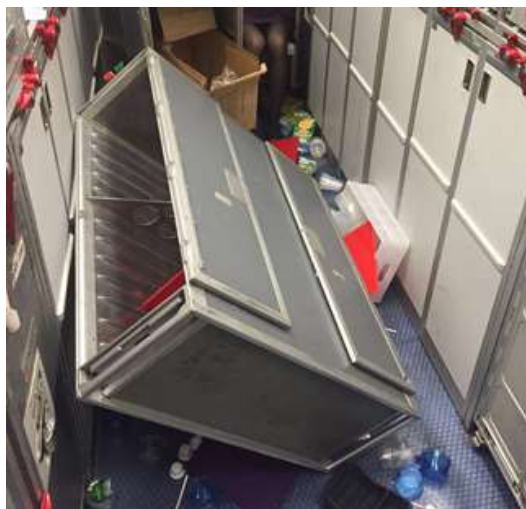
After finishing the meal service, the flight attendants were clearing up the food carts in the aft galley when the sudden turbulence occurred. In the aft galley, three flight attendants and two food carts lifted and hit the ceiling then fell back on the floor.

There were some damages on the ceiling and two food carts fell back to the floor.

Figure 10: The aft galley condition after encounter turbulence

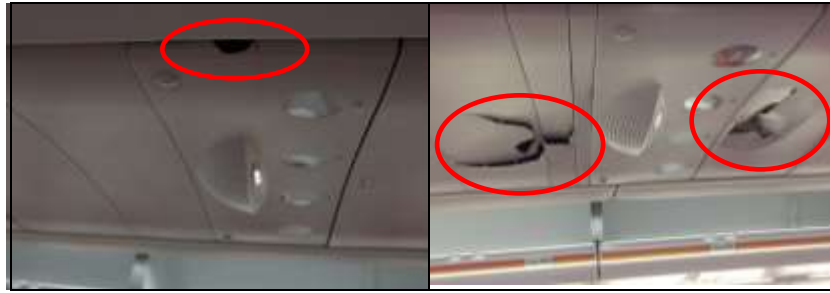
Several passengers service units damaged found above passenger seats number 11A, 11C, 46C, 57E, 58F, 58G, 59F and 59G.

Figure 11: Damage on passenger service units

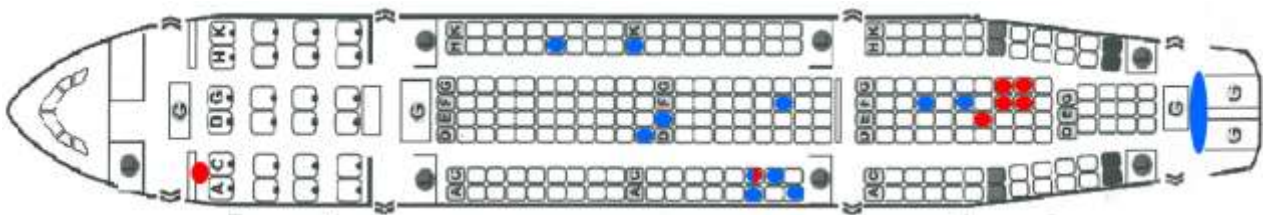
Figure 12: Position of ceiling damage (red marks) and seat position of the injured occupants (blue marks)

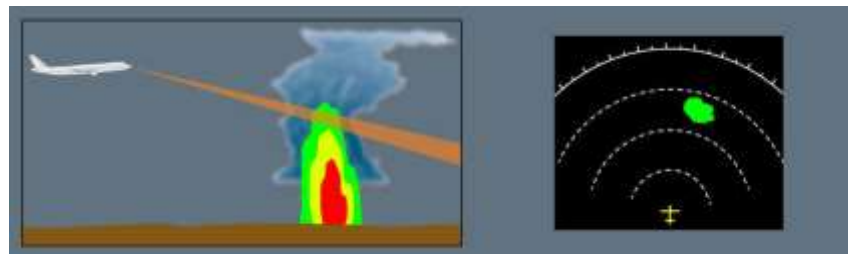
Overscanning

At high altitude, a storm cell may contain ice particles that have low reflectivity. If the tilt setting is not correct, the ND may display only the upper (less reflective) part of a storm cell (overscanning). As a result, the flight crew may underestimate or not detect a storm cell.
