**KOMITE NASIONAL KESELAMATAN TRANSPORTASI
REPUBLIC OF INDONESIA**

KNKT.16.10.35.04

Aircraft Accident Investigation Report

**Perkasa Flight School
Piper PA28-161 Warrior II; PK-PBH
Jeruk Legi Village, Cilacap, Central Java
Republic of Indonesia
19 October 2016**

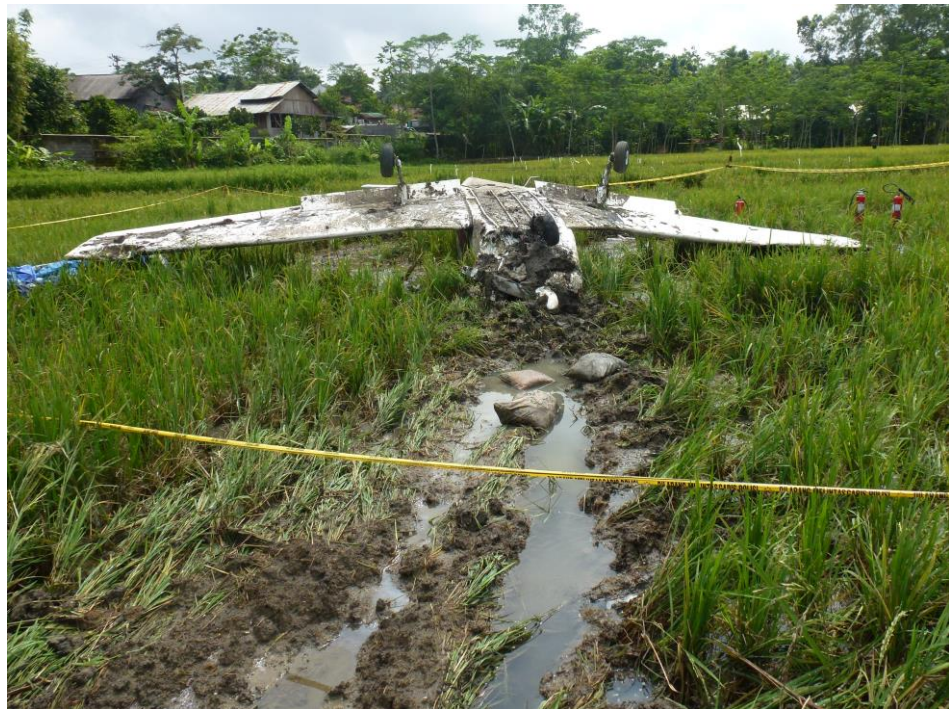
Figure 1: Aircraft last position

The aircraft position was upside down that might be caused by the nose wheel impacted to the paddy field embankment during the landing roll.

Both pilots survived and self-evacuated the aircraft. The aircraft was substantially damage.

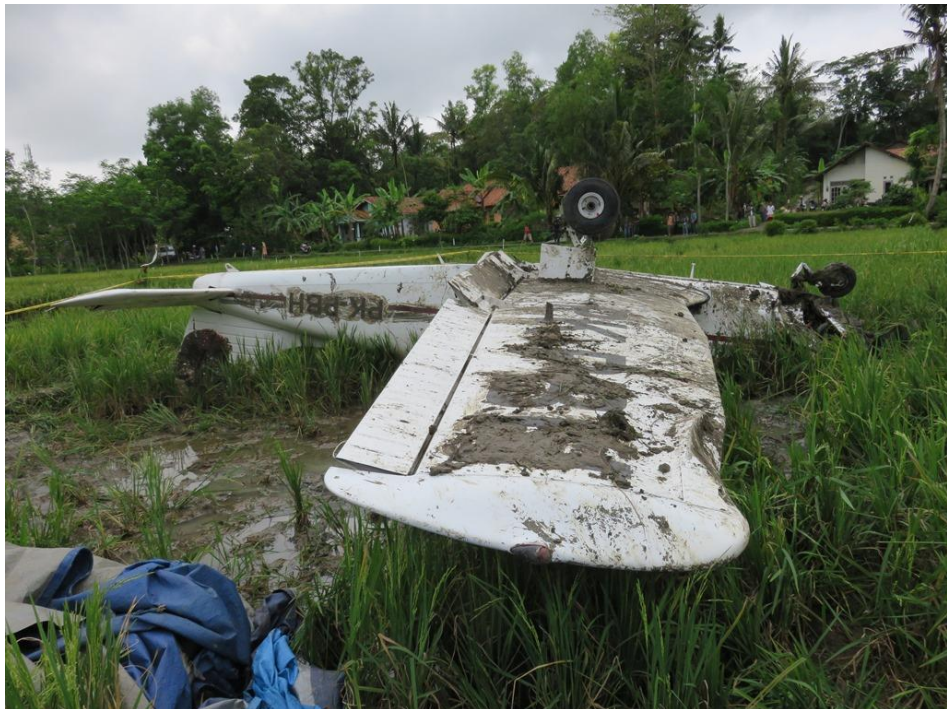
Figure 2: The damage on the left wing

1. The left wing leading edge damaged approximately one meter form the wing tip and buckling approximately 20 centimeters inward
2. The right wing was damage on the wing lower surface at position approximately two meters from the wing tip and buckling approximately two cm depth.

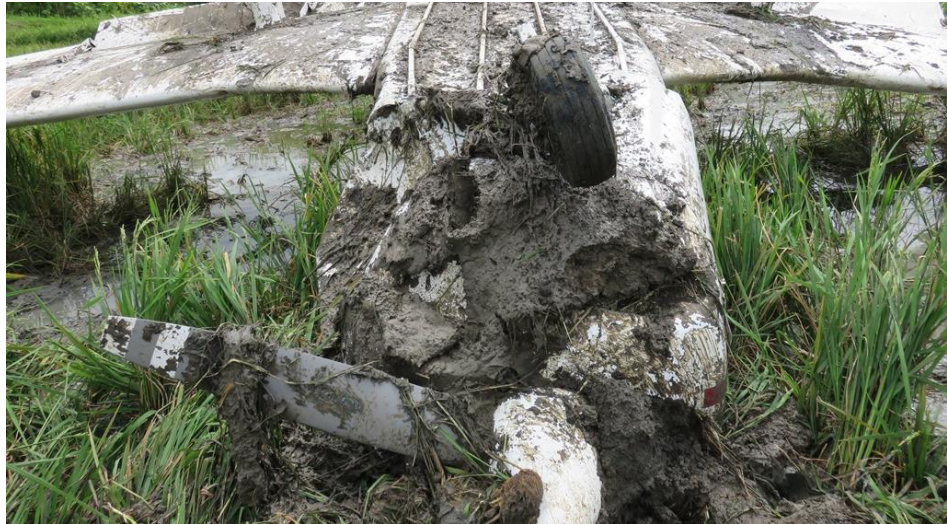
Figure 3: The nose section of the aircraft

3. The vertical stabilizer was damage on the tip and deformation on the rudder.
4. The right main landing gear torque link broken
5. The nose landing gear detached from its bulkhead with the distance of 25 centimeters.

6. The right side of the lower engine cowling buckled inward with dimension approximately 90×30 centimeters.
7. One of the propeller blades bend inward approximately 7° probably due to impact to the ground however, in general, the propeller blades were relatively undamaged.

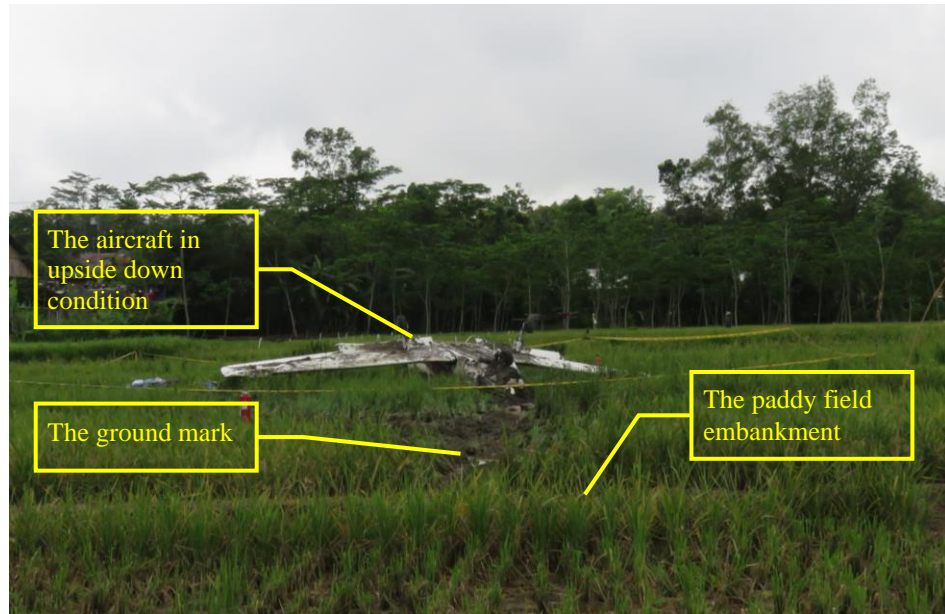
Figure 6: The aircraft at the paddy field

The ground mark after the aircraft tumbling was approximately 10×2 meters from the embankment of paddy field. The observation of the landing path, after landed the aircraft nose wheel impacted the embankment of paddy field resulted in aircraft upside-down as indicated by the ground marks.

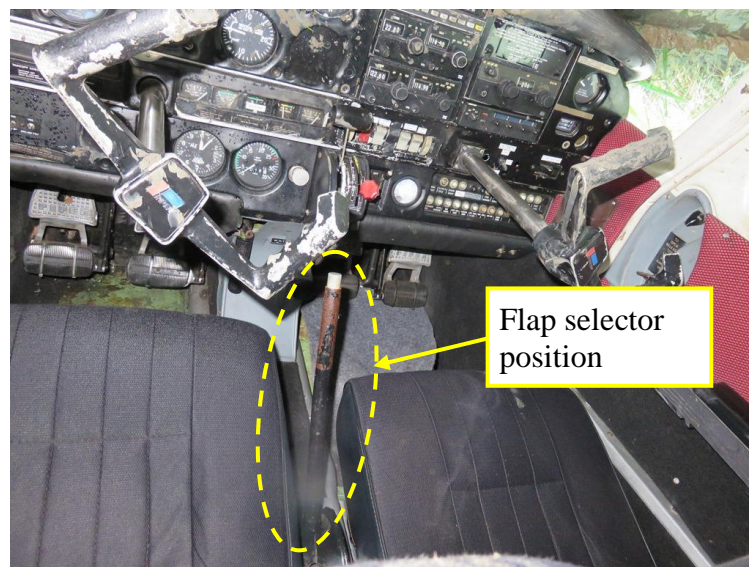
Figure 7: Flap selector

The flap selector has position selections of 0, 10, 25, and 40 degrees flaps position. The flap lever in the cockpit showed on up the deflection position as shown in the figure below.

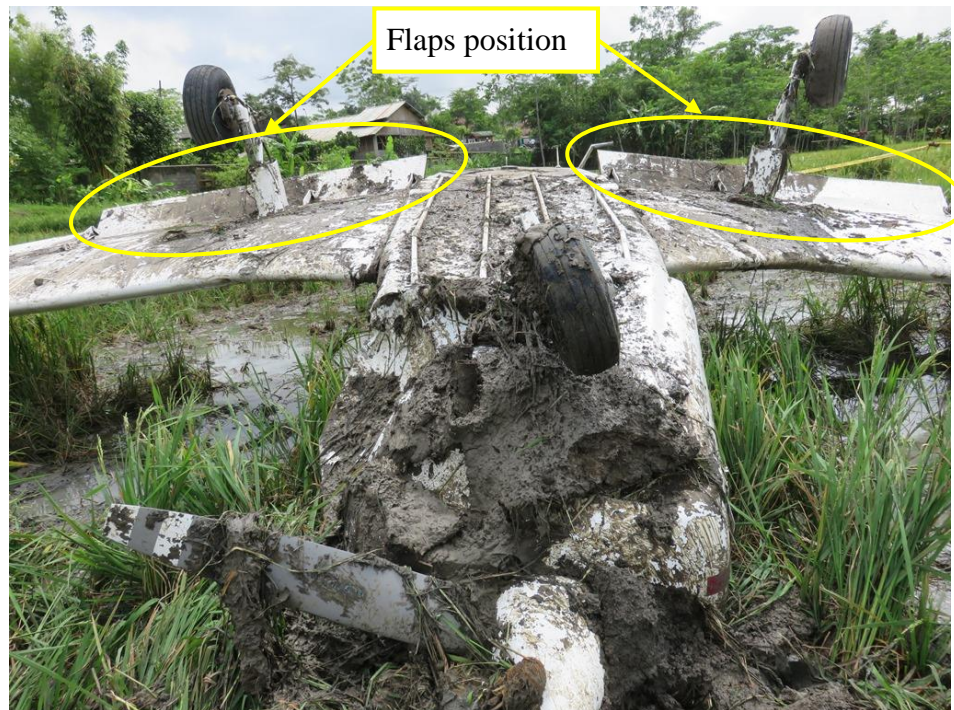
Figure 8: Flaps position

Observation on the accident site found that the flaps were extended however, the deflection angle was unable to be determined as shown in the figure below.

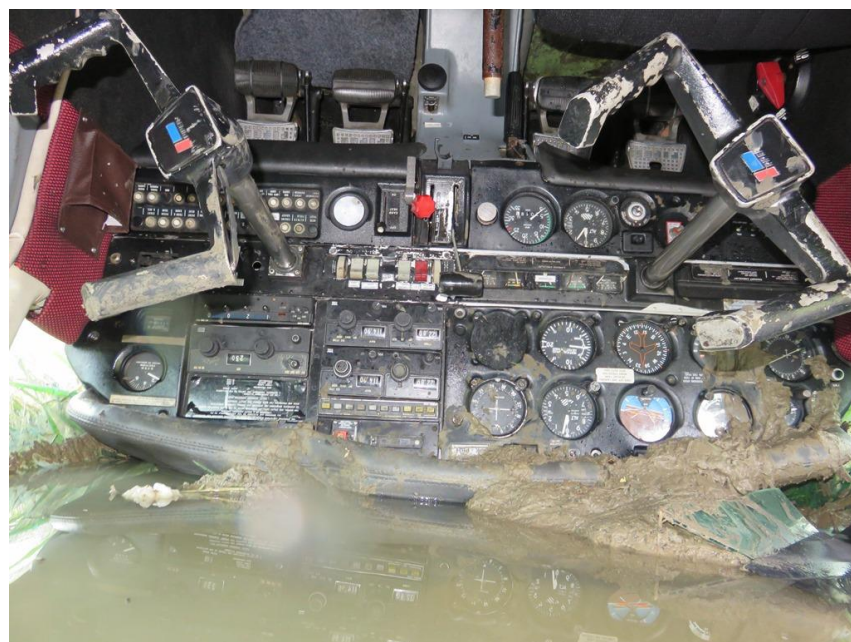
Figure 9: The cockpit instruments

The cockpit was partly immersed in the water however all the cockpit instruments were relatively no damage.

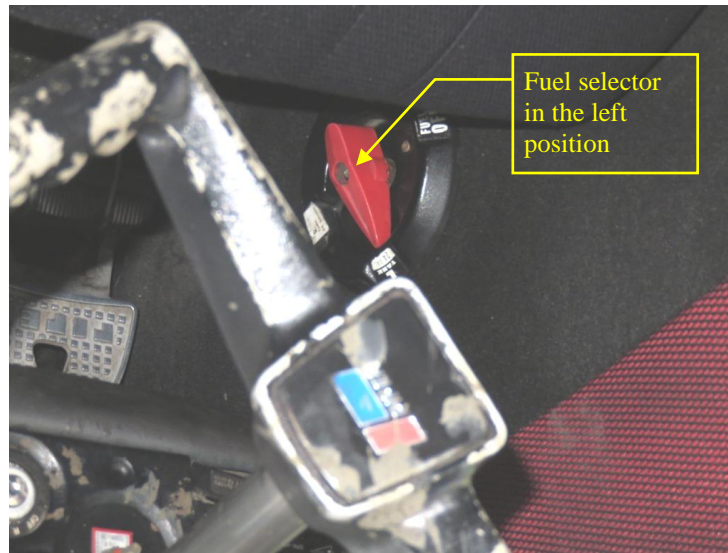
Figure 10: The fuel selector last position

The fuel selector position was on the L TANK position as shown in the figure below.

The investigation found the fuel selector position was at the L TANK position at the crash site. The instructor pilot stated that during the force landing, the engine restart was attempted and the fuel selector was moved from L to R TANK position and finally the instructor pilot placed the fuel selector to the L TANK position. However, the engine restart was unsuccessful.

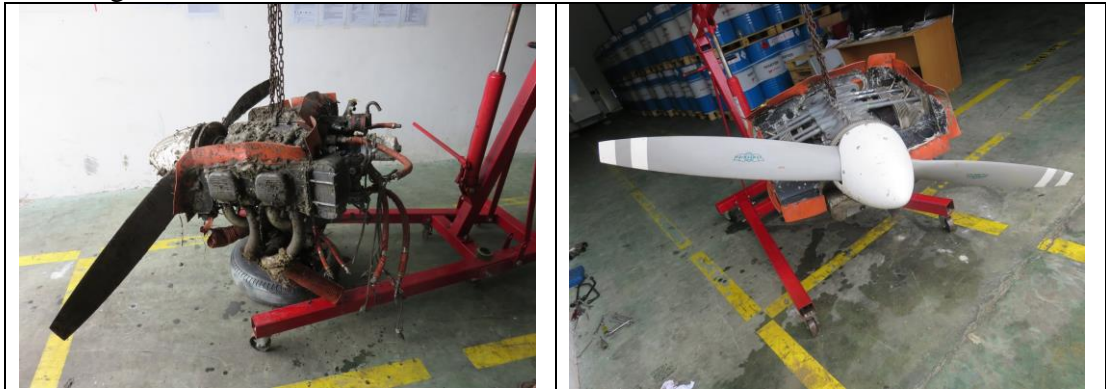
Figure 11: The engine before and after washed

In general, the engine condition appeared in good condition without significant damage. One of the propeller blades bends inward approximately 7° possibly due to impact to the ground and there was no damage to the propeller leading edge which was consistent with no propeller rotation.

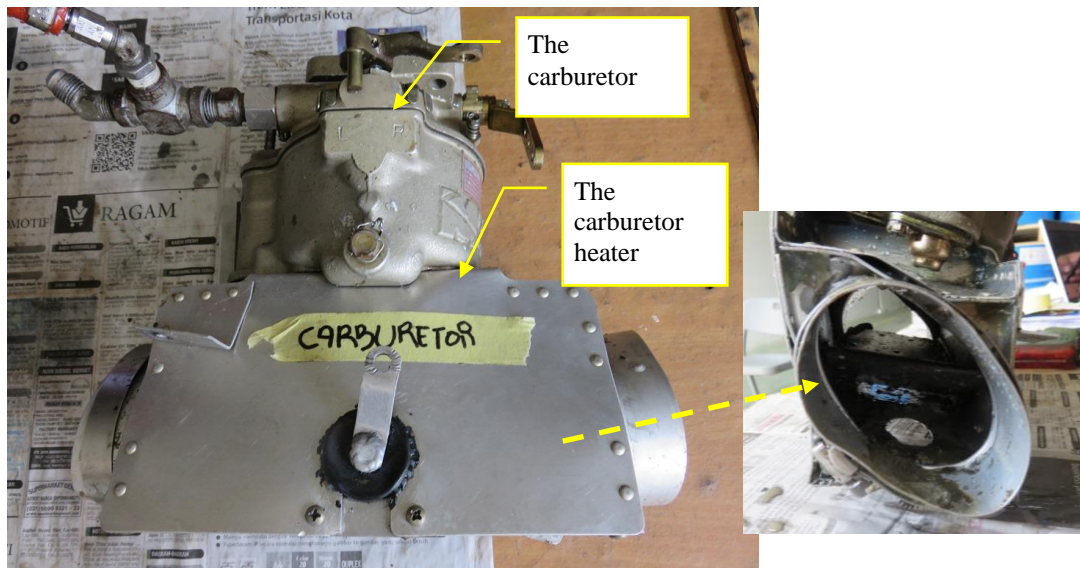
Figure 13: The carburetor and carburetor heater

The carburetor was removed for examination. The general condition was good without significant damage. The carburetor heater was deformed due to impact as shown in the figure below.

The water contamination test was applied to the inner part of the carburetor fuel container and no evidence of water contamination found.

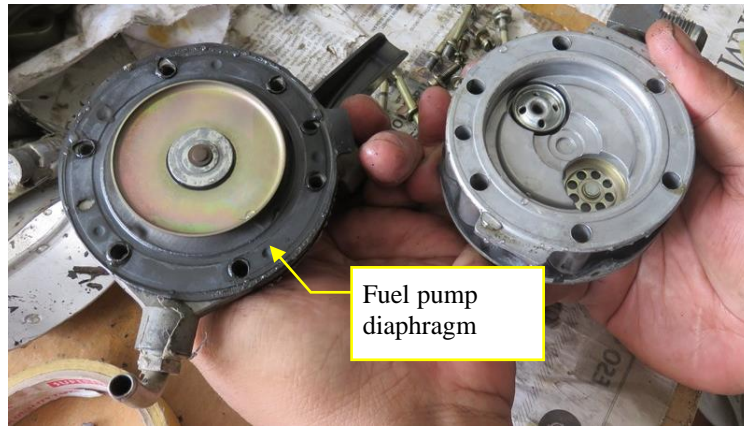
Figure 14: The exposed fuel pump condition

The fuel pump was dismantled to expose the inside of the diaphragm system. The diaphragm was good and there was no rubber deformation.

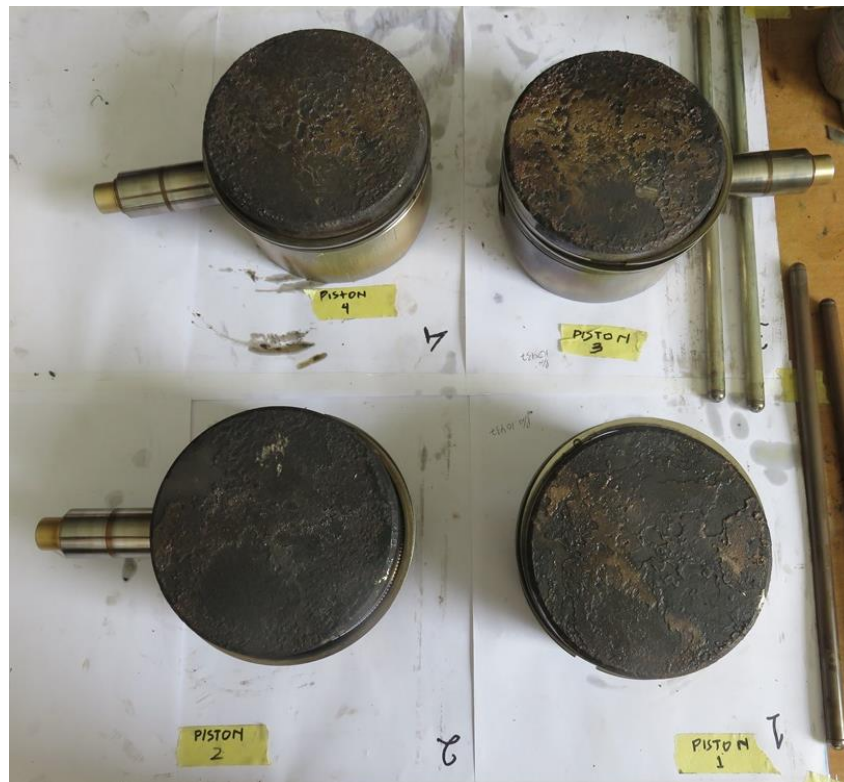
Figure 15: The exposed piston condition

The piston crowns were covered by carbon deposit which considered normal in the service life of the engine.

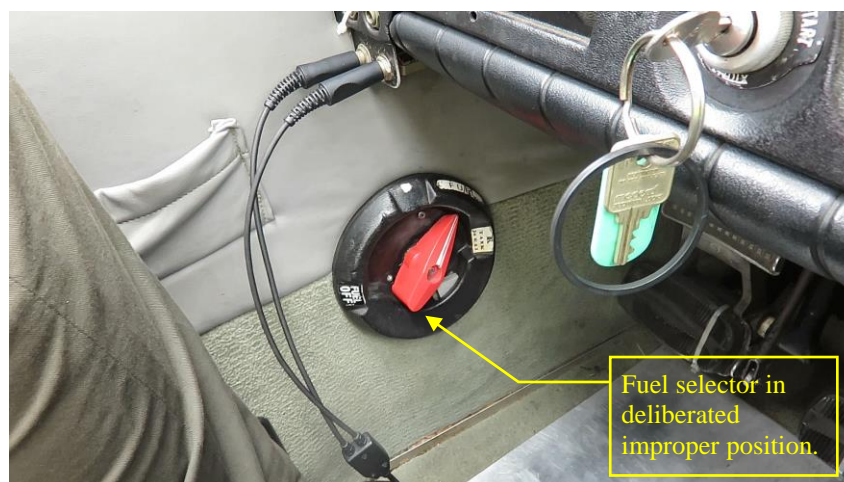
Figure 17: The fuel selector in dedicated improper position

When the fuel selector was between L TANK and R TANK position, the engine was able to be started and run normally. When the throttle set to take off position, after approximately 30 seconds the engine became hesitation⁷ and subsequently the engine quit.

The second examination was performed with the similar fuel selector position and during the engine hesitation the fuel selector immediately repositioned to the L TANK. The exercise found that it took approximately 3 seconds for the engine to return to normal run without difficulties. However, if the repositioning of the fuel selector to L TANK position conducted in more than 3 seconds after engine hesitation, the engine would not recover and afterward the engine would quit.

The symptom of the accident flight when the engine quit a few minutes after takeoff power setting was similar to the fuel selector valve improper selection during the engine ground run. Considering the engine examination which did not find any abnormality and the fuel met the requirement, it is most likely that the engine quit was caused by improper position of fuel selector.

KNKT recommend the flying school to have fitness for duty monitoring system including self-reporting of the fitness before flight.
