**KOMITE NASIONAL KESELAMATAN TRANSPORTASI
REPUBLIC OF INDONESIA**

Aircraft Accident Investigation Report

Perkumpulan Penerbangan Alfa Indonesia

DHC – 4 Caribou; PK-SWW

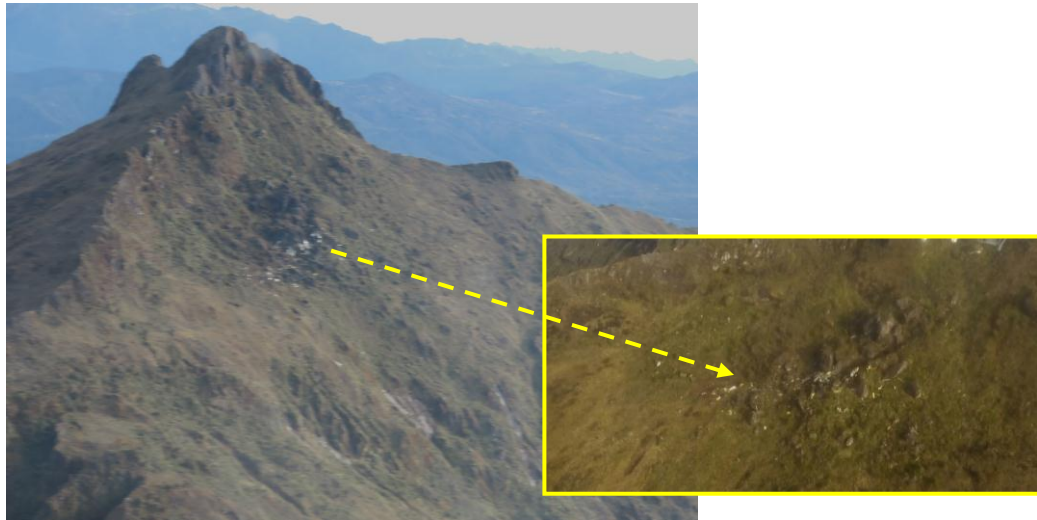
Figure 1: The location of the aircraft wreckage

On 1 November 2016, the aircraft wreckage was found on a ridge of mountain near Jila Pass on coordinate 4°5'55.10" S; 137°38'47.60" E, at the elevation approximately of 13,000 feet. The accident site was about 7.5 Nm on bearing 170° from Ilaga.

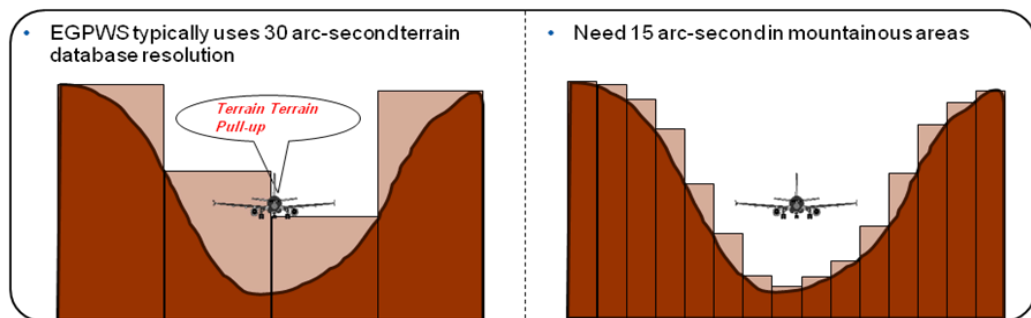
Figure 8: The 30 arc second and 15 arc second resolution comparison

In figure 8 shows that when an aircraft flies in the mountainous area where the terrain database resolution is 30 arcs second, the TAWS or EGPWS will issue a caution or warning even though the distance margin to the terrain is sufficient and safe to conduct the flight. This unnecessary caution or warning may generate nuisance that may annoy the pilot during the flight. According to the statement of several pilots flying in Papua area, to avoid this condition, sometime pilot elected to inhibit or pull the TAWS circuit breaker to silent the nuisance.

Therefore, KNKT recommends to coordinate with the TAWS or EGPWS manufacturer to provide the high-resolution terrain database to meet the requirement of Technical Standard Order (TSO) number TSO-C151c Terrain Awareness and Warning System (TAWS) for Papua area.

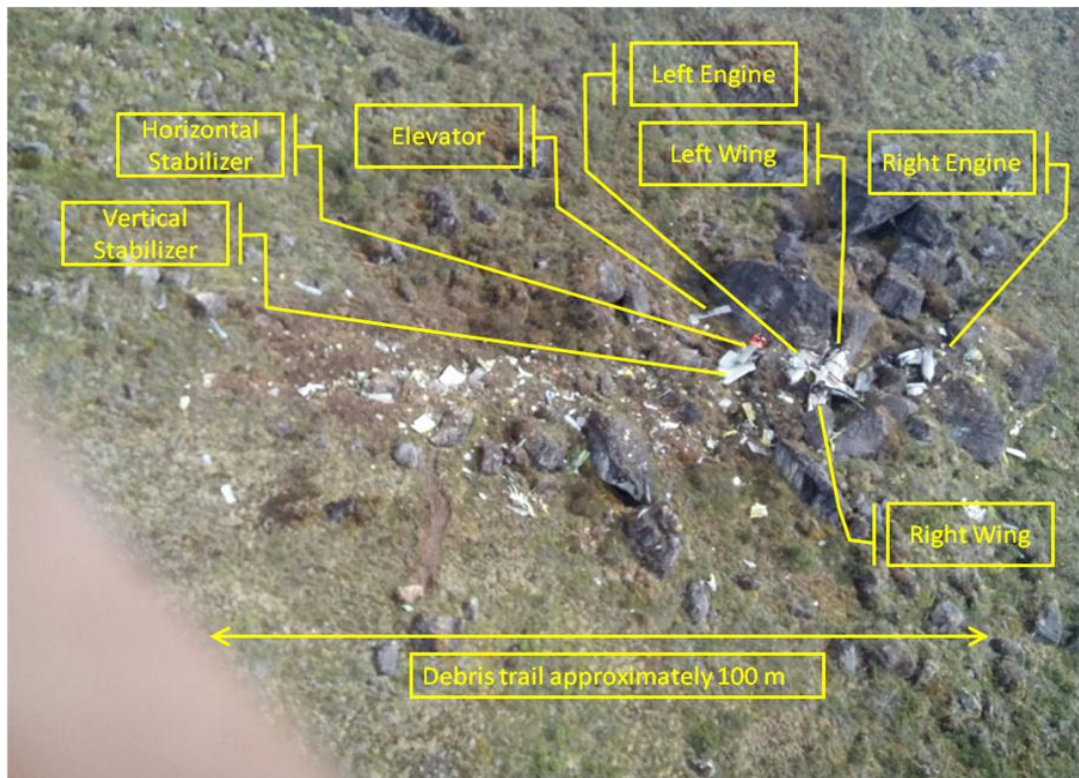
Figure 11: The wreckage distribution

The aircraft wreckage found at the ridge of a mountain on coordinate 4° 5' 55.10" S 137°38' 47.60" E at elevation approximately 13,000 feet. The wreckage spread approximately 100 m long on direction of about 080°.

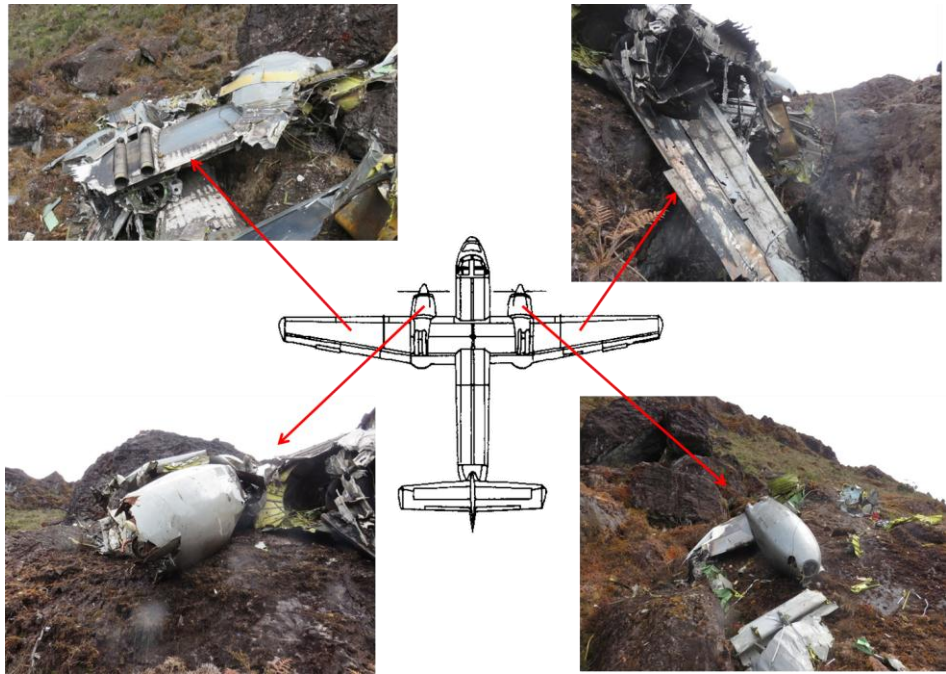
Figure 12: Wings and engines wreckage

All aircraft major parts were found in the one area. The details of identified major components are as follow:

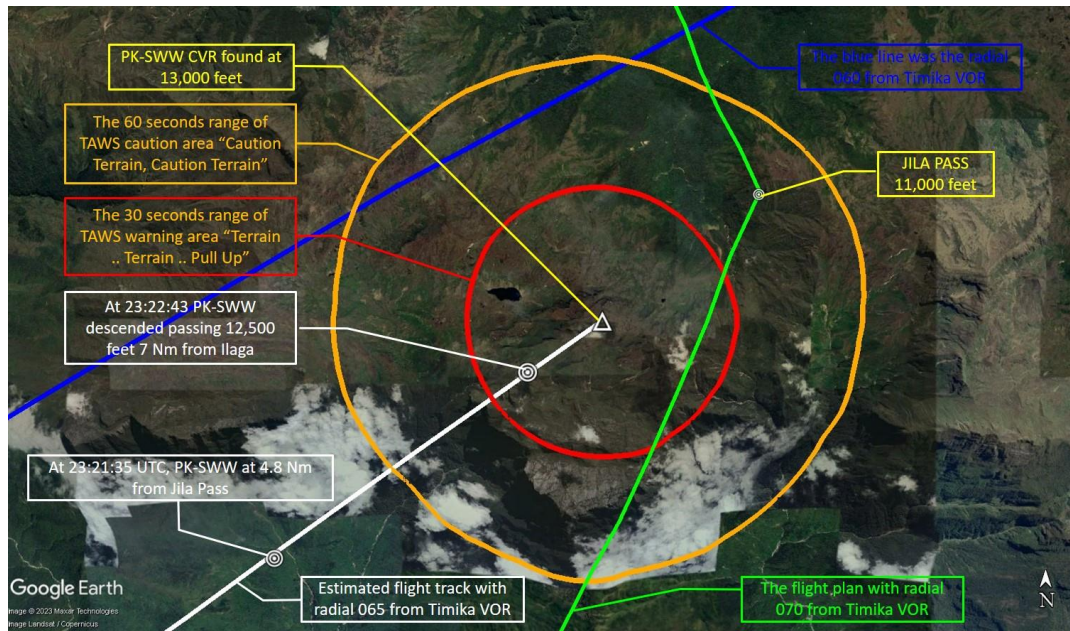
Figure 17: The estimated TAWS caution (amber line) and warning (red line) areas

Assuming the aircraft speed was 120 knots, therefore the 60 seconds TAWS caution area is $S = V \times t$ or $120 \text{ knots} \times (60 \div 3600) = 2 \text{ Nm}$. Hence, the 30 seconds TAWS warning area is 1 Nm.

At 23:22:43 UTC, the SIC reported to the Ilaga FISO informed that the aircraft was on descend passing 12,500 feet and 7 Nm from Ilaga Airport and at 23:22:54 UTC, the aircraft was impacted to the ridge of the mountain. The 60 seconds TAWS caution should have been active at 23:21:54 UTC, and the 30 seconds TAWS warning should have been active at 23:22:24 UTC.

It can be concluded that if the TAWS was functioning properly, 19 seconds or 0.63 Nm after the SIC broadcasted the message that the aircraft was ready for descend, the TAWS caution should have been active and because the pilot did not react to the caution, 30 seconds later the TAWS warning of “Terrain Terrain, Pull Up” should have been active.

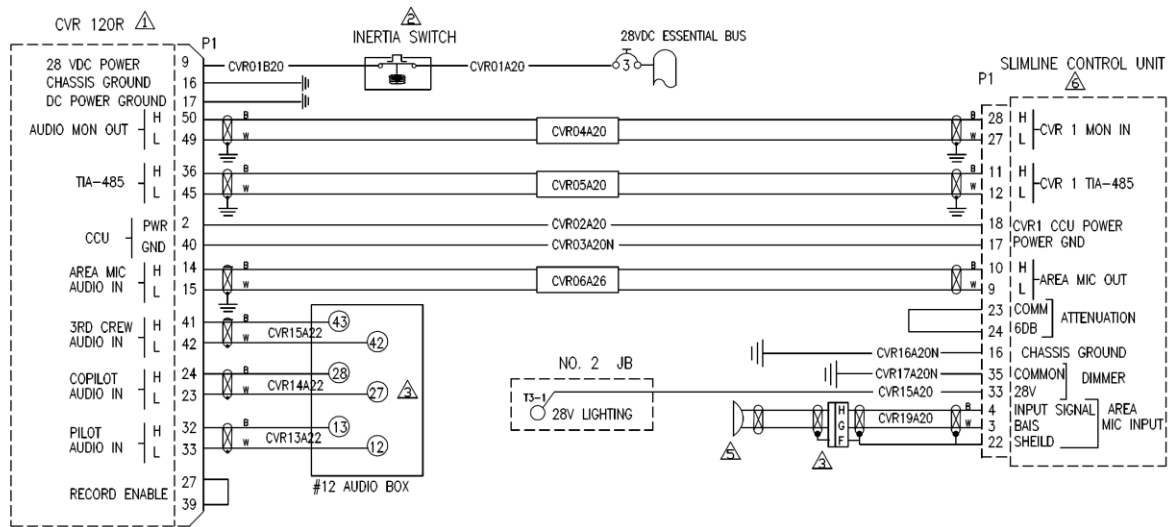
6.2.1 CVR Wiring

After completion of the modification, the investigation revealed that in the modified CVR wiring system of the aircraft, the microphones lines of the SIC, PIC and spare line, were directly hooked to the channel 1 (SIC), 2 (PIC) and 3 (spare) of CVR audio line respectively. As the result, the incoming audio communication and other audio which generated by the aircraft system were not accommodated into the CVR. In addition, it was found that the CVR CAM channel was filled by the engine noise therefore the other station calling or aircraft system sound was not recorded in the CVR. To record audio in the cockpit to the CAM channel of the CVR, the modification probably only rely on the cockpit area microphone input. This design resulted in the any audio in the cockpit was covered by engine noise while the engines were running. The improper modification leads to the CVR important information was unavailable during the investigation.

Therefore, KNKT recommend to review the CVR wiring design so all of the required voices are accommodated in the CVR in all flight phase.

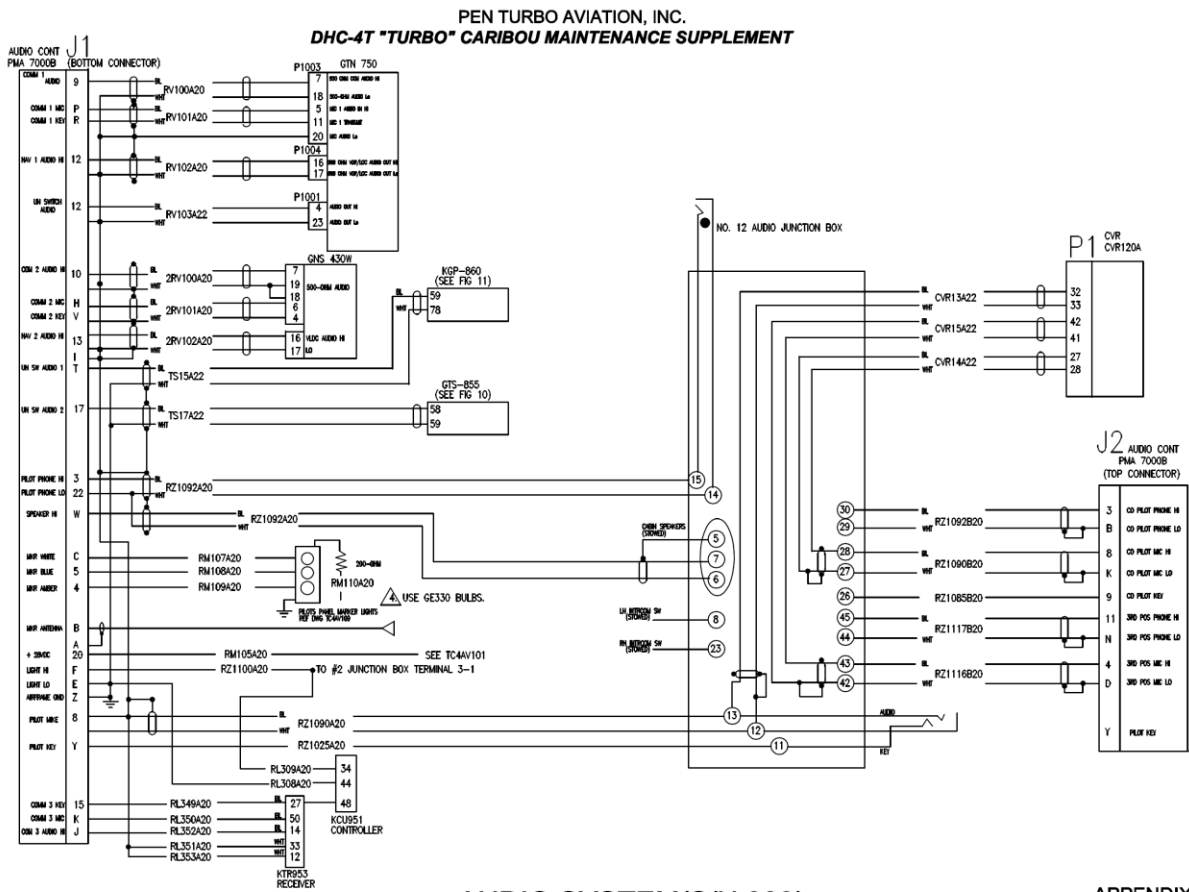
6.2.2 Audio System and CVR Wiring Interconnection

It seems that to provide the audio other than pilot's voice, the modification expected that any audio in the cockpit only rely on the area microphone line to be recorded into the CAM channel of the CVR. It was found when the aircraft was on ground with the electrical system activated and the engines were not operated, the sound surrounding the cockpit was clearly heard from the CAM channel of the CVR, however when the engine were operated, the audio was covered the engine noise. This design resulted in the audio in the cockpit was covered by engine noise while the engines were running.

During the investigation, it was found that the CVR CAM channel was covered by the engine noise and the voice in the cockpit could not be heard. The other station communication and aircraft system alert or warning sound were not recorded in the CVR. The review to the wiring design found that the CVR wiring interconnection had caused in the improper CVR recording.

Therefore, KNKT recommend to review the CVR initial and annual download by the operator was examined properly to ensure that all channels were functioning properly and clearly readable during the whole aircraft operation (in all flight phase).
