**KOMITE NASIONAL KESELAMATAN TRANSPORTASI
REPUBLIC OF INDONESIA**

Aircraft Serious Incident Investigation Report

PT. Nusa Flying International

Cessna 172P; PK-NIZ

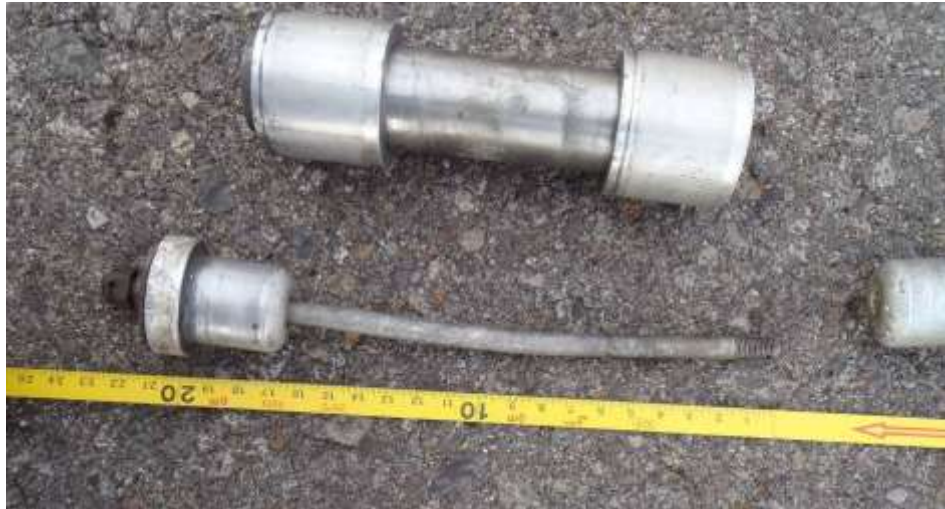
Metal scratch marks were found at touchdown area with approximately 8 meters length. The nose wheel axle stud⁴ (axle stud) was found on runway surface approximately 500 meters from runway threshold. The axle through bolt was found, with condition of the one end of the axle stud nut was still intact including its cotter pin while the other end was found without the nut and its cotter pin.

Figure 2: the nose wheel axle components (castellated nut, washer and cotter pin) found on runway separately

The detachment of the nose landing wheel axle, axle nut and castellated nut, indicated that the cotter pin was not installed or missing. Without the cotter pin, the castellated nut would have been loosening and eventually detached.

1. During Pre-flight inspection the engineer should ensure the installation of the aircraft component including nose landing gear bolt and castle nut is installed with cotter pin.
2. During maintenance or replacement of the nose landing gear, the engineer should install with the new cotter pin and prohibited the re-use of the cotter pin.
3. The engineer should record in the Maintenance Log Book of any replacement of the cotter pin and report to the Storeman.

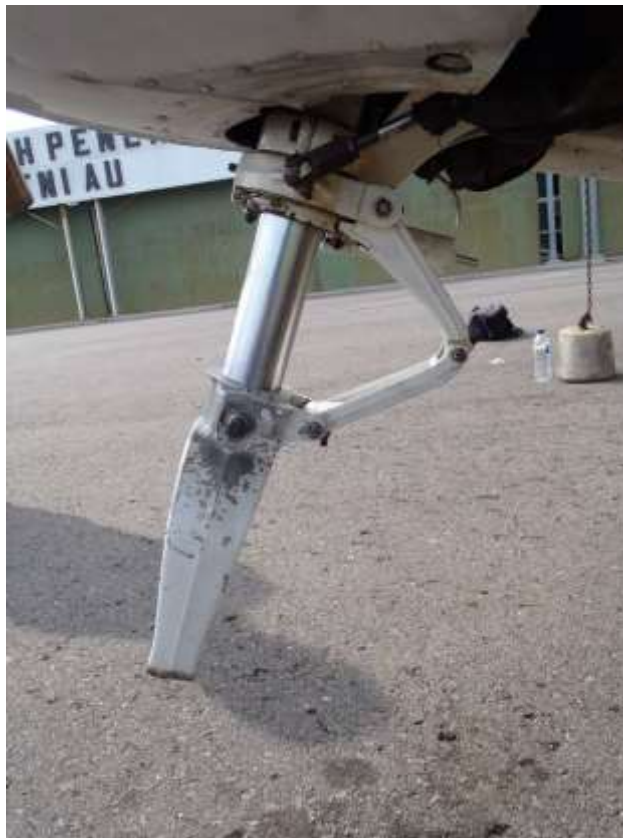
The nose wheel fork found scrap for about 5 centimeters and the propeller tip found bent forward for about 10 centimeters.

Figure 3: The scrap on nose wheel fork

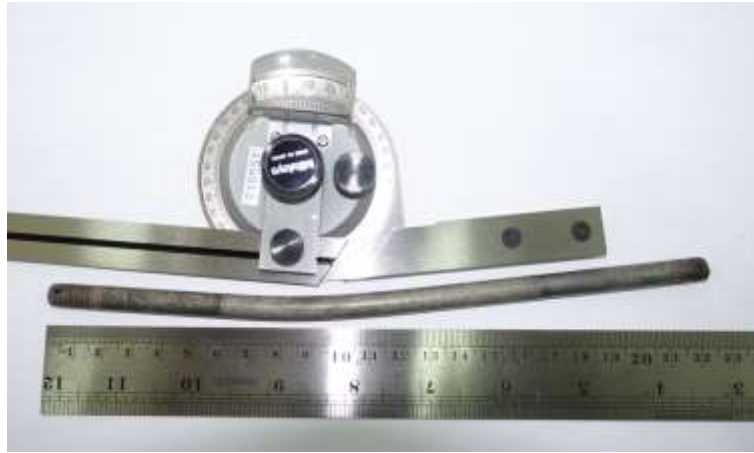
The axle stud exhibit bend approximately 10° at approximately 8 centimeters from short end.

Figure 7: The axle stud

At the end of the axle stud where the nut was missing, the thread experienced in contact with hard object damaging 11 threads from the end of the axle stud.

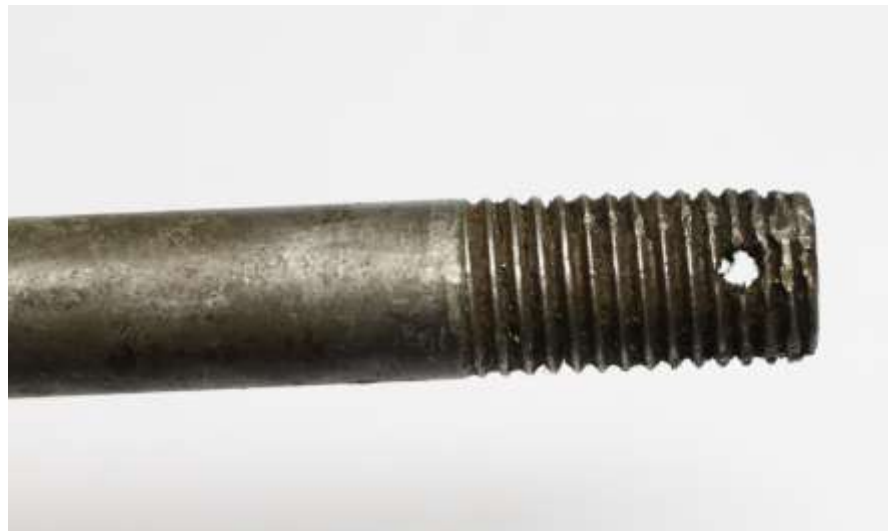
The examination to the cotter pin hole revealed that the hole was contaminated with dirt like grease residue and dust as seen on the figure below.

Figure 8: The dirt in the hole of the axle stud

In summary, the examination showed that the cotter pin hole where the castellated nut was missing exhibit a dirt like grease residue and dust. The cotter pin trace in the cotter pin hole was difficult to be determined under the microscope. The condition of the cotter pin hole installed with the castellated nut and its cotter pin was similar to the cotter pin hole where the castellated nut and its cotter pin was missing. The exception was, a rust was developed inside the cotter pin hole where the castellated nut and its cotter pin was still in place.

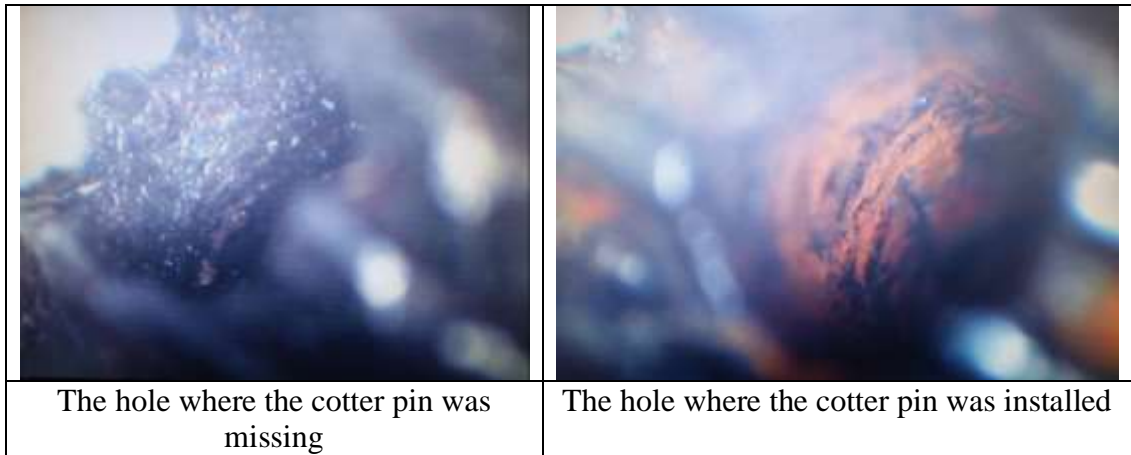
The examination of the hole under the microscope was difficult to determine the trace of a cotter pin because comparing with the other end of the axle stud where the cotter pin was installed revealed the same imagery as shown in the figure below.

Figure 9: Comparison of the cotter pin hole of the axle stud

The cotter pin hole of the axle stud where the nut and its cotter pin were installed exhibit corrosion, indicated by the rust inside of the hole. The rust most likely generated during the operational where the surface of the inner surface of the hole was in contact with the cotter pin while the grease or other lubricative material was not present.

The last maintenance on the nose wheel assembly was to repair on the shock strut and was performed 8 days prior to the occurrence flight. The detached of the nose wheel indicated that the castellated nut had been loosening and detached from the axle stud. The loosening castellated nut indicated that the cotter pin was not installed or eventually missing. Without cotter pin installed, the dirt might had accumulated in the cotter pin hole during the aircraft operation as found during the examination of the cotter pin hole under the microscope. The examination of the cotter pin hole under the microscope showed the similarity between the cotter pin holes where the castellated nut with the cotter pin in place and missing.
