**KOMITE NASIONAL KESELAMATAN TRANSPORTASI
REPUBLIC OF INDONESIA**

Aircraft Accident Investigation Report

Pilatus Porter PC-6, PK-BVM

Ilaga Airport

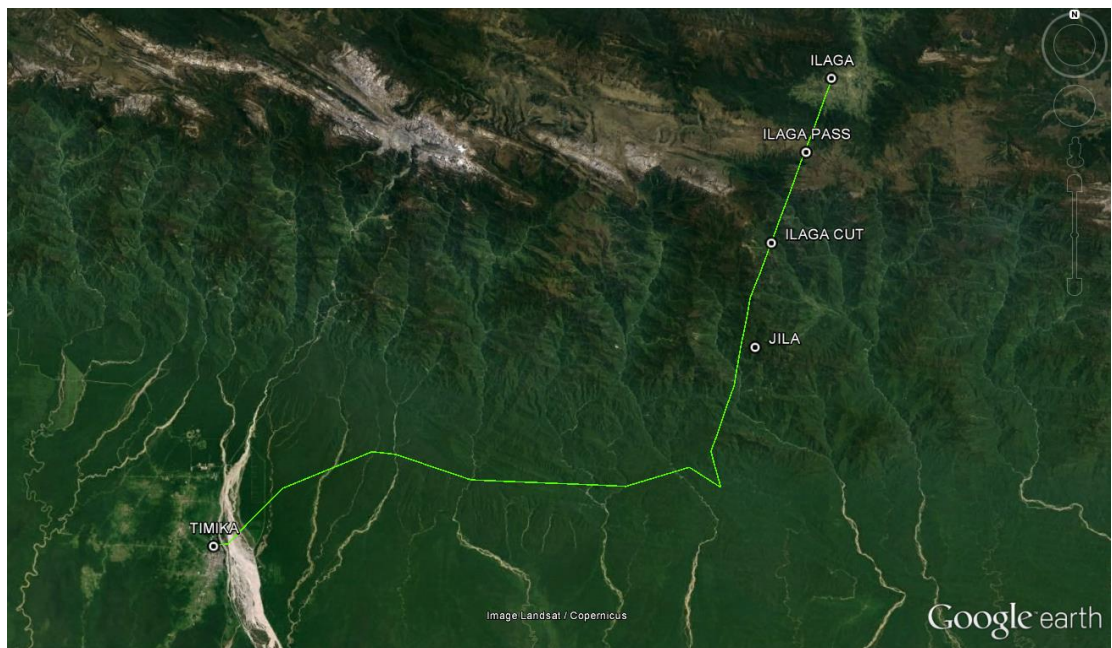
Figure 1: The illustration of the flight path based on flight following

At 0656 LT (2156 UTC³), the aircraft departed Timika and turned left to intercept radial 060 TMK VOR⁴. At approximately 17 Nm from TMK, the aircraft turned right and intercepted radial 080 TMK VOR then climbed to 13,000 feet. At approximately 10 Nm south of Jila, the aircraft turned right directing to Ilaga Cut. When the aircraft position at abeam Jila, the aircraft altitude was 13,500 feet, and then when the aircraft was overhead Ilaga Cut, the pilot turned the aircraft to the right to Ilaga Pass.

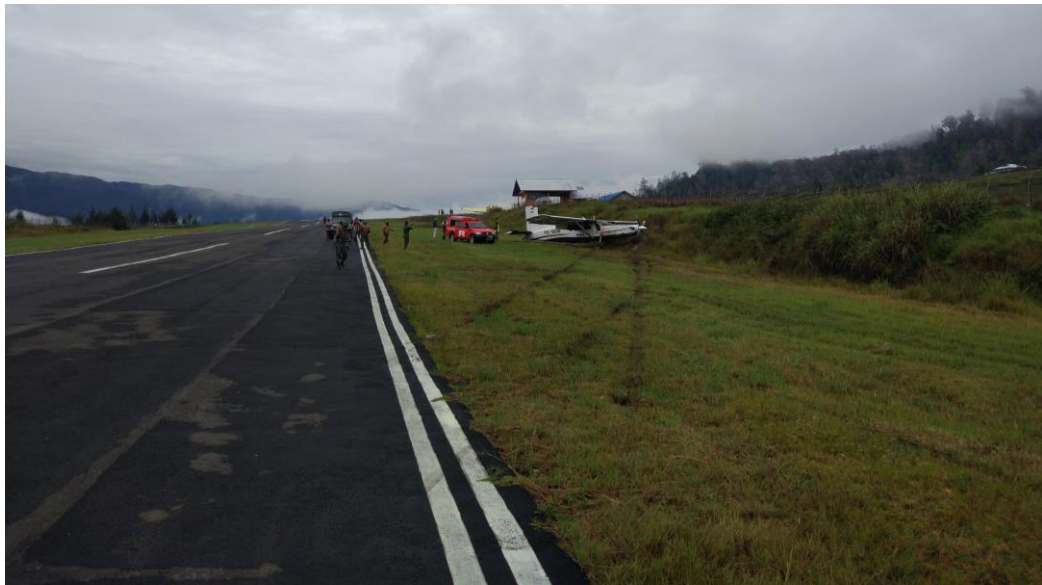
Figure 2: The aircraft last position

The aircraft touched down with three wheels at approximately 100 meters from the beginning runway 25. The pilot felt that the aircraft was slightly on the left of runway centerline, and then the pilot recovered the aircraft by applying right rudder pedal and brake moderately. The aircraft yawed to the right and the pilot recovered by applying full left rudder pedal and full brake. The aircraft continued travelled to the right and veered out of the runway. The right-wing tip hit the slope at the edge of the runway shoulder which was higher than the runway elevation. The aircraft heading changed at approximately 45° and stopped at approximately 20 meters right of the runway pavement.

No one injured in this occurrence. The aircraft was substantially damaged with the right wing broken, tail section bent and the propellers tip bent.

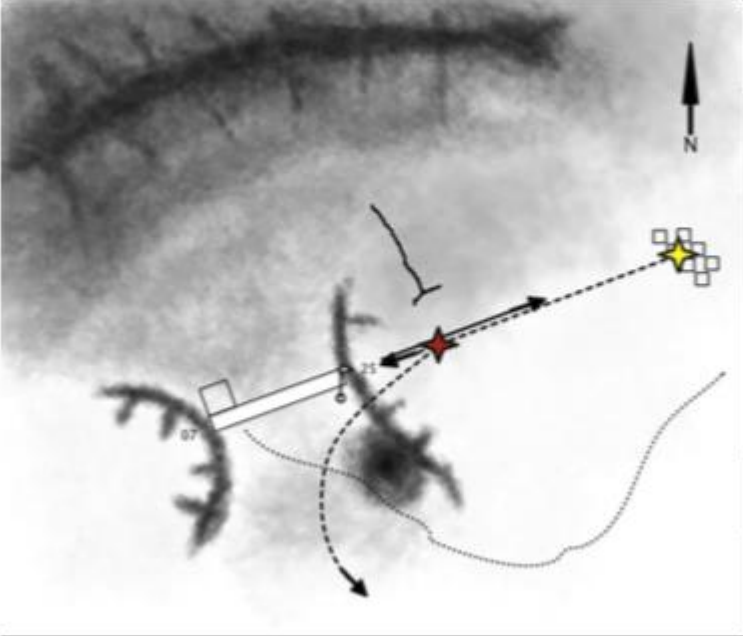
Figure 5: The operator airstrip booklet

The aircraft operator has developed Susi Air Airstrip Booklet dated September 2014 which contained visual guide for Ilaga which stated that the airport elevation was 7500 feet at touchdown zone runway 25 and the elevation of runway 07 was 7,580 feet. The runway surface was sealed which has 2 % down slope and followed by 7% up slope longitudinal toward runway 07.

- The airport information between AIP Indonesia and Susi Air Airstrip Booklet have different information of Ilaga Airport related to the airport elevation and runway slope.
