**KOMITE NASIONAL KESELAMATAN TRANSPORTASI
REPUBLIC OF INDONESIA**

Aircraft Accident Investigation Report

Batik Air Indonesia and TransNusa Aviation Mandiri

Boeing 737-800 (PK-LBS) and ATR 42-600 (PK-TNJ)

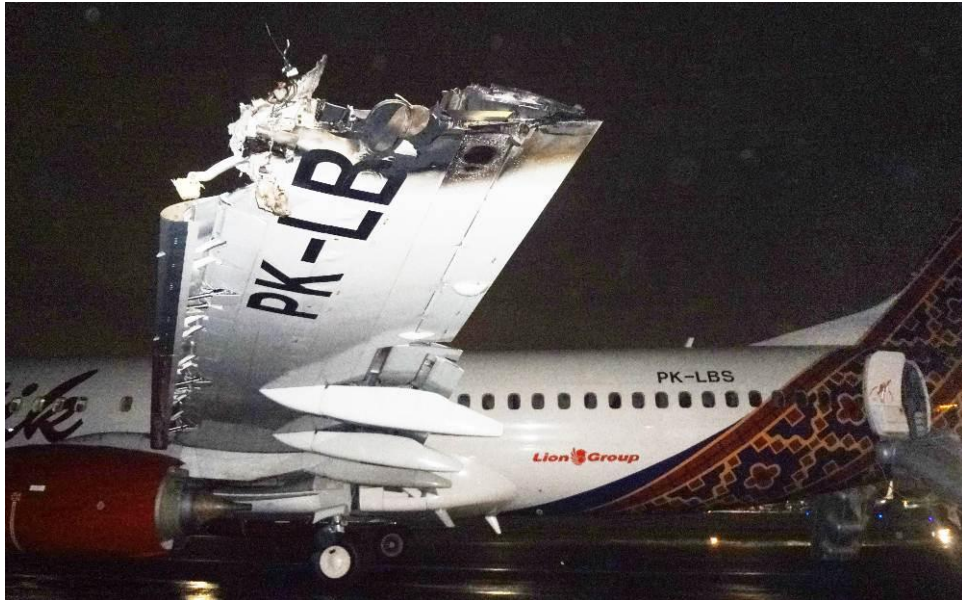
Figure 4: The damaged on left wing

The ID 7703 aircraft was substantially damaged. The damage was as follows:

- The left wing was damaged approximately 575 centimeters from the wingtip. The wingtip detached including part of the aileron and the winglet.
- The wingtip was broken into three large parts.

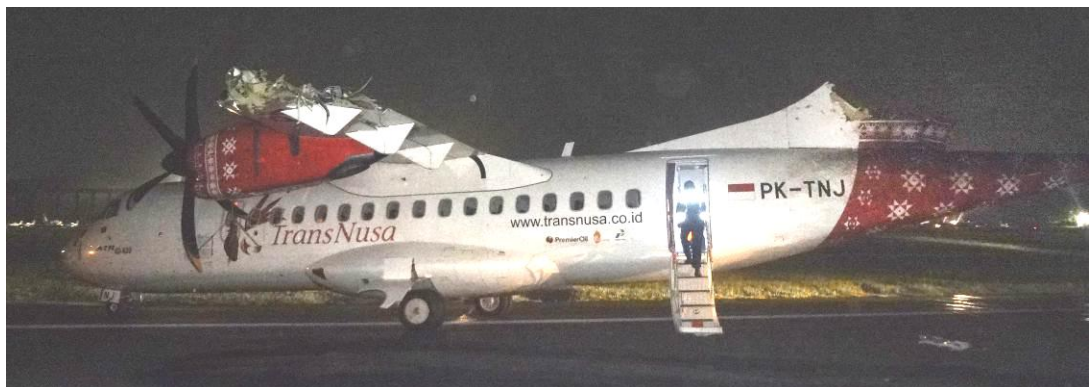
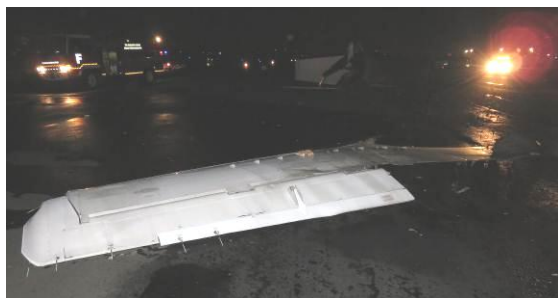
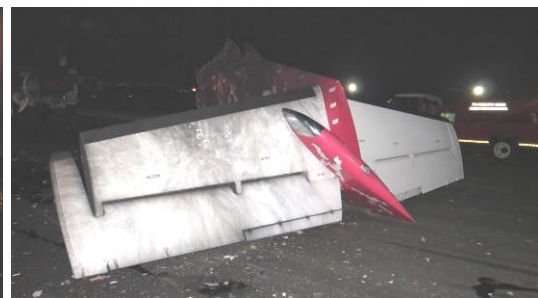
Figure 5: The detached parts of wing and horizontal stabilizer

The towed aircraft was substantially damaged. The damage was as follows:

- The left wing was damaged approximately 260 centimeters from the wingtip.
- The vertical stabilizer was severed from the fuselage, including the horizontal stabilizer.

The detached left wing was found approximately 17 meters behind the towed aircraft. The horizontal stabilizer and the vertical stabilizer found approximately 30 meters behind the towed aircraft.

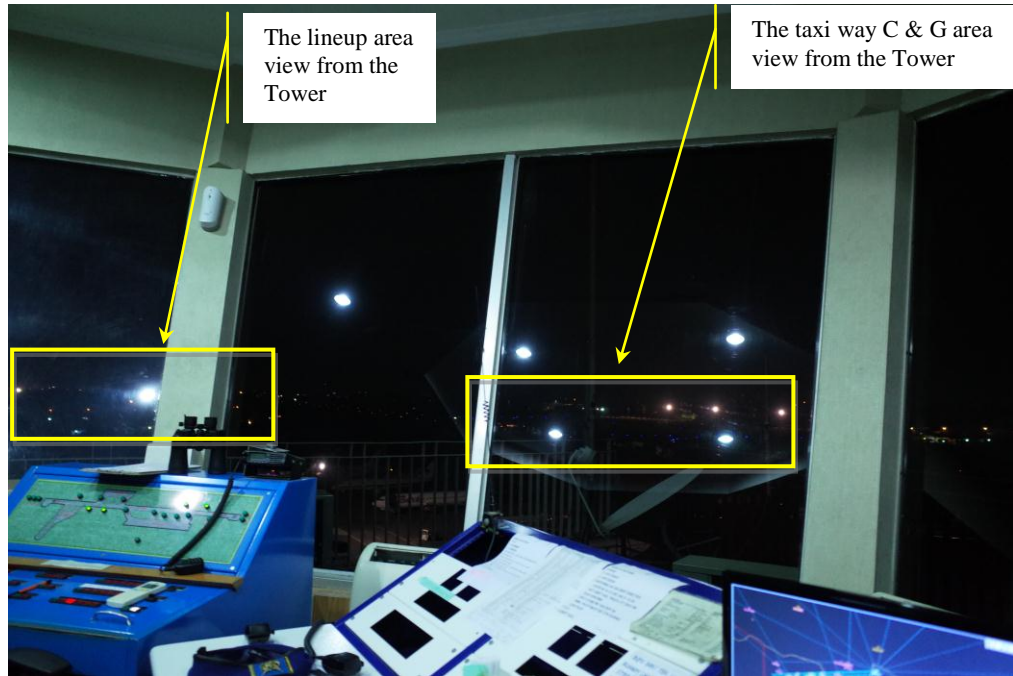
Figure 7: The lighting in Halim Tower cab and the view to the taxiways and the runway

The investigation observed the lighting condition in Halim Tower cab after the occurrence which was similar with the condition at the time of occurrence. The lighting condition as observed is shown on the following figure.

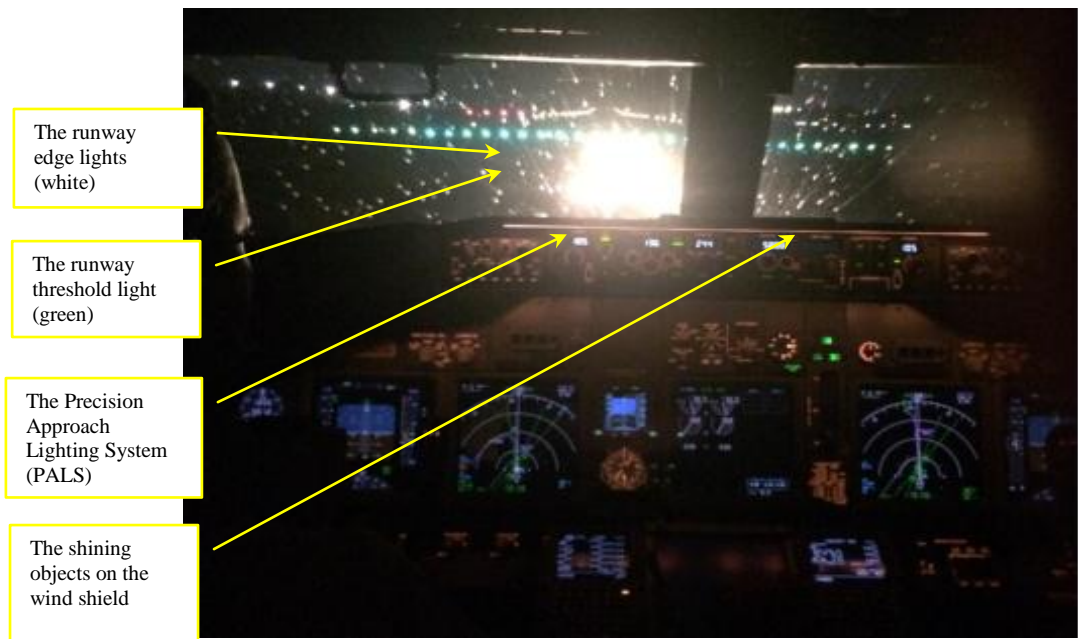
Figure 8: The view from cockpit on the turning pad runway 24 area

The investigation received a photo of the lighting conditions surrounding the turn pad on Runway 24 which was taken on 20 November 2015 by a flight crew during line up (figure 7).

Based on the crew interviews, the lightings situation surrounding the turn pad of runway 24 at the time of occurrence was similar to that visualized in the photo.

In the preliminary report, KNKT issued recommendation to airport operator and AirNav Indonesia branch office Halim to inform aircraft operators to initiate takeoff from the threshold runway 24 of Halim. Until the issuance of this final report, it was found several aircraft initiated the takeoff before the threshold runway 24.

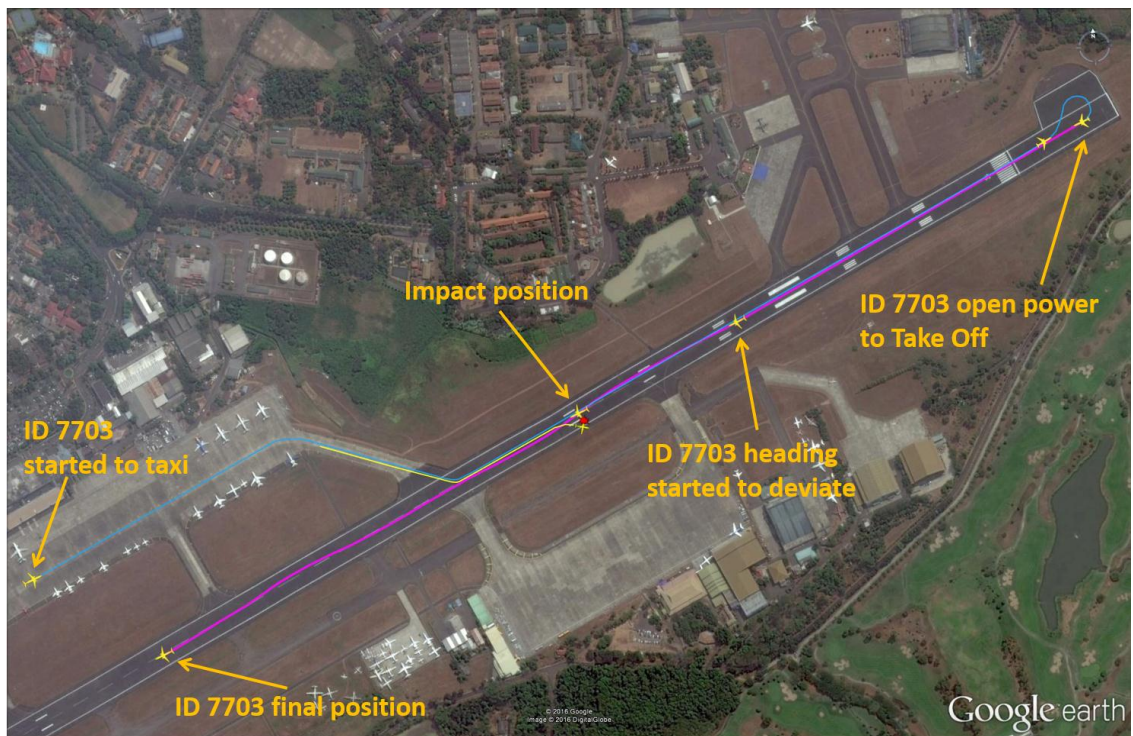
Figure 11: The ID 7703 movement based on the FDR

- 12:57:18 UTC, the speed brake handle extended, and the N1 decreased. The computed airspeed reached the highest value equal to V1⁸ value then the airspeed started to decrease;
- 12:57:19 UTC, the autobrake deactivated, the brake pressure remained on high pressure;
- 12:57:21 UTC, the thrust reversers deployed followed by N1 increased;
- 12:57:35 UTC, the thrust reversers stowed and N1 decreased;
- 12:57:45 UTC, the groundspeed showed 0. The FDR recorded the location was 6° 16' 4.9584" S, 106° 53' 16.9656" E or approximately 1,680 meters from threshold or 1,832 meters from when TO/GA was executed.

The ID 7703 collided with the left wing of the towed aircraft at approximately 866 meters from the threshold of runway 24.

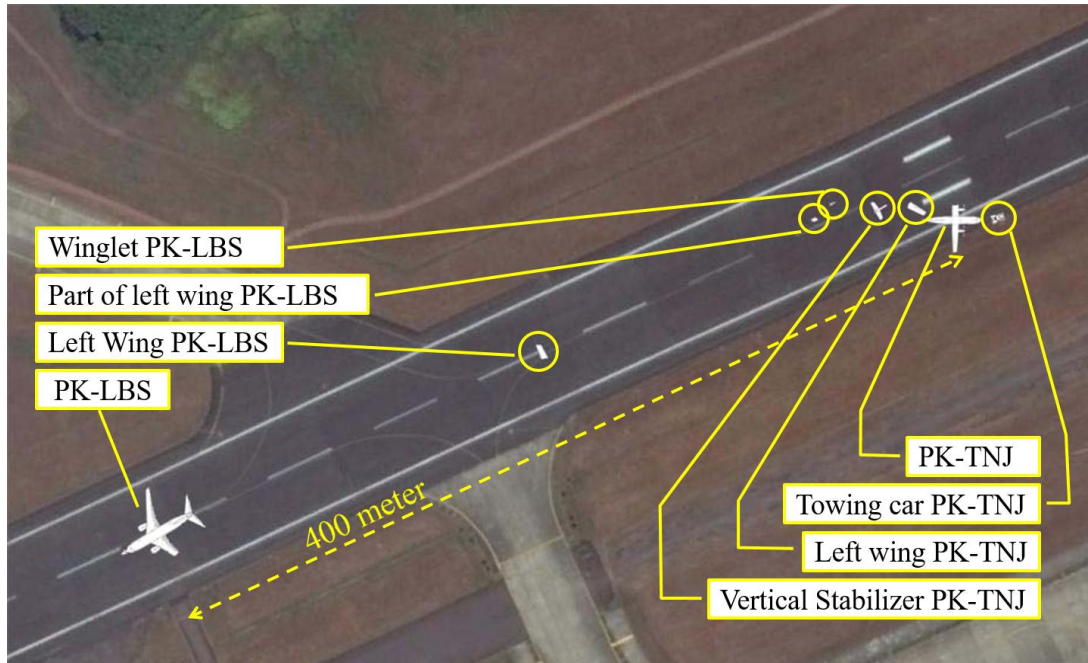
Figure 12: The illustration of the wreckage distribution superimposed to Google earth

The left wing was found damaged in three large parts. The first part was found at approximately 200 meter behind the ID 7703 near the taxiway H, while two other parts (winglet) found approximately 350 meters behind the ID 7703.

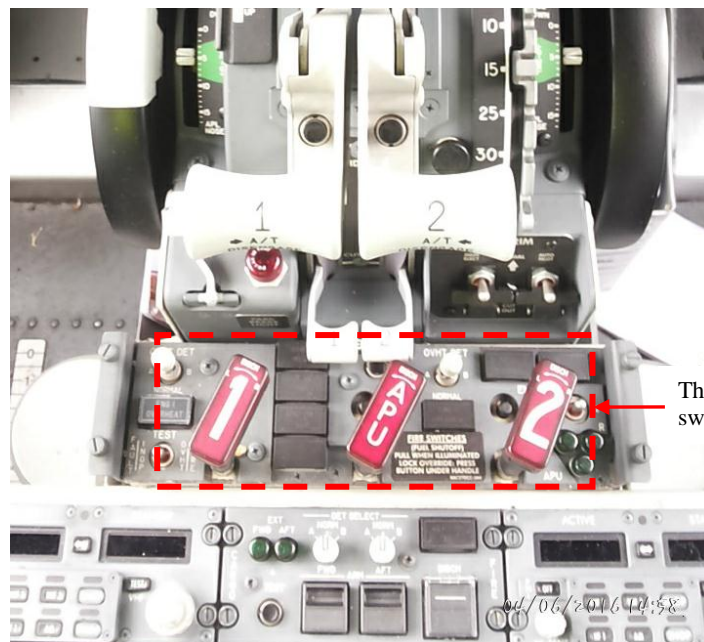
Figure 13: The ID 7703 fire switches activated

Both Engines and the Auxiliary Power Unit (APU) fire switches were pulled and rotated to the right.

The Engines and APU Fire switches position.

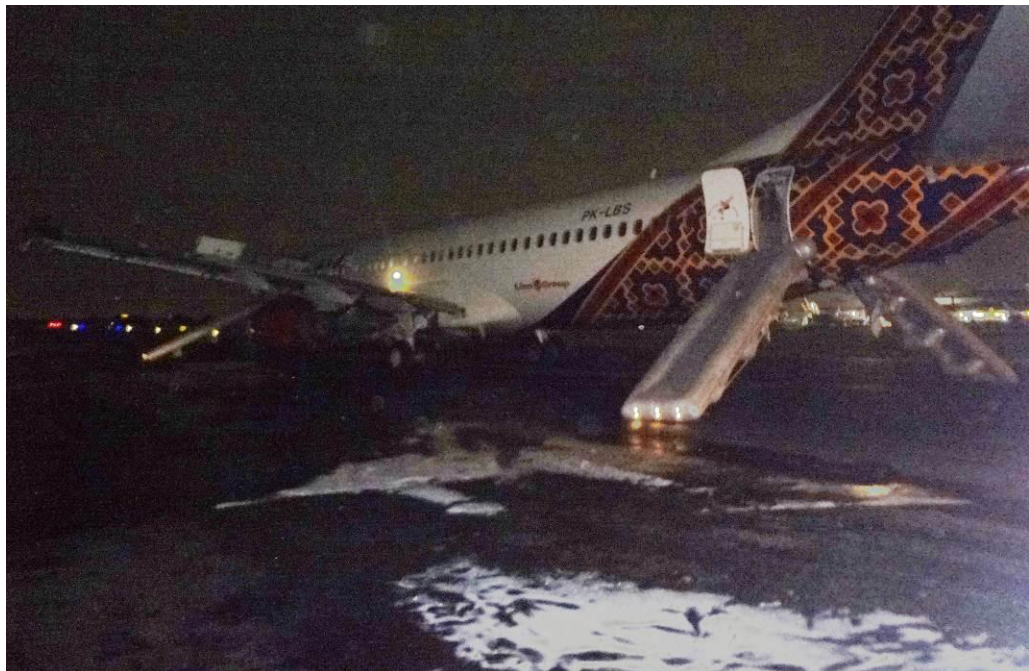
Figure 14: The ID 7703 showing deployed escape slides

On ID 7703 aircraft, all escape slides were deployed by the flight attendants and the passengers were evacuated through the escape slides safely. The passengers and the crew were then transported by bus to the passenger terminal.

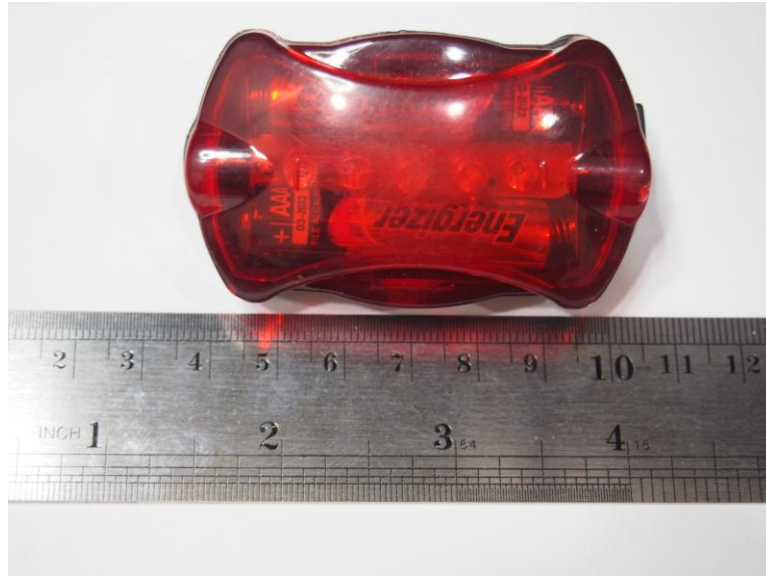
Figure 16: The portable light fitted on the wing tips of the towed aircraft

The investigation found red and green commercial strobe lights with dimension approximately of 8 × 3 cm (figure 15). These lights were used as alternate portable anti-collision & navigation lights installed in towed aircraft.

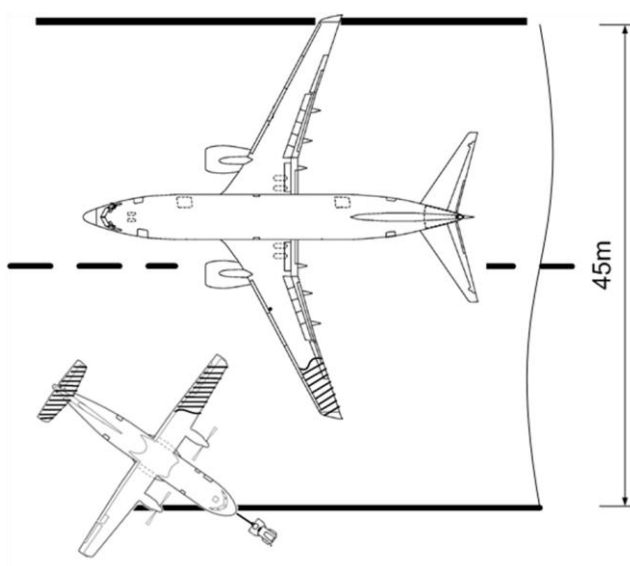
Figure 27: Illustration of the impact

Both aircraft had moved away from the runway centerline, however the ID 7703 left wing collided with the left wing and the vertical stabilizer of the towed aircraft. The illustration of the impact is depicted in the figure below.

The decision of both the pilot and the towing car driver to move away from the runway centerline avoided a centerline (head to head) collision however the wing collision was unavoidable. The wing collision was less severe compared to an aircraft collision on the runway centerline.
