PRELIMINARY REPORT

KNKT.16.10.32.04

Aircraft Serious Incident Investigation Report

Cessna 208B EX; PK-LTV

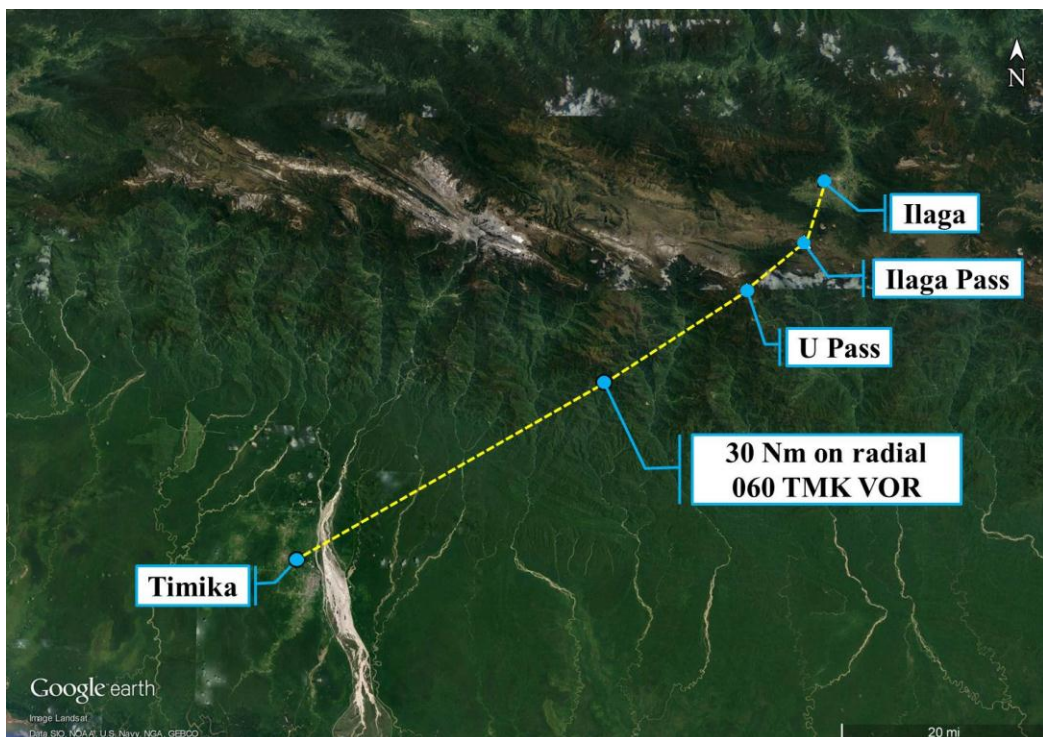
Figure 1: The illustration of the flight path

The aircraft flew to north east of Timika and at about 30 NM from Timika, the pilot changed the aircraft heading to U Pass⁴. Thereafter, the flight was flown to Ilaga Pass⁵ and descent to altitude of 12,500 feet after maintained altitude of 13,000 feet for about 5 up to 10 minutes.

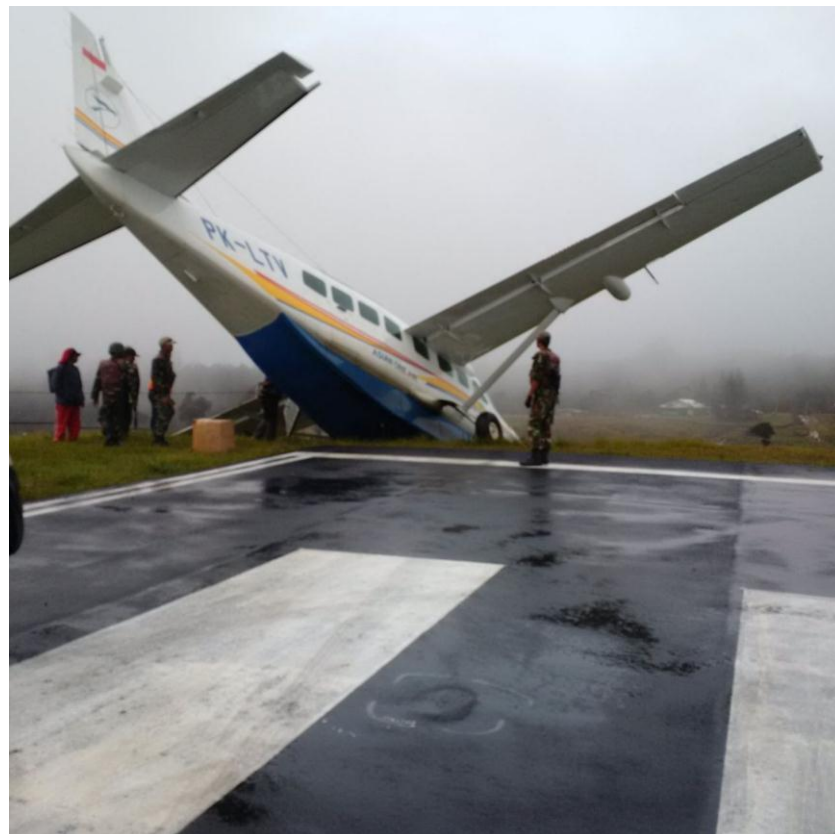
Figure 2: The aircraft last position

The aircraft overrun the runway and stopped on the left corner of the end runway 25 and the propeller impacted the ground. No one injured in this serious incident.

The aircraft was substantially damaged with the nose landing gear collapsed and the propellers bent backward.

To ensure the operation of flights conducted under Visual Flight Rules (VFR) performs according to the VFR limitations.

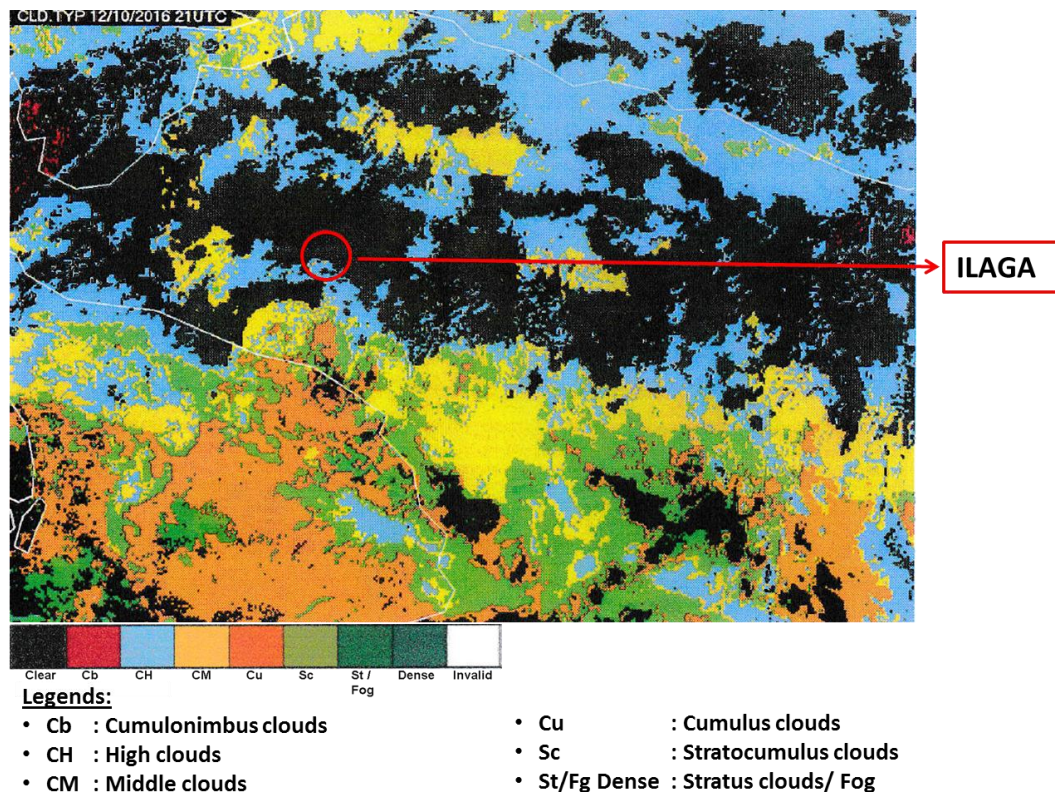
Figure 3: Satellite image at 2100 UTC

The following satellite images were provided by *Badan Meteorologi Klimatologi dan Geofisika* (BMKG – Bureau of Meteorology, Climatology and Geophysics) at 2100 UTC and 2200 UTC (figure 3 and 4). The images indicated a development of middle, and high clouds⁶ around Ilaga during the occurrence flight.
