**KOMITE NASIONAL KESELAMATAN TRANSPORTASI
REPUBLIC OF INDONESIA**

FINAL
KNKT.16.06.21.04

Aircraft Accident Investigation Report

**Nusa Flying School
Cessna 172P; PK-NIV
Demak, Central Java
06°48.094'S, 110°35.011'E
Republic of Indonesia
20 June 2016**

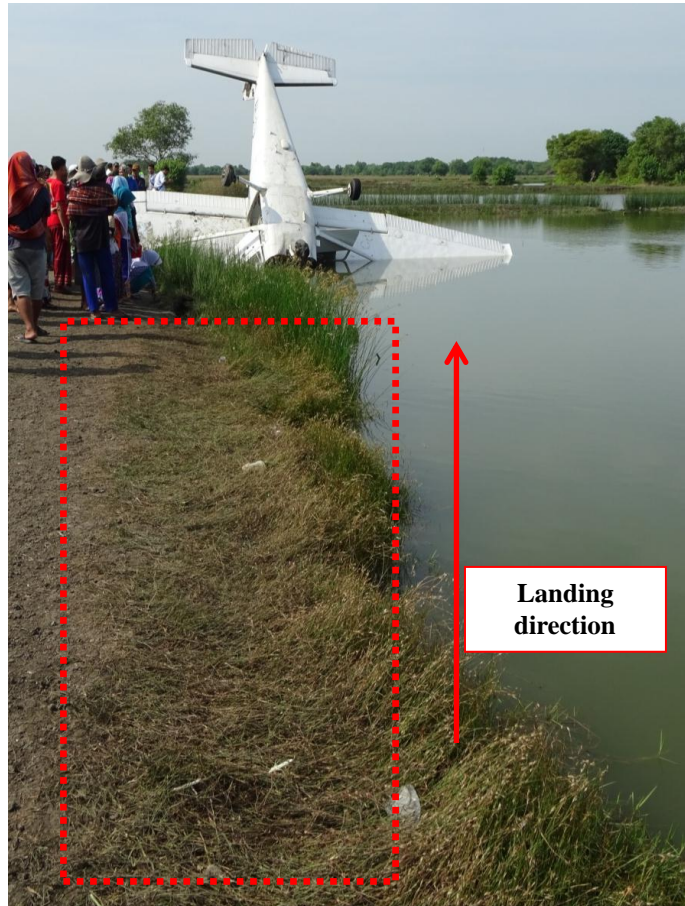
Figure 4: Wheel mark on the fishpond access road and aircraft final position

On the fishpond access road, toward the direction of the flight, found mark on heading approximately 130°.

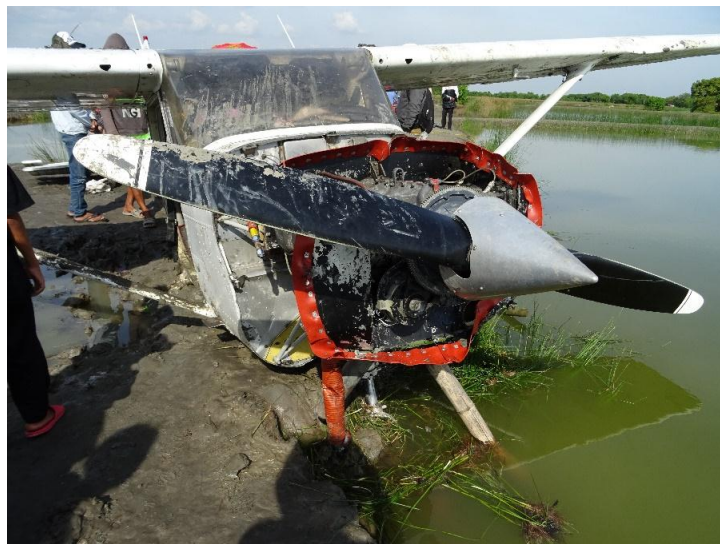
Figure 5: Propeller condition

The propeller blades found intact and no evidence of impact damage.

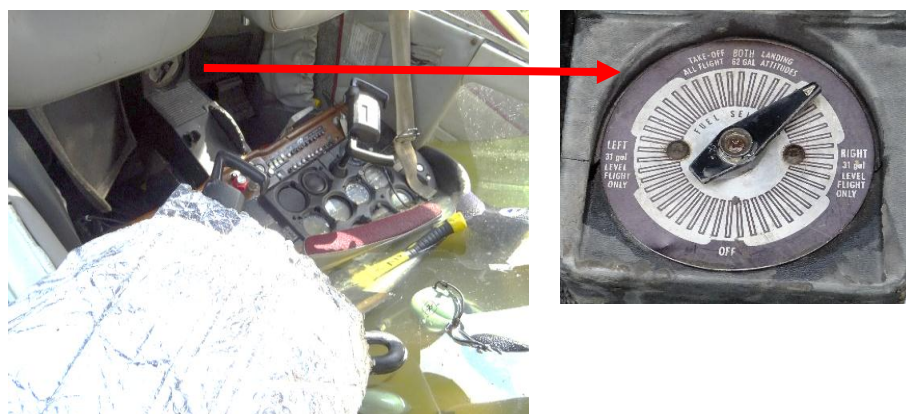
Figure 6: The fuel selector valve position found after impact

The investigation found that the fuel selector was on 2 o'clock position between position BOTH and RIGHT.

On the accident site, the investigation found that the fuel selector was on 2 o'clock position between BOTH and RIGHT. The student pilot noticed this condition while conducted the procedure to identify the cause of the engine failure.

The fuel selector valve is mechanically controlled and selecting the valve on intermediate position between any detent will cause the fuel valve partially open or even totally close. This resulted to improper fuel flow to the engine. The engine ground run test with the fuel selector position in between BOTH and RIGHT concluded the engine stopped not more than one minute.

The investigation concluded that the cause of the engine failure in flight was improper fuel flow to the engine as the fuel selector valve was on intermediate position between BOTH and RIGHT. The fuel test was found that the octane number was below the minimum required however, the engine examination did not find any indication of improper combustion to the engine.

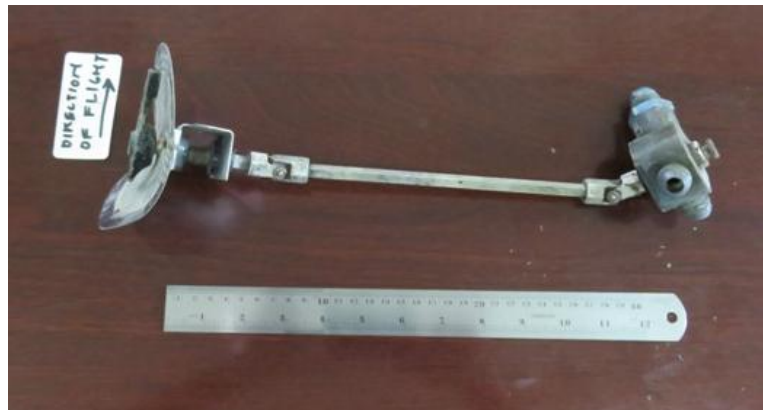
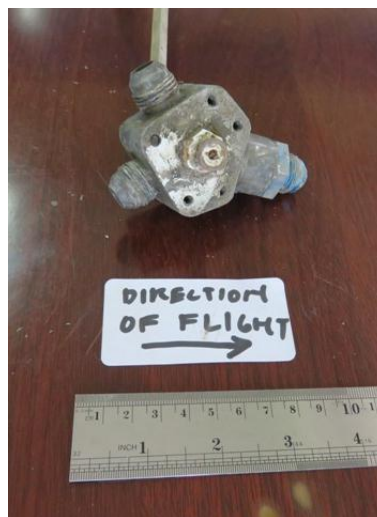
Figure 8: Fuel selector valve

The selector cannot move inadvertently in any position because the valve was equipped with detents to ensure the valve properly selected on the desired position. The examination found that the fuel selector valve was working properly.

9. The fuel selector test found that if the selector handle was positioned in between of any selected label (e.g. between "LEFT and BOTH", "RIGHT and BOTH", "LEFT and OFF", and "RIGHT and OFF") the valve was partially open or even totally close in certain position.

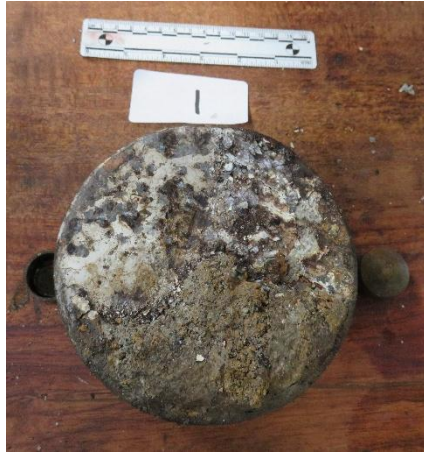
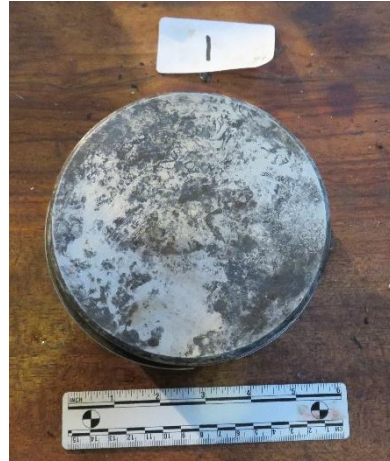
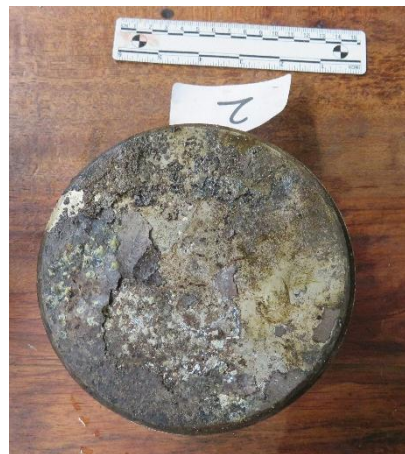
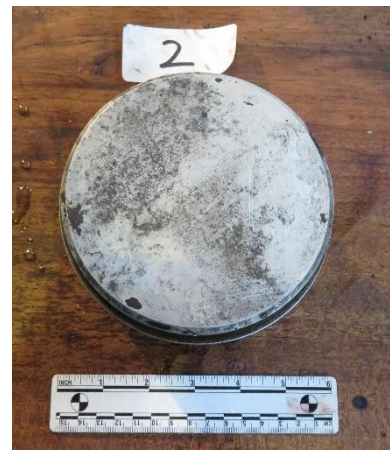
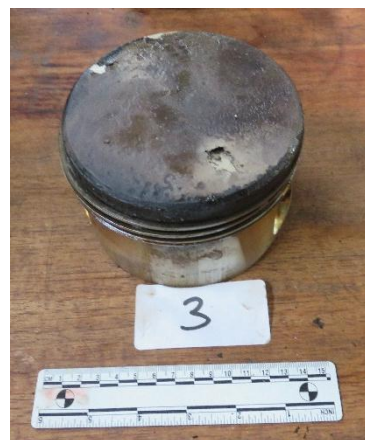
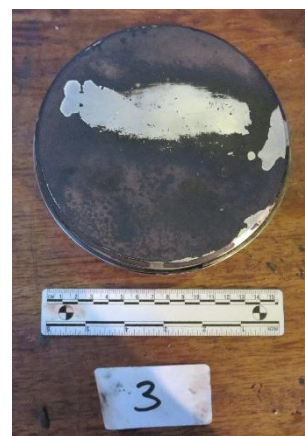
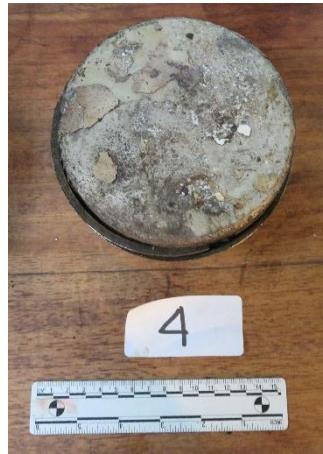
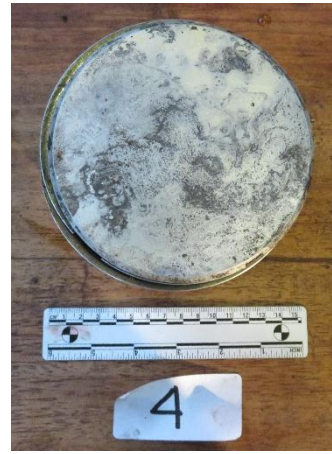
After the pistons had been cleaned, the crown pistons were visible. The black marks on the pistons were the sign of corrosion that possibly caused by submerged in the water. The corrosion occurred since the coating on the crown piston had eroded.

The coating on the crown piston eroded also might cause by detonation. The eroded on the crown piston led to the exposure of the piston metal to the air and oxidized. The oxidation created the corrosion.

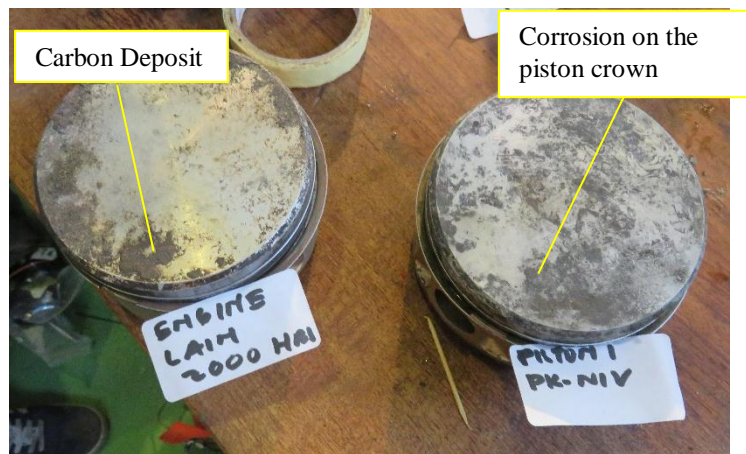
Figure x: Comparison of PK-NIV piston with another piston (left side)

The piston of the accident aircraft was compared to another piston that has 2,000 flight hours.

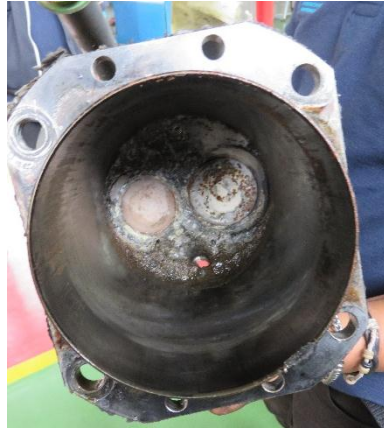
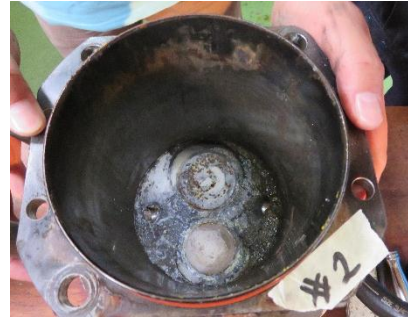
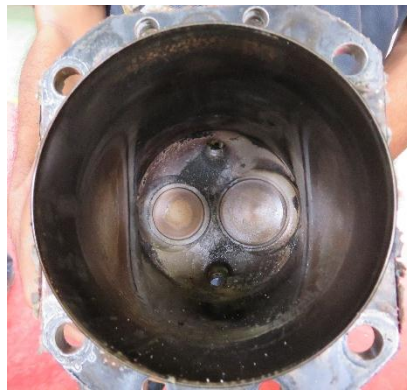
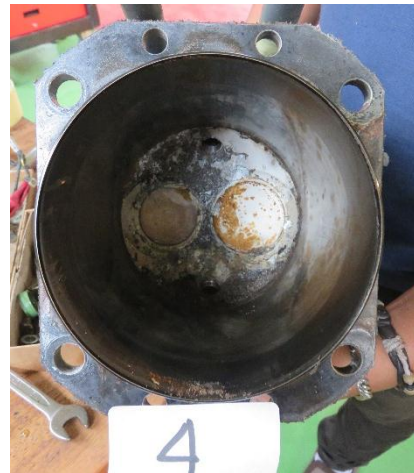
It concluded that all cylinders and pistons were in normal condition.
