**KOMITE NASIONAL KESELAMATAN TRANSPORTASI  
REPUBLIC OF INDONESIA**

**Aircraft Accident Investigation Report**

**PT. Amur Aviation Indonesia**

**Helicopter Bell 206L-4; PK-UAG**

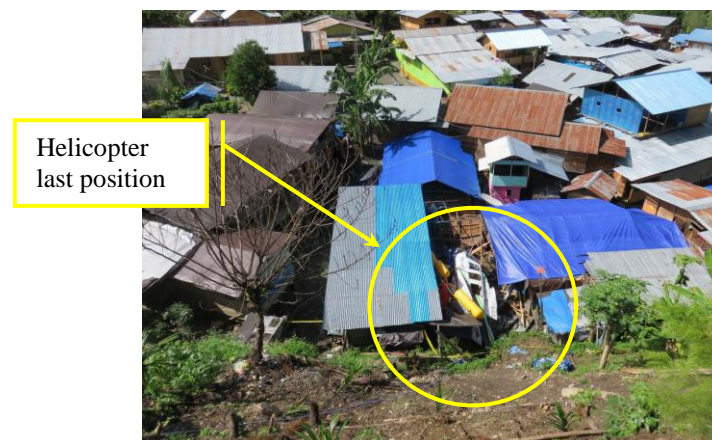
**Figure 1. The helicopter last position**

At 0040 UTC, the helicopter arrived at Spot 99 area at the altitude approximately 150 feet. The helicopter approached to Spot 99 helipad on inbound heading 066 then turned right for proceeding final approach from the north of the helipad. At about 30 feet Above Ground Level (AGL) and speed approximately of 10 – 15 knots the helicopter entered spin to the right. The pilot pushed the cyclic stick with intention to gain the speed and applied left rudder pedal to recover the spin. The spin was not recovered and the pilot decided to close the power lever to idle and impacted to the roof of local housing near the helipad at coordinate 3° 36' 2.60" S 136° 18' 15.61" E.

The pilot was seriously injured and three passengers were not injured. Two local houses were severely damage. The helicopter substantially damaged as result of impact forces.

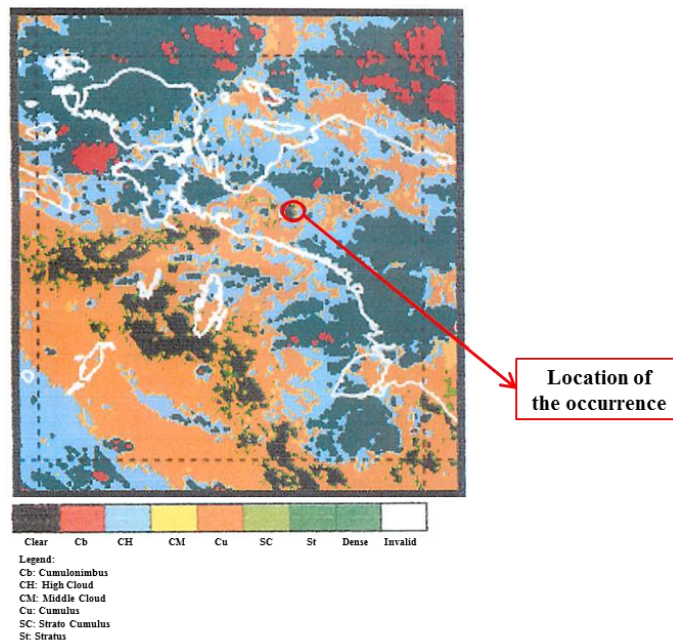
**Figure 2. Satellite image at 0100 UTC**

A satellite image provided by *Badan Meteorologi, Klimatologi dan Geofisika* (BMKG – Bureau of Meteorology, Climatology and Geophysics) on 0100 UTC indicated development of Cumulus clouds around the Spot 99 area (red circle). The cumulus clouds usually have their bases in the low altitude from the earth surface up to 6,500 feet and their vertical extent is often that their tops may reach into the middle and high clouds<sup>4</sup>.

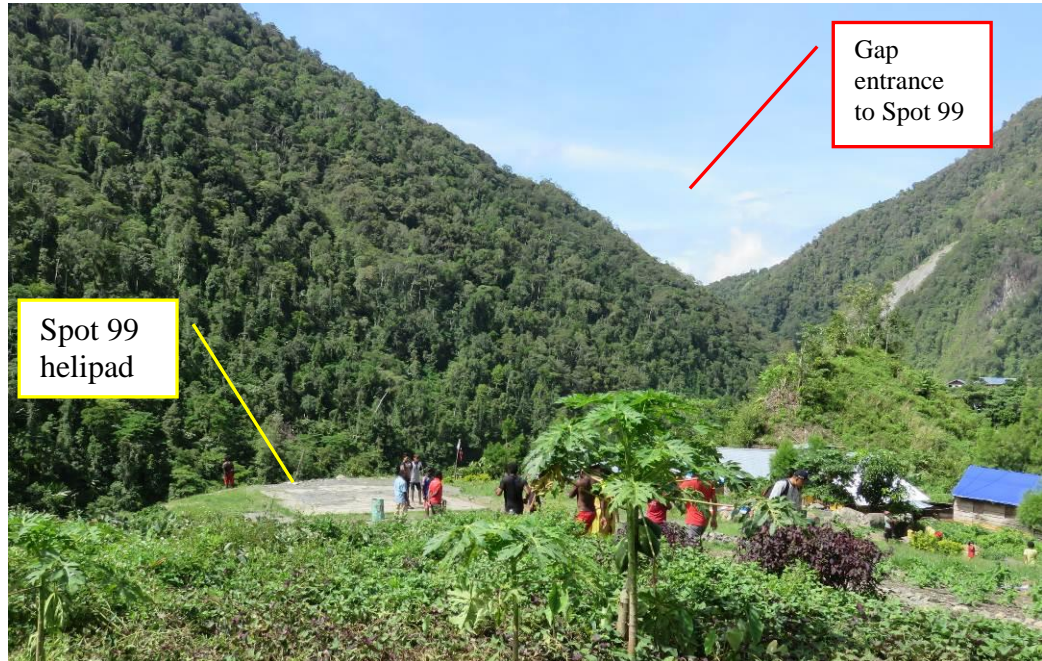
**Figure 3. Helipad Spot 99 and the gap for entry and exit the area**

The Spot 99 helipad located at coordinate 3° 36' 6" S 136° 18' 14" E approximately 20 Nm from Enarotali on direction 350° with elevation of 3,257 feet. Only one gap available for entry and exit the area. The helipad used for transportation of person and equipment of the traditional gold mining.

Several experienced pilots familiar with the Spot 99 stated that the approach to this helipad normally initiated from the river on inbound heading 060°, when go around required, the pilot shall make turn right while gaining the altitude approximately 1,000 feet and return to inbound for another attempt to land.

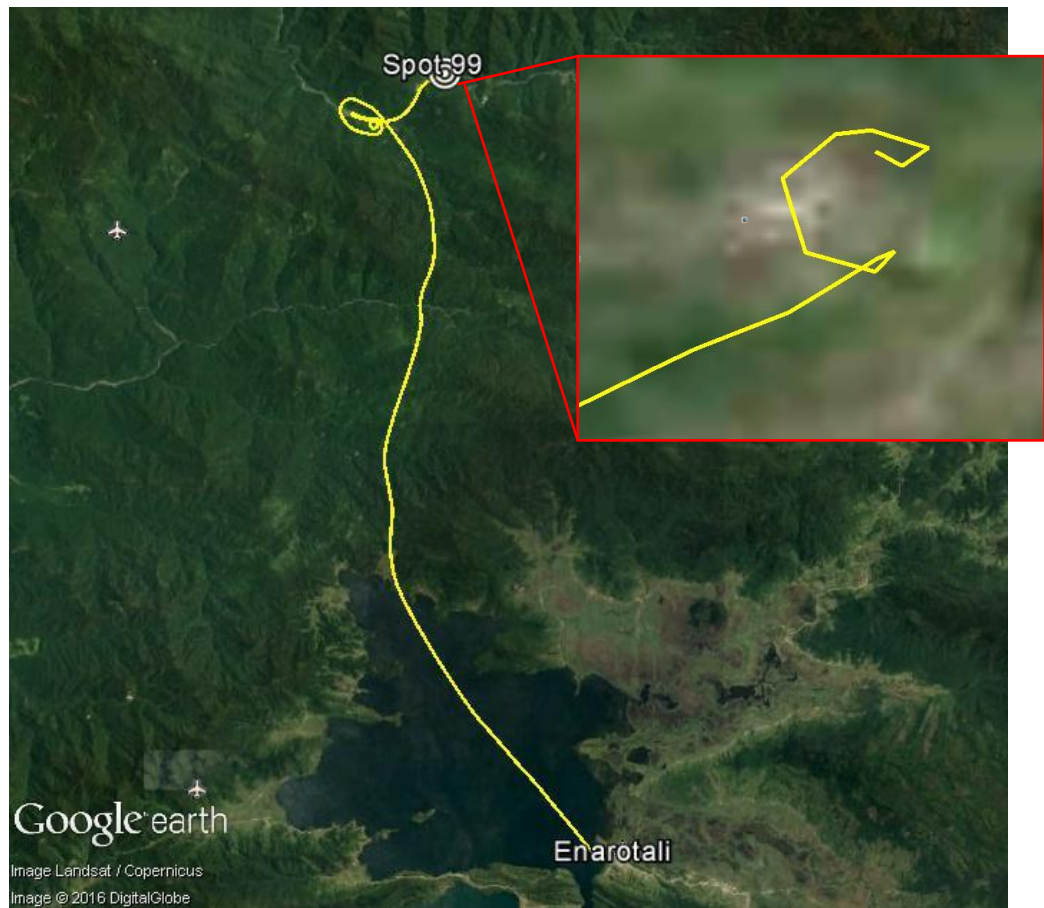
**Figure 4. The flight path from Enarotali to Spot 99**

The pilot was fitted with a Global Positioning System (GPS) Garmin GPS Map 296. The GPS was recovered from the accident site. The GPS data was successfully retrieved and contained the several information of the flight.

The helicopter flight track retrieved from the GPS and superimposed to the Google earth is as follow:

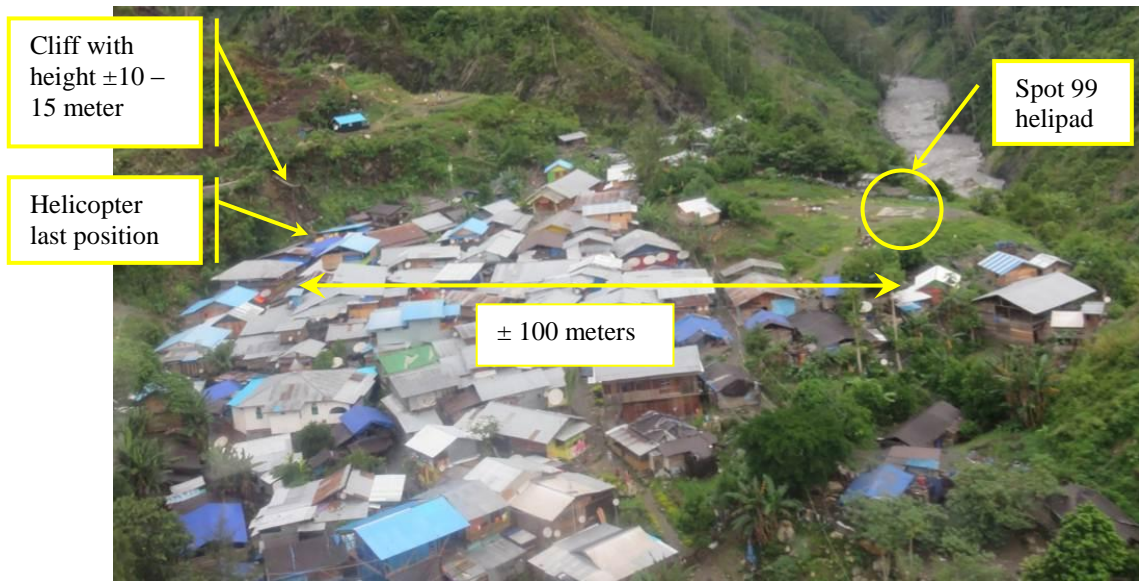
**Figure 5. Aerial view of crash site**

The helicopter crashed at a local house which at coordinate  $3^{\circ} 36' 2.60''$  S  $136^{\circ} 18' 15.61''$  E approximately 100 meter on radial  $30^{\circ}$  from the Spot 99 helipad at elevation of 3,240 feet. The location was near the cliff with height approximately 10 – 15 meters. The heading of helicopter wreckage was  $210^{\circ}$  and the floatation devices were inflated. The main rotor blades and the tail boom detached and found within radius approximately 2 meters.

The figure below shows the location of the helicopter wreckage relative to the Spot 99.

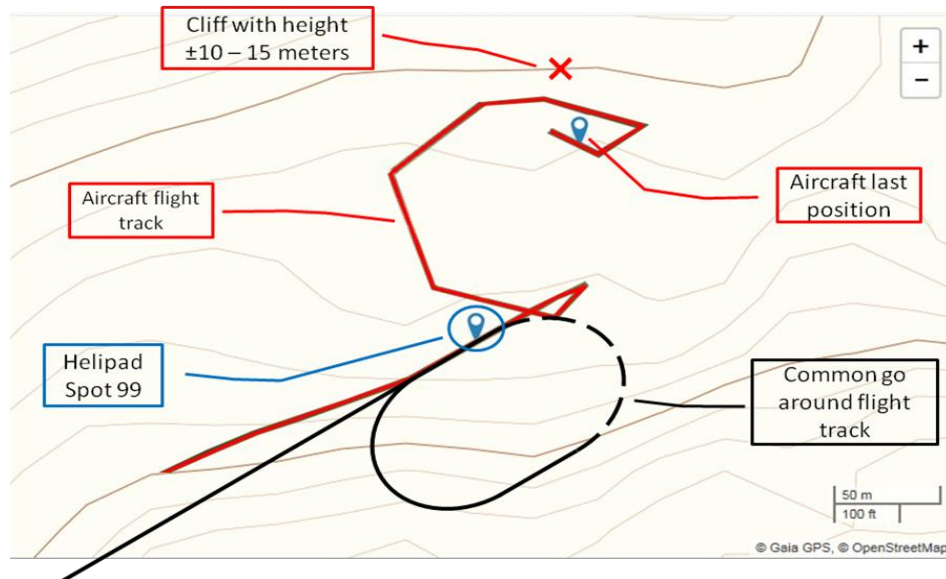
**Figure 8. Illustrated actual flight track and common go around flight track**

Several pilots experienced to the Spot 99 stated that to reach this location, the track was conducted by flying over the river with inbound heading of 060°. If a go-around should be conducted, make right turn while gaining altitude up to approximately 1,000 feet and make another approach over the river.

The illustration of the common approach compared to the accident flight is showed in the following picture.

The accident flight was the first flight for the pilot to Spot 99 therefore reconnaissance was required, however the location and terrain prevented a high reconnaissance. This may have resulted in a lack of awareness of the pilot to the estimate of the height of surrounding terrain, the presence of obstacles, the size of the area, and the slope of the terrain. The approach was conducted in a limited space without anticipating abnormal condition. During approach, the helicopter experienced LTE and the helicopter entered the spin. The recovery action was conducted correctly however due to the limited space the spin was unrecoverable.
