**KOMITE NASIONAL KESELAMATAN TRANSPORTASI
REPUBLIC OF INDONESIA**

Aircraft Serious Incident Investigation Report

Malaysia Airlines

Boeing 737-800; 9M-MXH

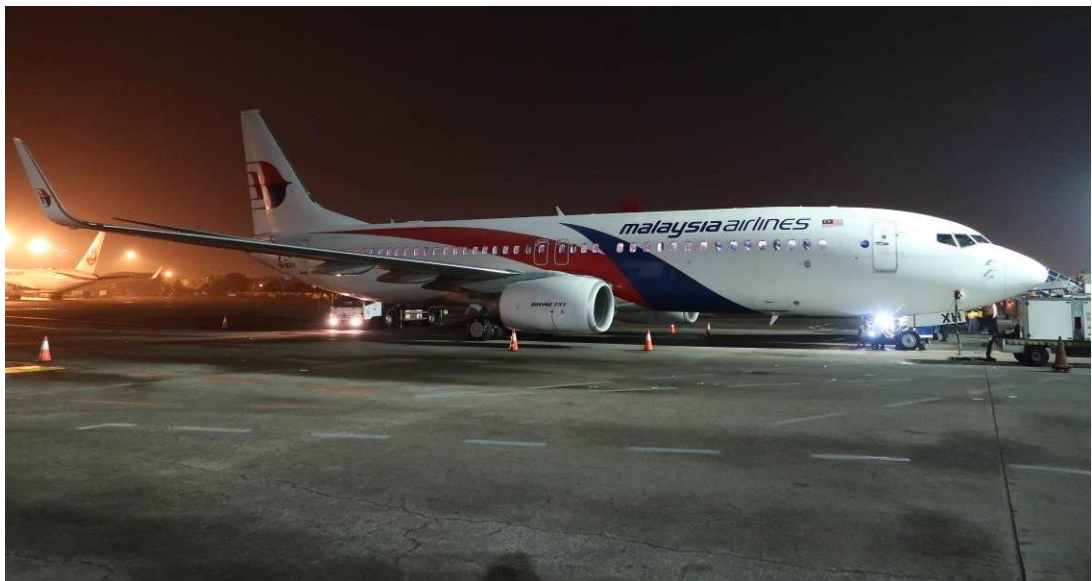
The aircraft has minor damaged. The outer tire of the right main landing gear was burst. All other tires damaged over limit. Some punctures found on the left inboard flap and right and left wing body fairings. There were three runway edge lights damaged.

Figure 1: The aircraft after the occurrence parked at parking stand R54

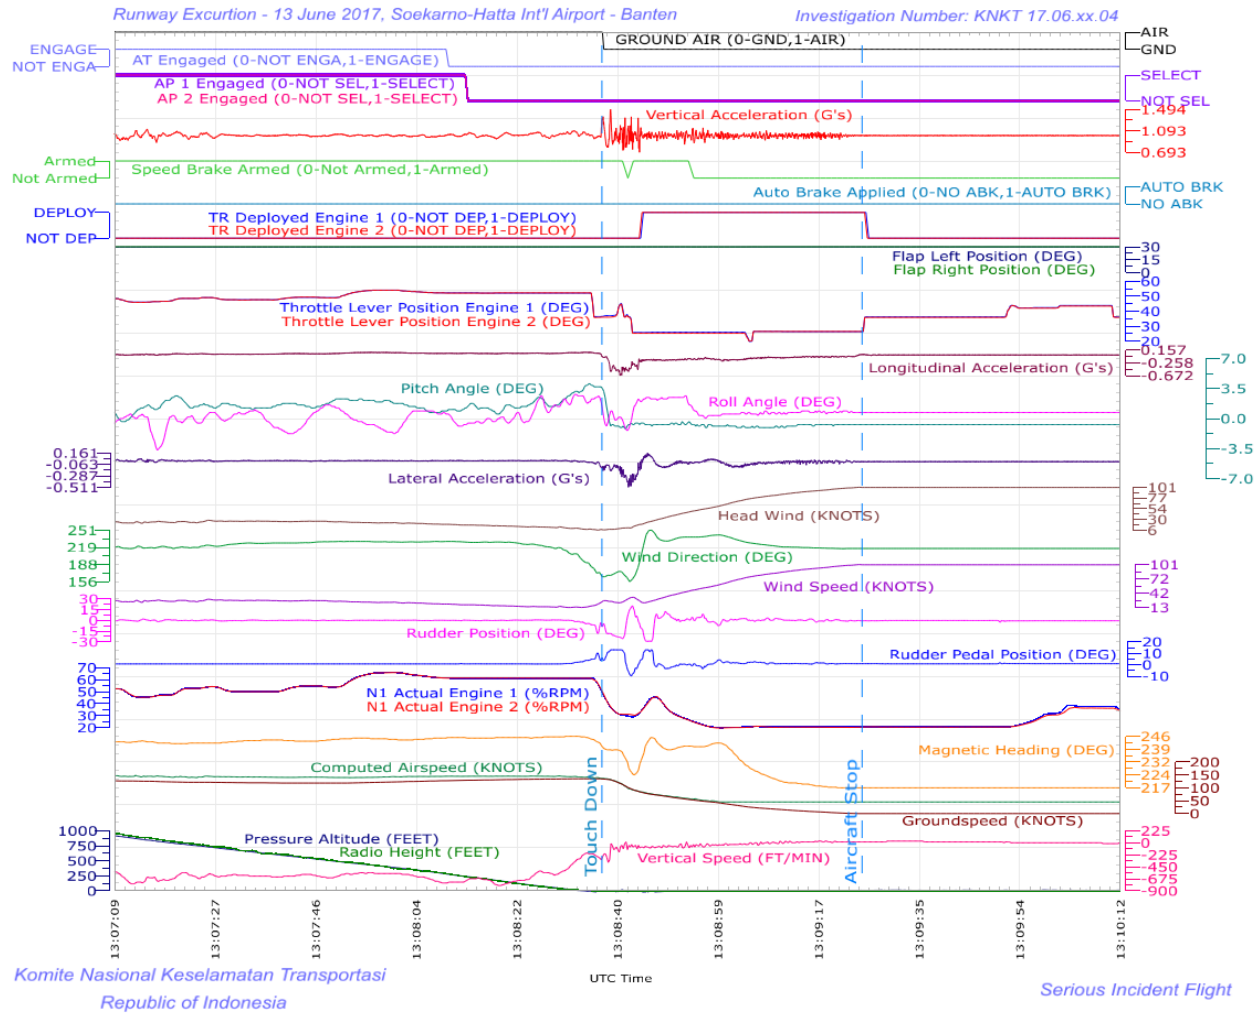
Figure 6: The selected FDR parameters taken from 1,000 feet until the aircraft stopped

The FDR graph showed (figure 6) significant parameters to be analyzed for the final report such as vertical acceleration, wind condition, aircraft attitude and aircraft speed.

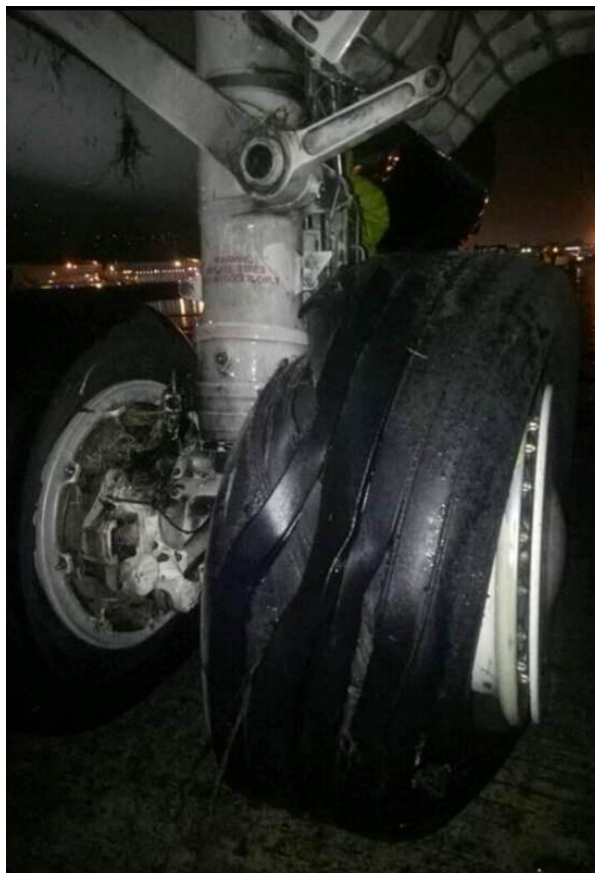
The outer tire of the right main landing gear found burst.

Figure 7: The burst outer tire of right main landing gear

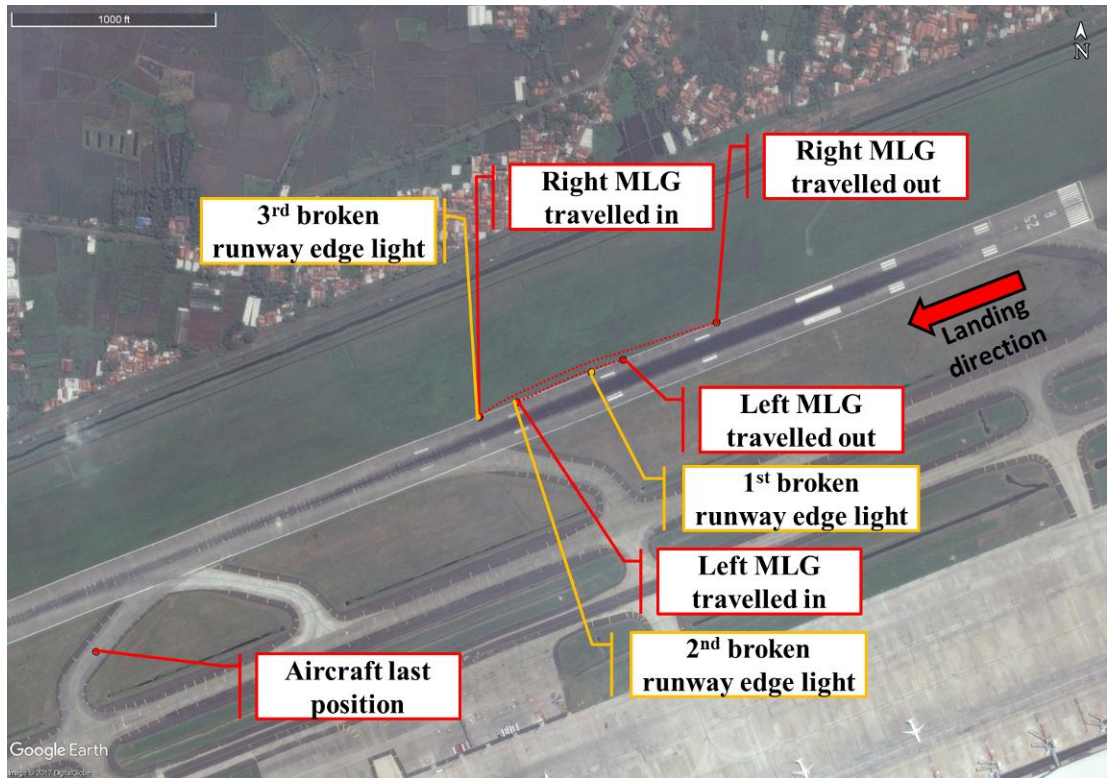
The investigation conducted runway observation after the occurrence. The observation found right main landing gear mark travelled out from runway pavement at about 580 meters from the beginning runway 25R. The left main landing gear mark travelled out from runway pavement found at about 730 meters from beginning runway. The left landing gear marks travelled back to the runway pavement at about 900 meters from the beginning runway and followed by the right main landing gear at about 960 meters.

Three runway edge lights found broken. The first broken runway edge light located at about 783 meters, the second at about 902 meters and the third at about 964 meter from the beginning runway 25R.

Figure 8: The position of marks and damage lights.

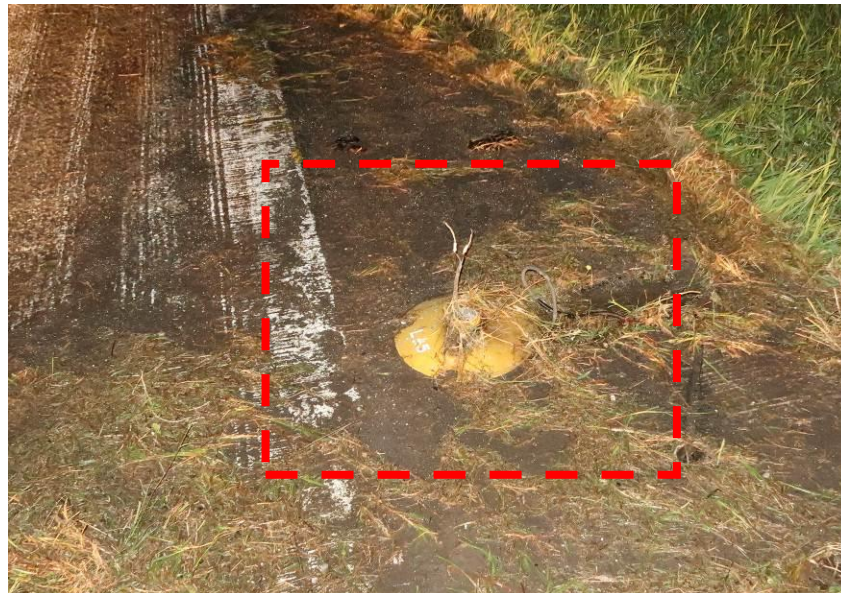
Figure 9: The third broken runway edge light
