**KOMITE NASIONAL KESELAMATAN TRANSPORTASI
REPUBLIC OF INDONESIA**

Aircraft Serious Incident Investigation Report

ATR 72-212A; PK-WHS and

Cessna 172S; PK-BYK

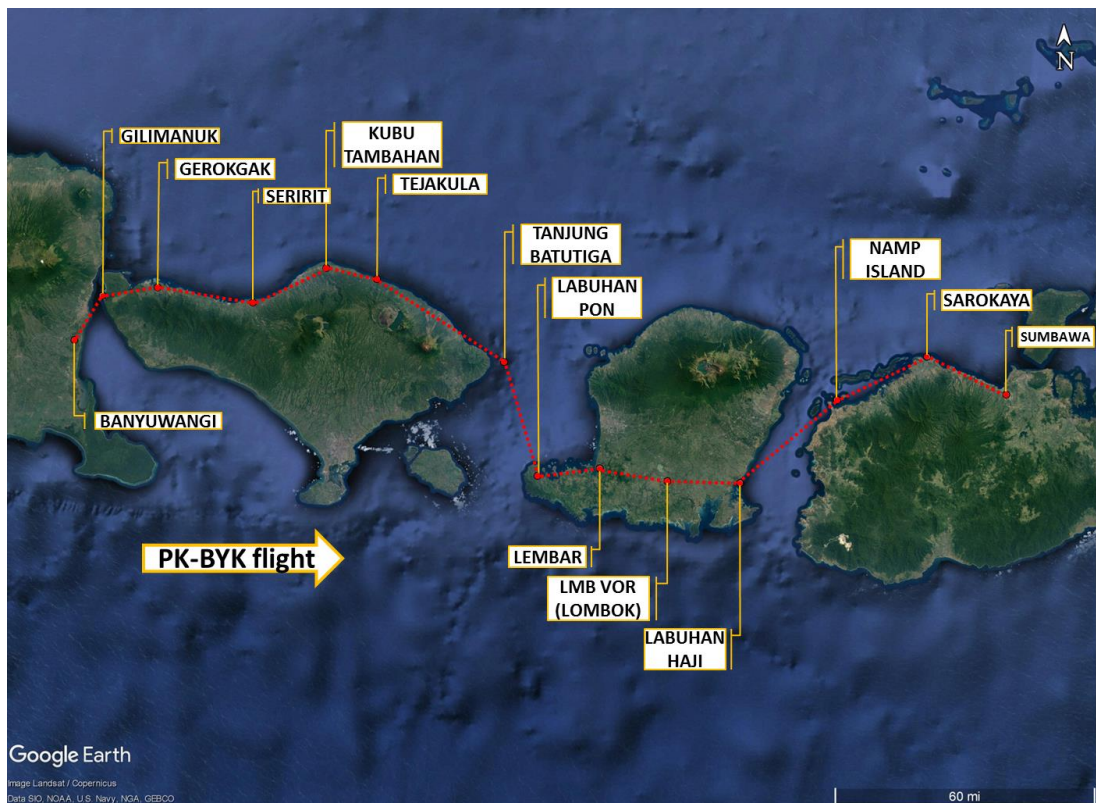
Figure 1: The flight plan route of PK-BYK

On 21 November 2017, a Cessna 172S aircraft registered PK-BYK was being operated by Balai Pendidikan dan Pelatihan Penerbangan Banyuwangi (BP3B) on a cross country training flight from Blimbingsari airport (WADY), Banyuwangi¹ to Sultan Muhammad Kaharuddin airport (WADS), Sumbawa Besar². The flight plan route followed the Visual Flight Rules (VFR) route as follows: Banyuwangi – GILIMANUK – GEROKGAK – SERIRIT – KUBU TAMBAHAN – TEJAKULA – TANJUNG BATUTIGA – LABUHAN PON – LEMBAR – LMB VOR³ – LABUHAN HAJI – NAMP ISLAND – SAROKAYA – Sumbawa (figure 1).

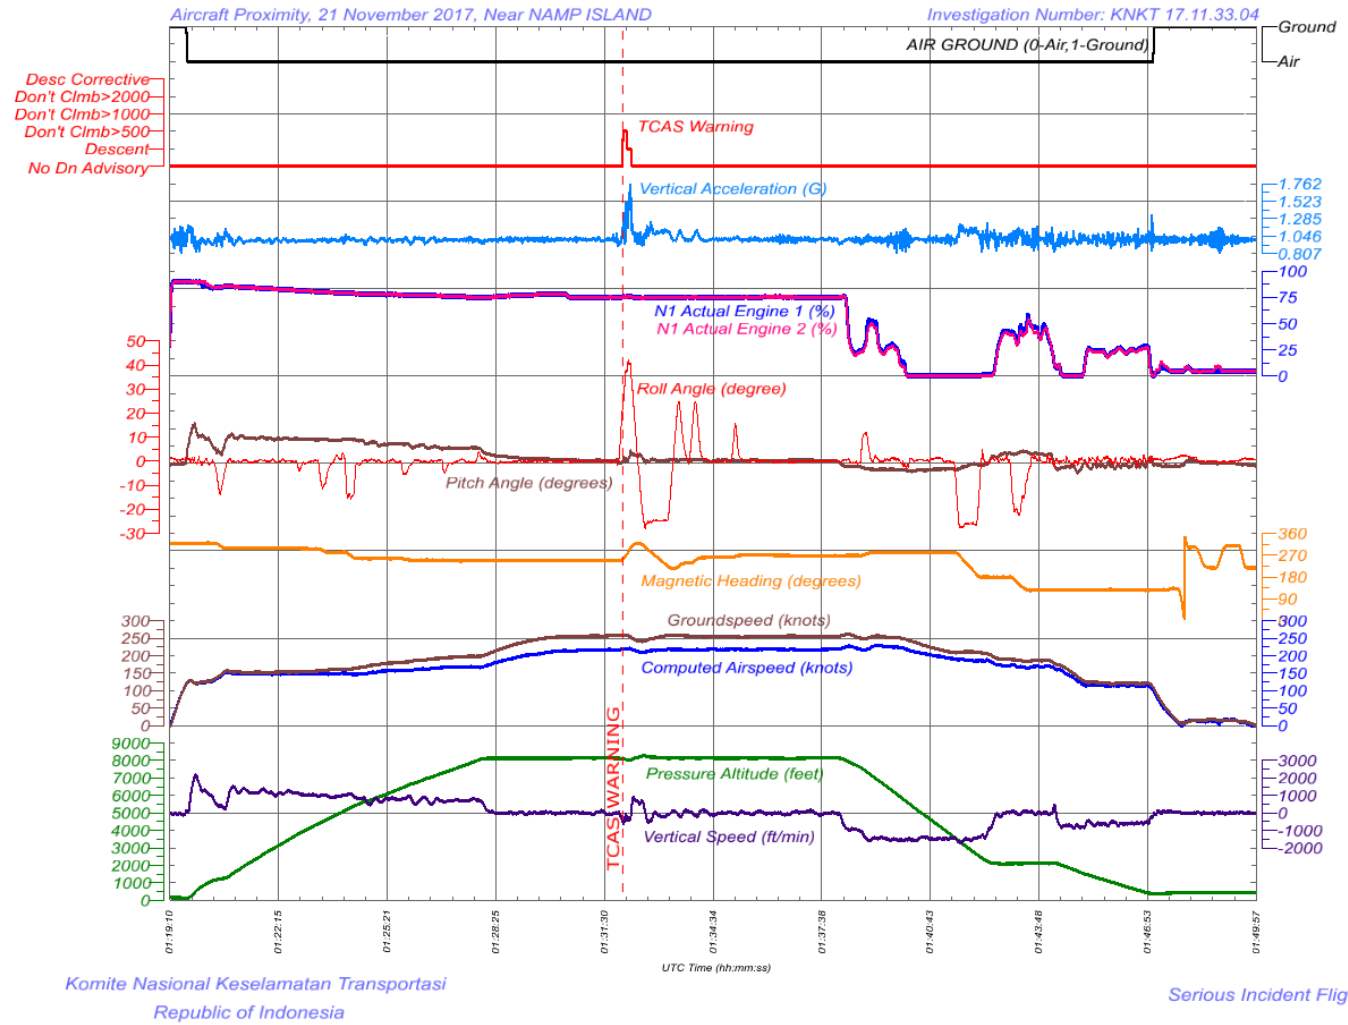
Figure 2: The significant recorded parameters

At 01:32:00 UTC, the WON1861 pilot started to turn the aircraft to the right.

At 01:32:06 UTC, the Bali radar screen recorded that the PK-BYK aircraft altitude was passing 8,000 feet and the horizontal distance with WON1861 was 2 Nm. One second later the WON1861 descended.

At 01:32:17 UTC, the WON1861 started to climb from altitude of 7,800 feet. The Sumbawa tower controller called the PK-BYK pilot with no respond.

At 01:32:27 UTC, the WON1861 pilot turned the aircraft heading to the left and then advised the Bali approach controller that there was Traffic Collision Avoidance System Resolution Alert (TCAS RA) activation with the intruder traffic was descending from 9,000 feet. The Bali approach controller acknowledged the information and instructed to maintain 8,000 feet after clear of traffic.

The Wings Air provided the KNKT of Quick Access Recorder (QAR) raw data taken from the FDR for analysis. The significant recorded parameters of the FDR were as follows:

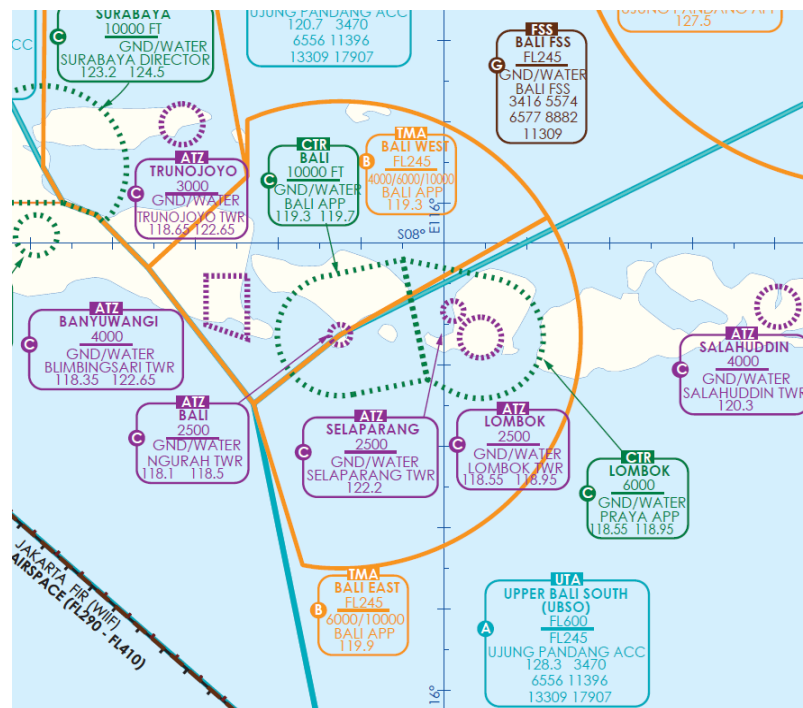
Figure 3: The ATS airspace in Bali, Lombok and Sumbawa (excerpt from AIP Volume 1)

The aerodrome control tower service in Sumbawa Aerodrome Traffic Zone (ATZ) is provided by AirNav Indonesia branch office Sumbawa utilizing procedural control (non-radar service). The service was responsible for air traffic up to 4,000 feet.
