KOMITE NASIONAL KESELAMATAN TRANSPORTASI  
REPUBLIC OF INDONESIA

KNKT.17.11.33.04

Aircraft Serious Incident Investigation Report

ATR 72-212A; PK-WHS

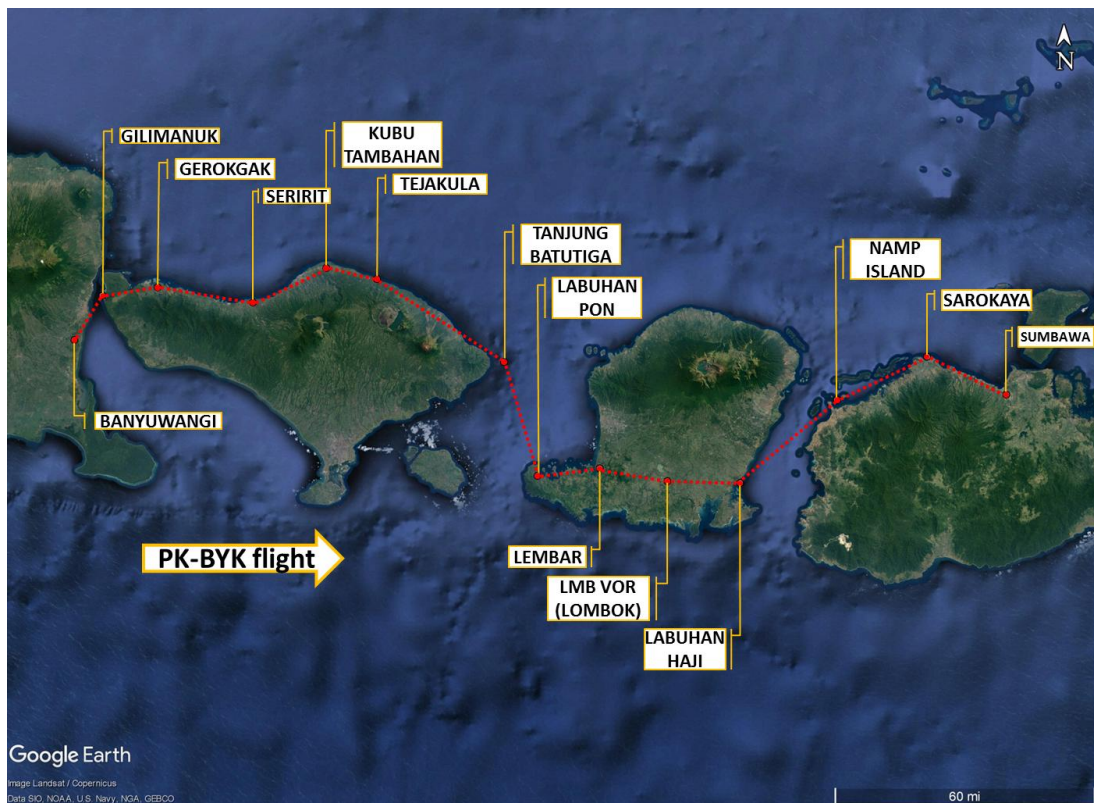
**Figure 1: The flight plan route of PK-BYK**

On 21 November 2017, a Cessna 172S aircraft registered PK-BYK was being operated by Balai Pendidikan dan Pelatihan Penerbangan Banyuwangi (BP3B) on a cross country training flight from Blimbingsari airport (WADY), Banyuwangi<sup>1</sup> to Sultan Muhammad Kaharuddin airport (WADS), Sumbawa Besar<sup>2</sup>. The flight plan route followed the Visual Flight Rules (VFR) route as follows: Banyuwangi – GILIMANUK – GEROKGAK – SERIRIT – KUBU TAMBAHAN – TEJAKULA – TANJUNG BATUTIGA – LABUHAN PON – LEMBAR – LMB VOR<sup>3</sup> – LABUHAN HAJI – NAMP ISLAND – SAROKAYA – Sumbawa (figure 1).

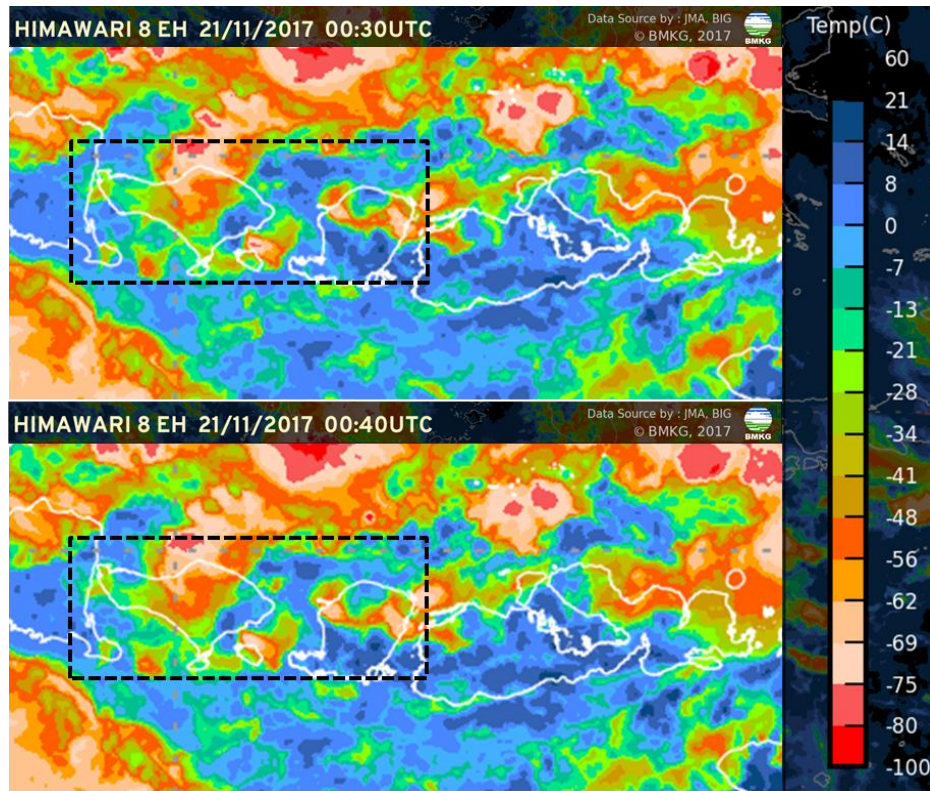
Figure 2: Satellite image at 0030 and 0040 UTC of the PK-BYK route area (black square)

The satellite images were provided by *Badan Meteorologi Klimatologi dan Geofisika* (BMKG – Bureau of Meteorology, Climatology and Geophysics of Indonesia) showed the route area that was flown by the PK-BYK aircraft and near the occurrence location had low temperature indicated the development of clouds.

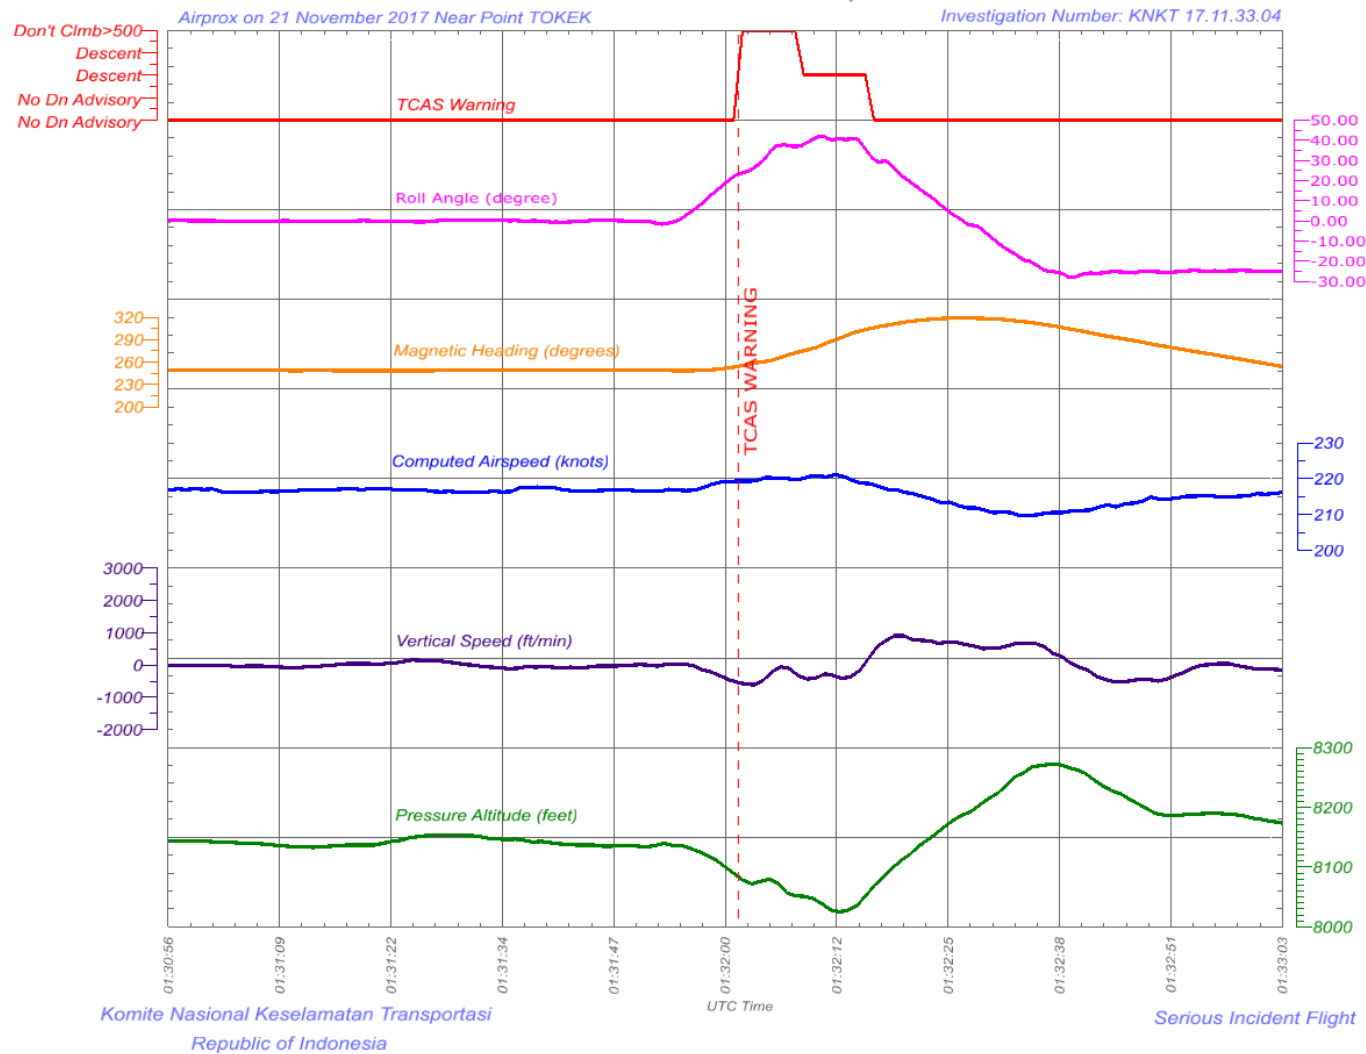
Figure 4: The significant recorded parameters

The CVR installed on the WON1861 aircraft was L3 Communication CVR model with part number 2100-1020-02 and serial number 001069443. The recorded voice during the occurrence was overwritten.

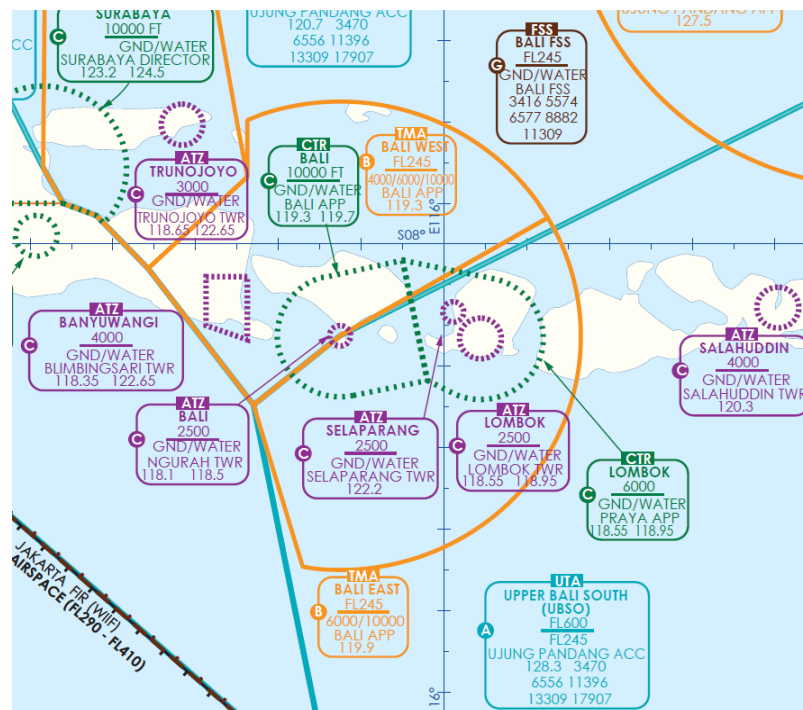
Figure 5: The ATS airspace in Bali, Lombok and Sumbawa (excerpt from AIP Volume 1)

The aerodrome control tower service in Sumbawa Aerodrome Traffic Zone (ATZ) is provided by AirNav Indonesia branch office Sumbawa utilizing procedural control (non-radar service). The service was responsible for air traffic up to 4,000 feet.

The KNKT recommend to AirNav Indonesia to ensure air traffic controller provides all necessary information to the accepting unit as stated in the SOP.
