**KOMITE NASIONAL KESELAMATAN TRANSPORTASI
REPUBLIC OF INDONESIA**

Aircraft Accident Investigation Report

Super King Air 350i; PK-CAQ

31 May 2017

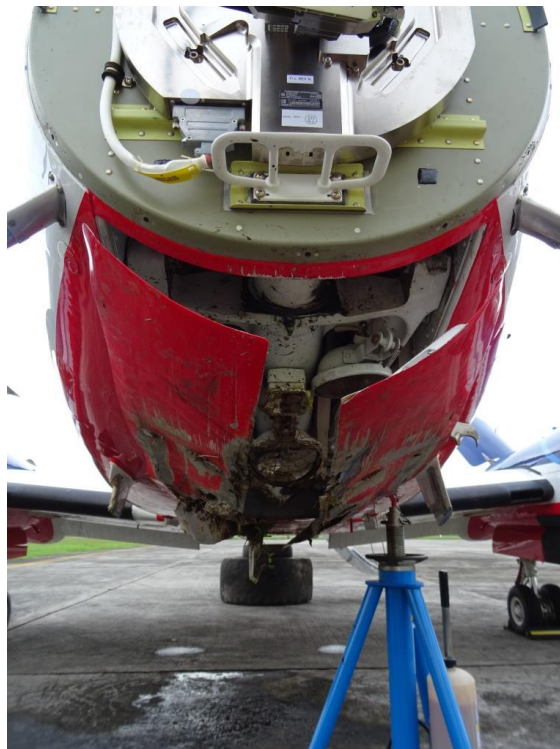
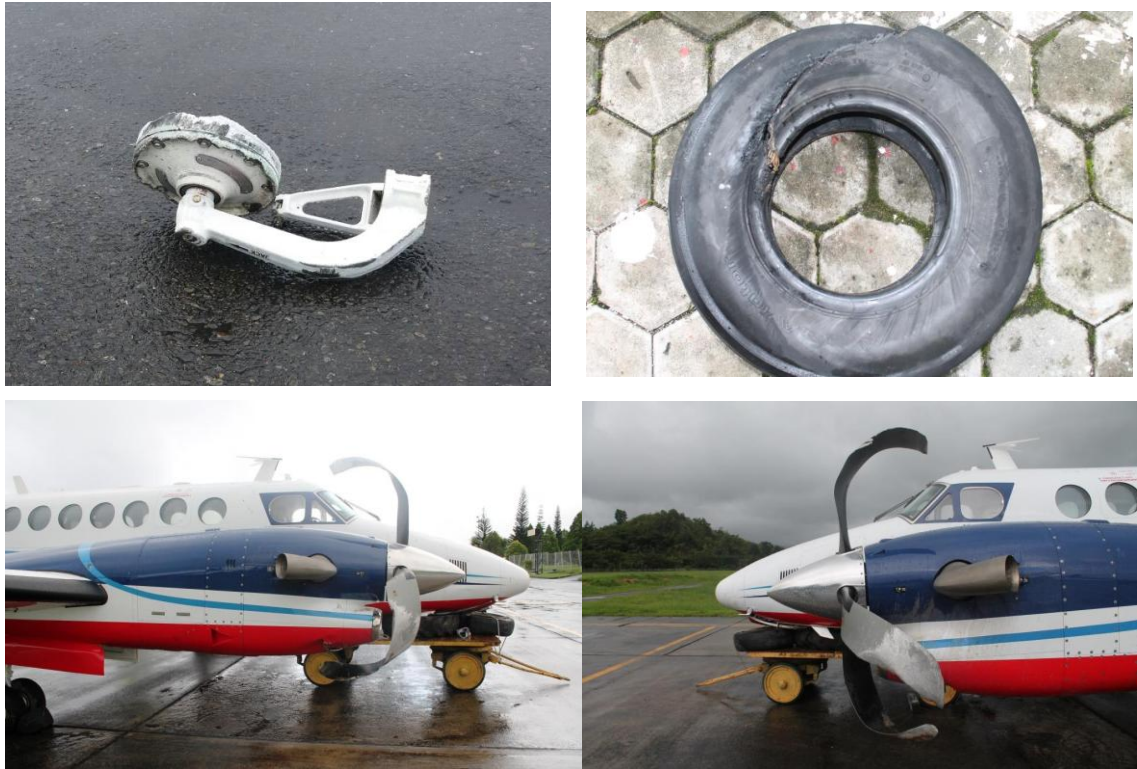
Figure 1: Detail damage to aircraft

- Nose landing gear collapsed
- Nose wheel tire burst and the wheel hub scratched
- The propeller blades of both engines bent
- Skin wrinkle in the area of nose dome.

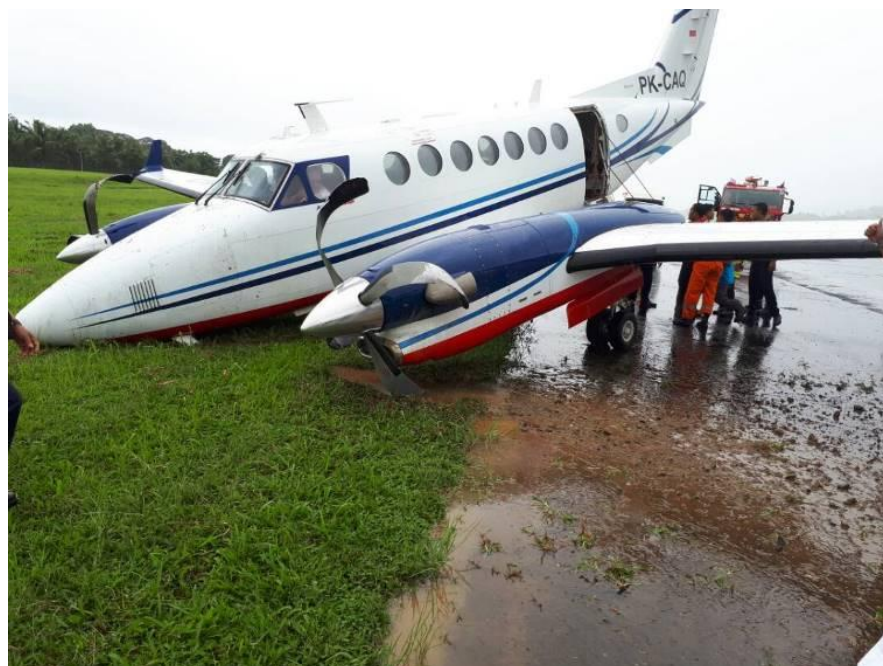
Figure 3: The aircraft condition after stop

The aircraft stopped near taxiway B at approximately 1,650 meters from the beginning of runway 04, the crew and passengers evacuated the aircraft safely with no injured.
