**KOMITE NASIONAL KESELAMATAN TRANSPORTASI  
REPUBLIC OF INDONESIA**

**Aircraft Accident Investigation Report**

**Boeing 737-300; PK-CJC**

**Rendani Airport, Manokwari, West Papua**

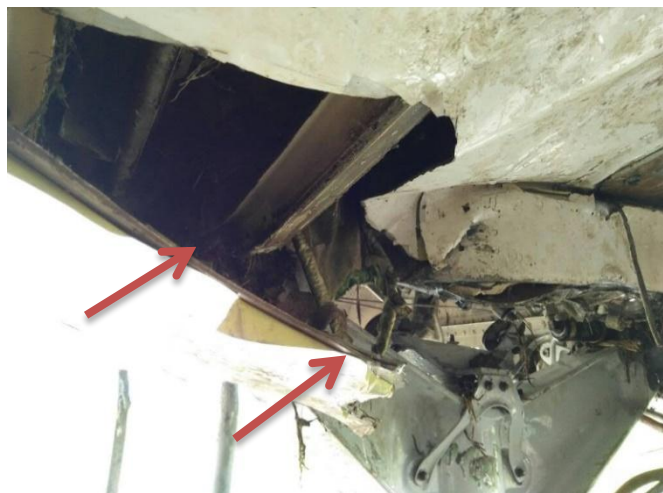
The aircraft was substantially damage. The damaged found on the nose landing gear, nose section lower fuselage, and both engine fan blades.

**Figure 1: Damage on the lower frame bulkhead of the nose landing gear compartment**

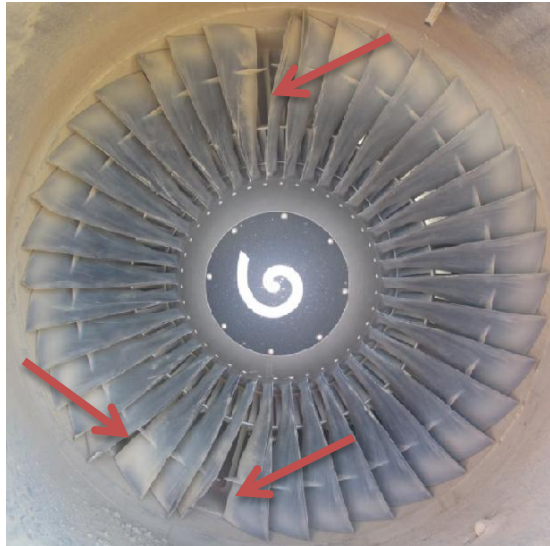
**Figure 2: Damage on left engine fan blades**

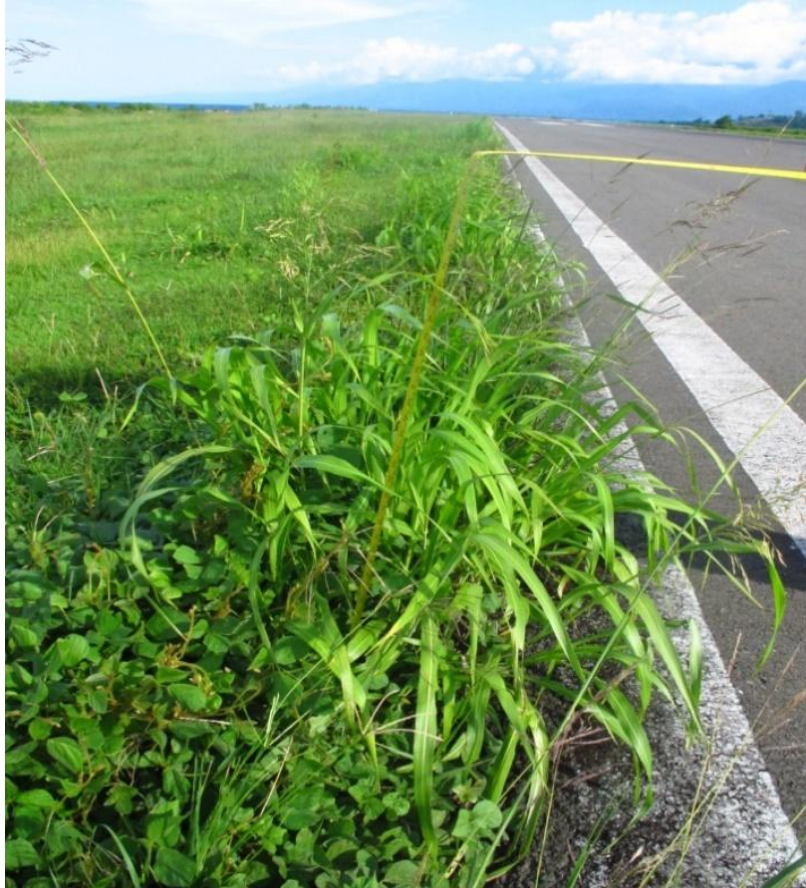
- Several areas of the runway surface warp (curving) in approximate 2 - 5 square meters with standing waters on the runway during and after rain. The CCTV recorded water splash when the accident aircraft landed and rolled on runway 35.
- Several runway edge lights were covered with grass that approximately of 30-40 cm high.

**Figure 4: Grass on the runway edge**

Refer to the aforesaid condition, KNKT recommends the airport operator to takes necessary action to minimize the present of standing water and maintain the runway lighting system alongside of runway.

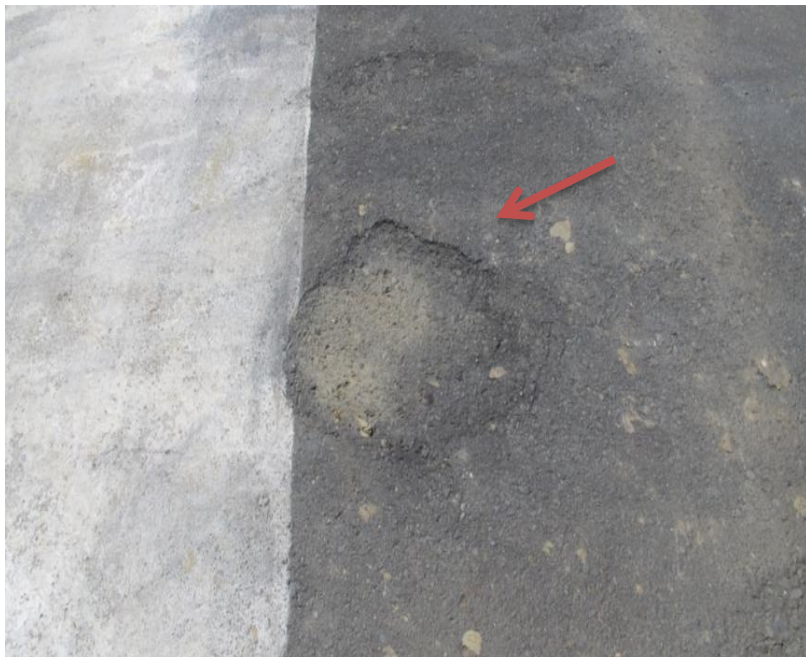
**Figure 5: Warp area on the runway surface**

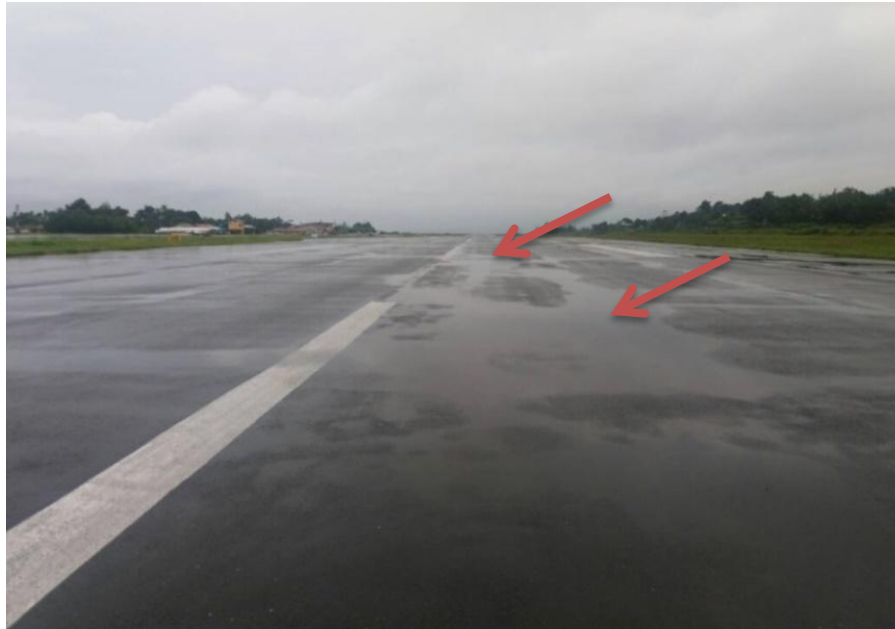
**Figure 6: Standing water in the warp runway surface**

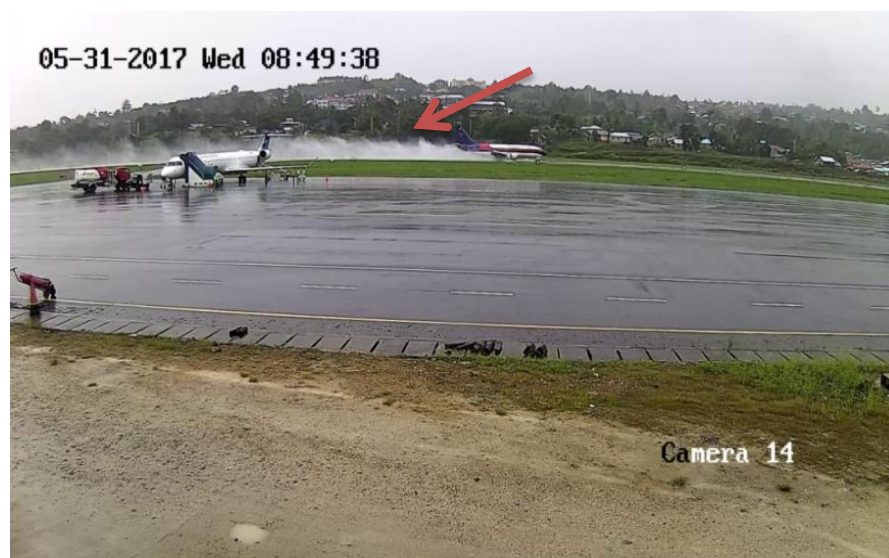
**Figure 7: The water splash of accident aircraft landed & rolled on runway 35 recorded on CCTV**

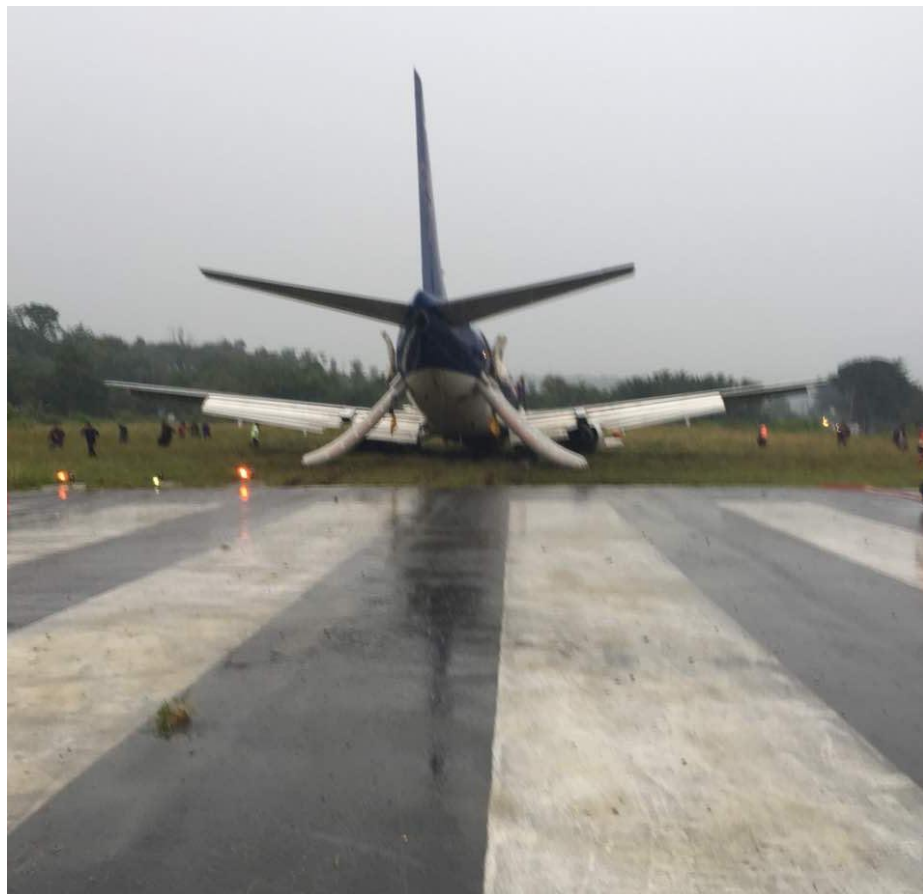
The aircraft stopped with the main wheels were at approximately 20 meters from end of runway 35 and all emergency exit slides deployed. The aircraft was substantially damaged, nose landing gear broken and folded backward into the electronic compartment, both fan blades on engine found damage, and damage on some fuselage areas. Reverted rubber marks found on the main landing gear tire.

**Figure 9: The aircraft position after stop**

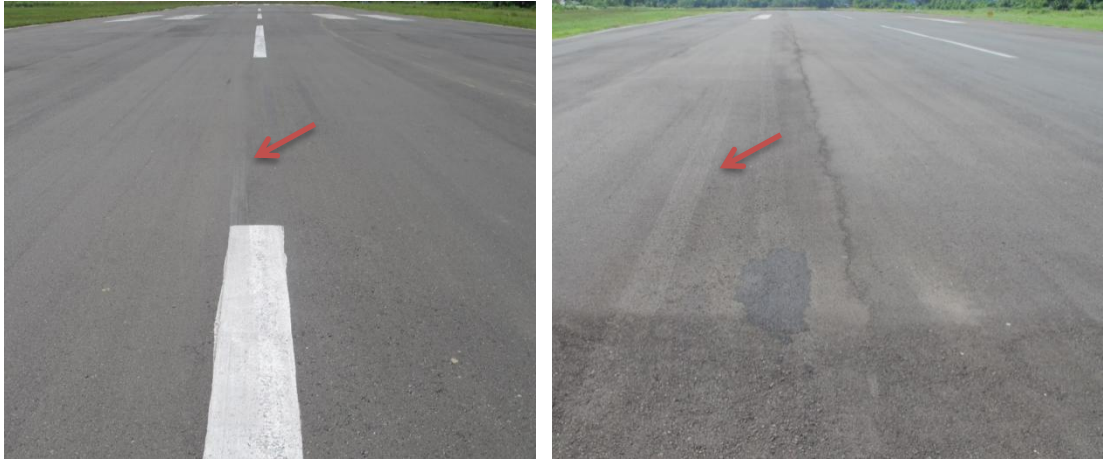
Observation on the runway found white tire marks on the aircraft trajectory.

**Figure 10: White marks of main wheel on runway along the aircraft trajectory**

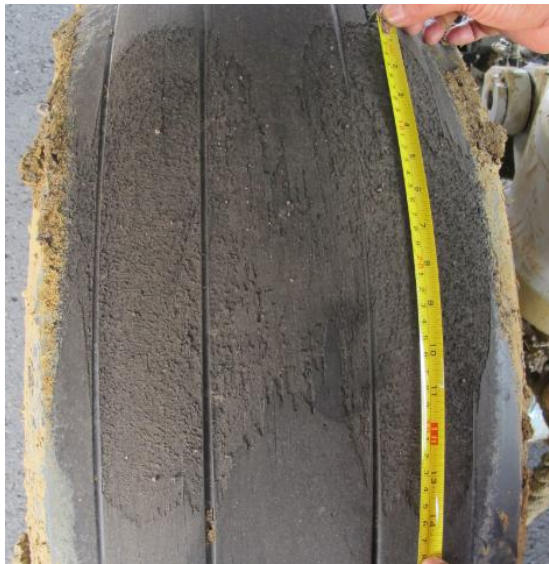
**Figure 11: Reverted rubber mark on main wheel**
