**KOMITE NASIONAL KESELAMATAN TRANSPORTASI  
REPUBLIC OF INDONESIA**

## **KNKT.17.04.10.04**

### **Aircraft Accident Investigation Report**

**Cessna 208; PK-FSO**

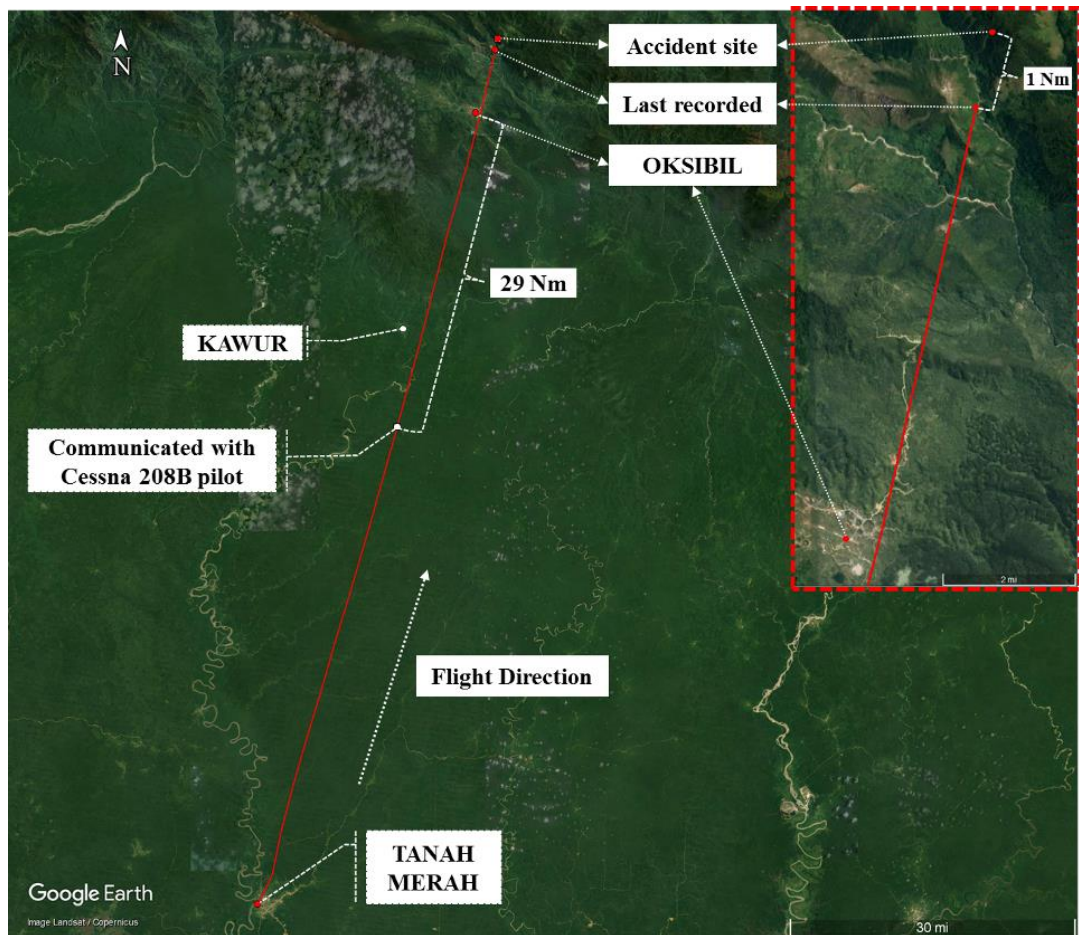
**Figure 2: The recorded accident flight track superimposed with Google Earth**

Based on the flight track, the absence of voice communication, the weather condition permitting the pilot to identify the airport location and the aircraft wreckage, consistently indicated that there were no pilot activities to fly the aircraft after the last known pilot activities at about 29 Nm from Oksibil until impact.
