**KOMITE NASIONAL KESELAMATAN TRANSPORTASI
REPUBLIC OF INDONESIA**

KNKT.17.02.06.04

Aircraft Serious Incident Investigation Report

Boeing 737-800; PK-GNK

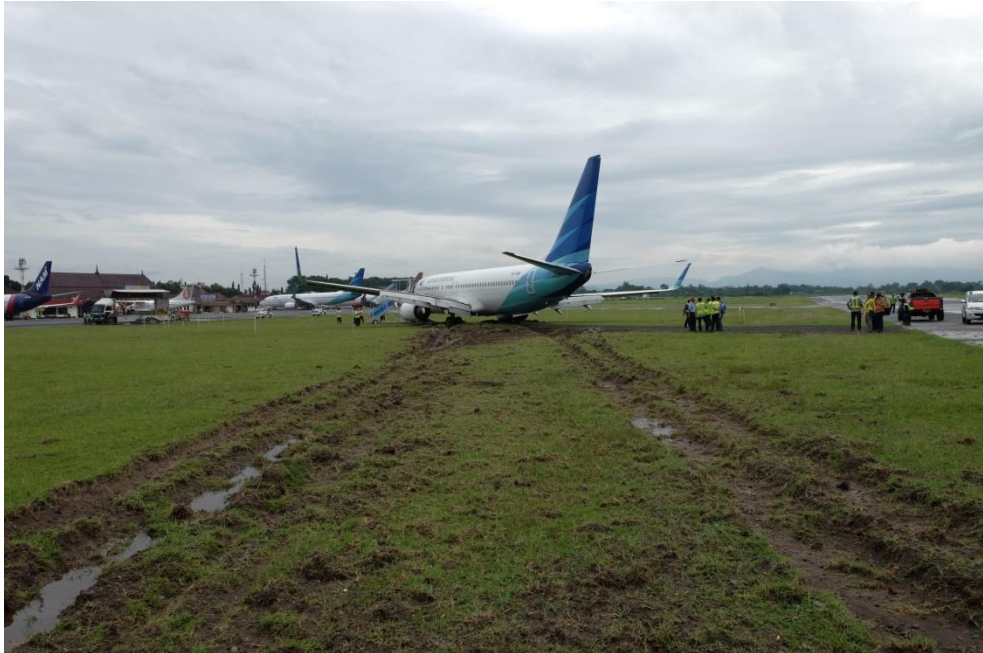
At about 1250 UTC, the aircraft touchdown and slightly on the right of runway centreline 09, and when approached taxiway N2 while applying the reverse thrusts, the aircraft veered to the left and stopped on the left shoulder of runway 09 at about 1,600 meters from beginning runway 09 and 20 meters from the runway edge. The tower controller activated the crash bell then informed the Airport Rescue and Fire Fighting (ARFF) that there was an aircraft veered of runway 09 and stopped near the taxiway N2.

Figure 1: The wheel marks on the shoulder and aircraft condition after stopped

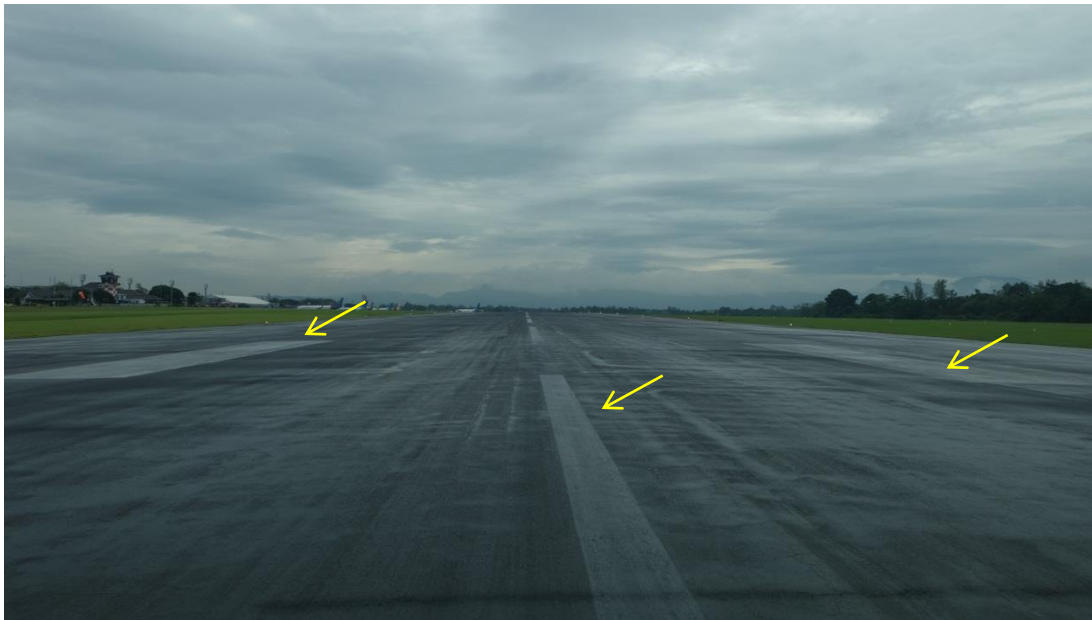
There were several runway centerline markings on the touchdown area of runway 09 that were unclearly visible. (Figure 3).

Figure 3: The unclear runway centreline and touchdown bar markings

The unclear runway centerline marking on the touchdown area on the reduced visibility could be possible increase a risk on aircraft operation. Therefore, KNKT recommends ensuring that the runway centerline marking is clearly visible during aircraft operation.

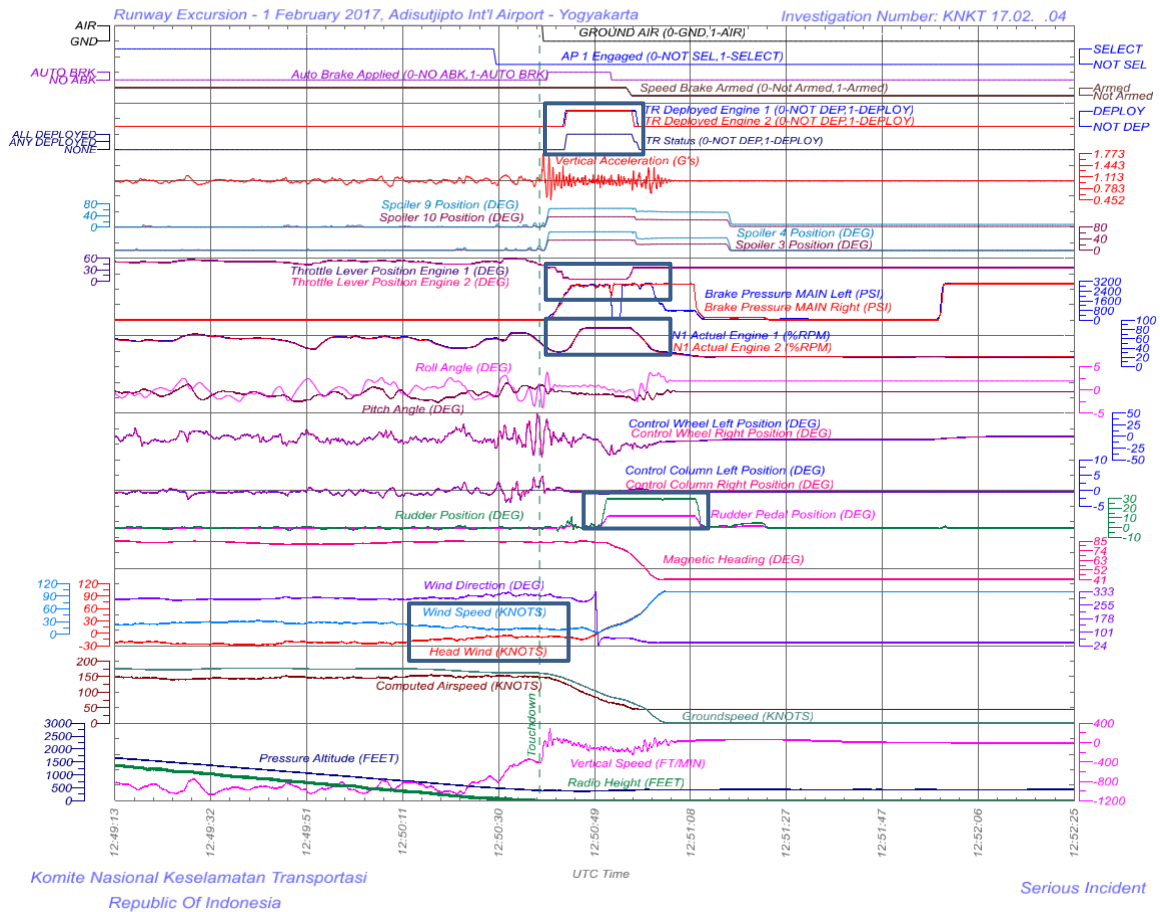
Figure 4: The significant FDR parameters

The FDR graph showed significant parameters prior touchdown and while landing roll which are shown in the boxes, such as wind speeds and directions, aircraft speeds, reversers, break pressures and rudder deflection that will be examined specifically in the final report.

5. The weather conditions during the occurrence were slight rain and runway was wet.
6. Prior to touchdown and on landing roll, the FDR data showed variation of wind speeds and directions, activation of reversers, asymmetry break pressures and rudder deflection.

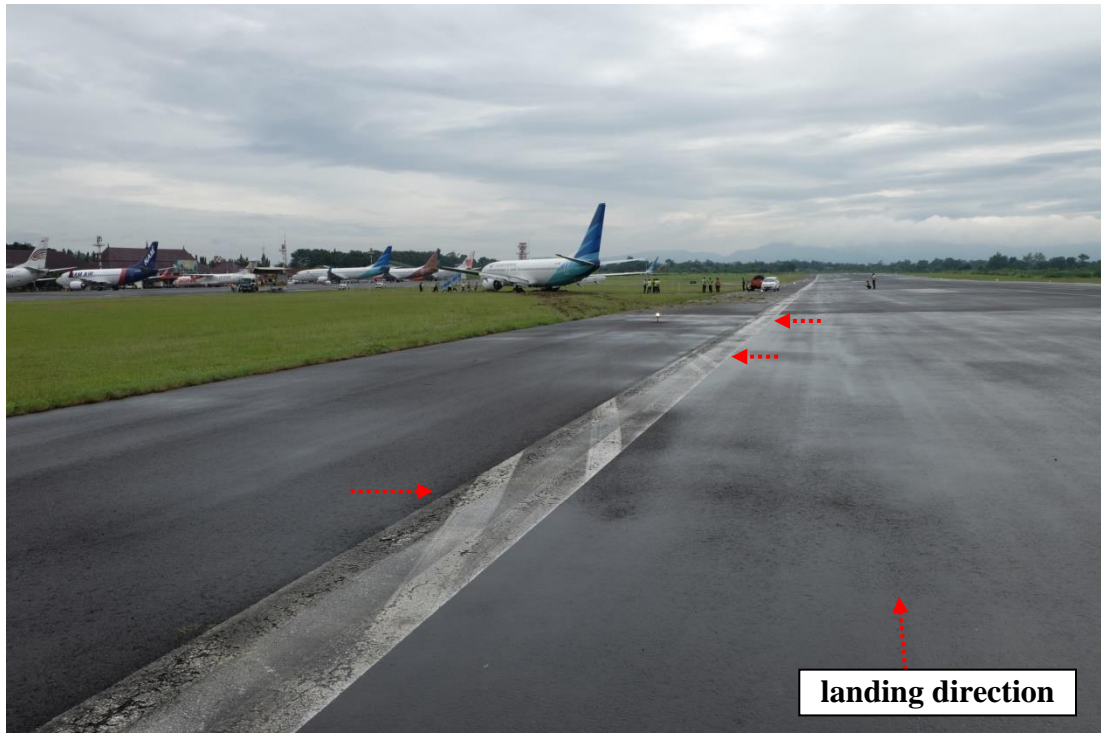
The aircraft stopped on the left shoulder runway 09 on heading 43° at about 1,600 meters from beginning runway 09 and 20 meters on the left of the runway edge. There was tire marks of the nose wheel, left and right main landing gear started from the left runway 09 edge marking until the aircraft stopped (Figure 4).

Figure 5: The tire marks on runway and on shoulder

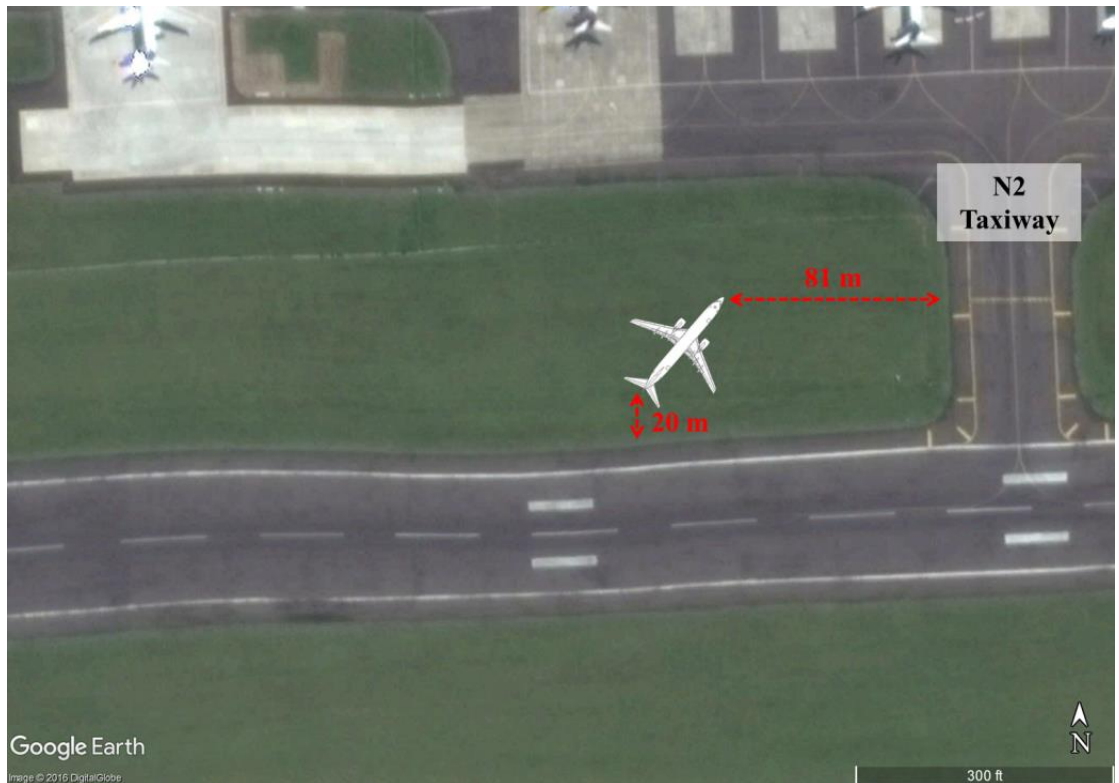
Figure 6: The location of aircraft stopped
