**KOMITE NASIONAL KESELAMATAN TRANSPORTASI
REPUBLIC OF INDONESIA**

Aircraft Accident Investigation Report

PT. Batik Air

Boeing 737-800; PK-LBY

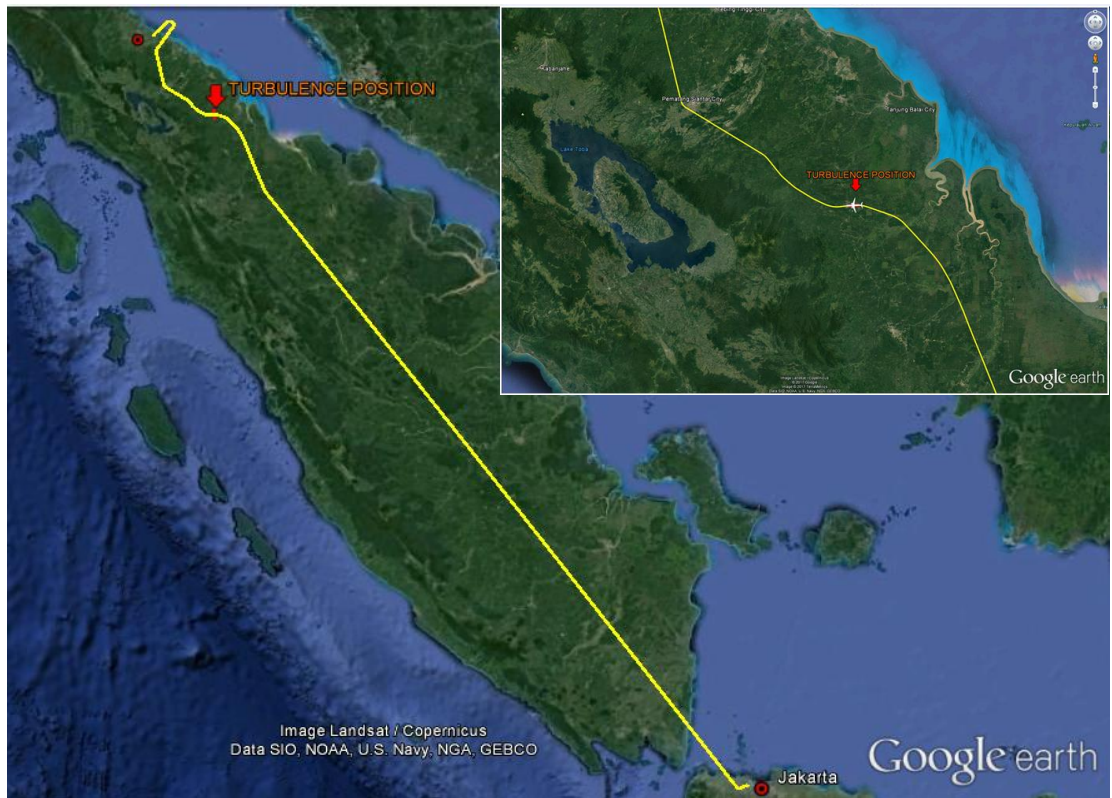
Figure 1: the flight route and the area of turbulence as recorded on the FDR

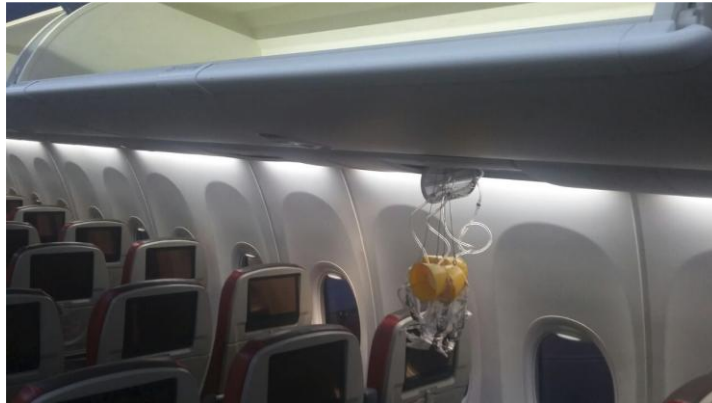
Several interior parts damaged such as misalignment of left aft entry ceiling, broken ceiling on the left aft lavatory, oxygen mask container dropped and broken passenger service units. The damaged passenger service units found on passenger seat number 24A, 24B, 24C, 25D, 25E, 25F.

Figure 2: Dropped oxygen mask

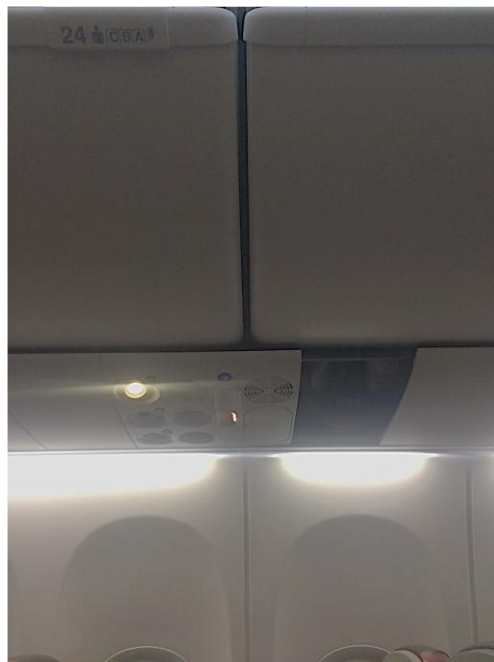
Figure 3: Damaged Passenger Service Unit

Some damaged to the interior parts of the aircraft found in the aft cabin area such as passenger service unit broken on the passenger seat row 24 and 25, oxygen mask container dropped and misalignment of the cabin ceiling on the lavatory and aft cabin.

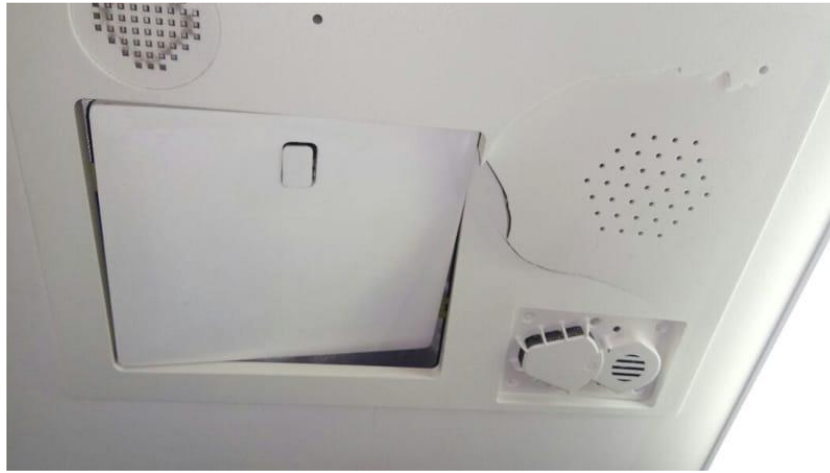
Figure 4: Broken Aft Lavatory Ceiling

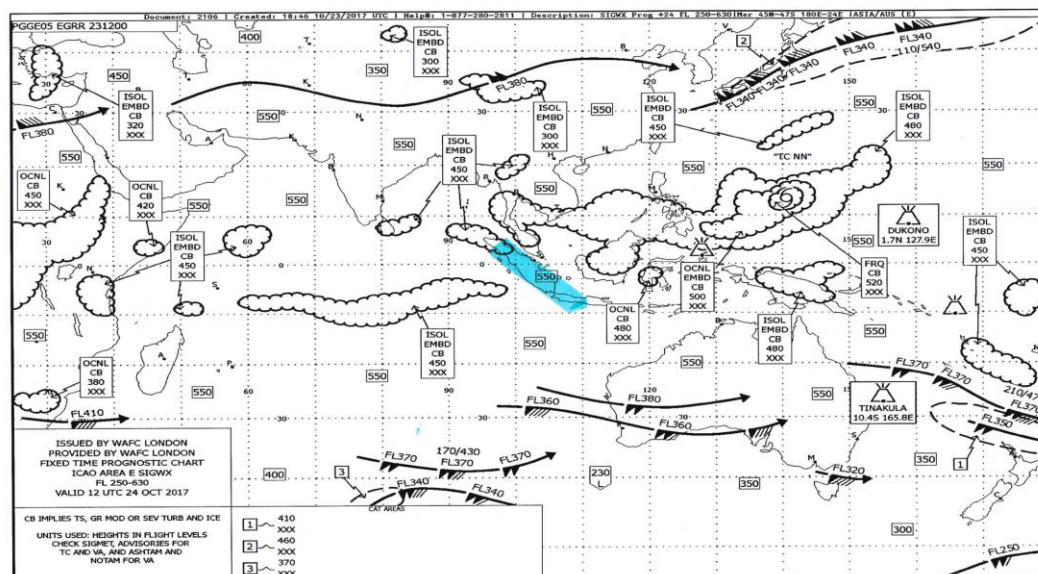
Figure 5. Prognosis Chart FL 250-630 valid for 24 October 2017 at 1200 UTC (highlighted blue)

The forecast weather from prognosis chart showed that on the area of turbulence event (red circle) was forecasted to have potential development of isolated embedded cumulonimbus clouds which may develop up to above 45,000 feet (FL 450).

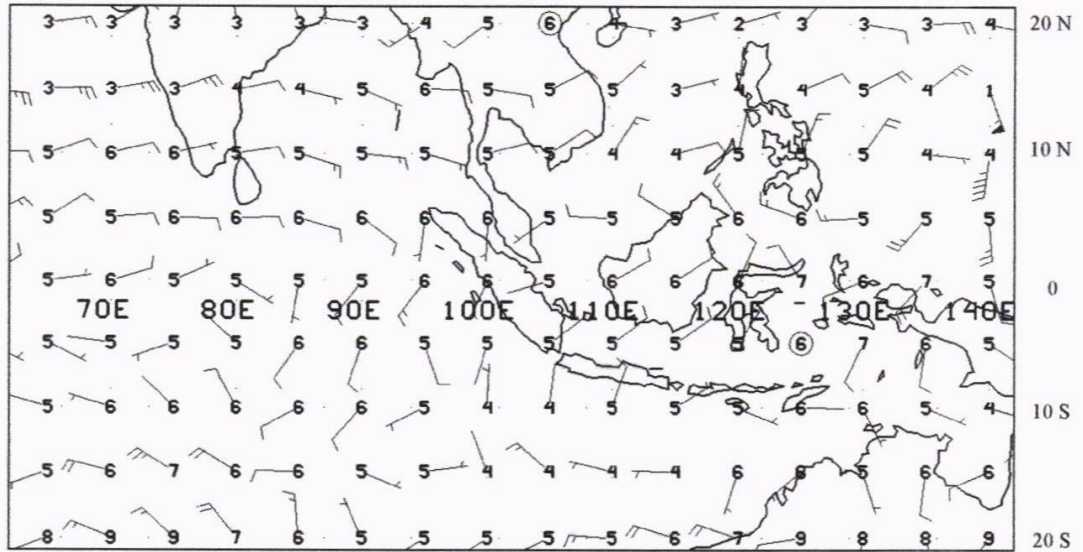
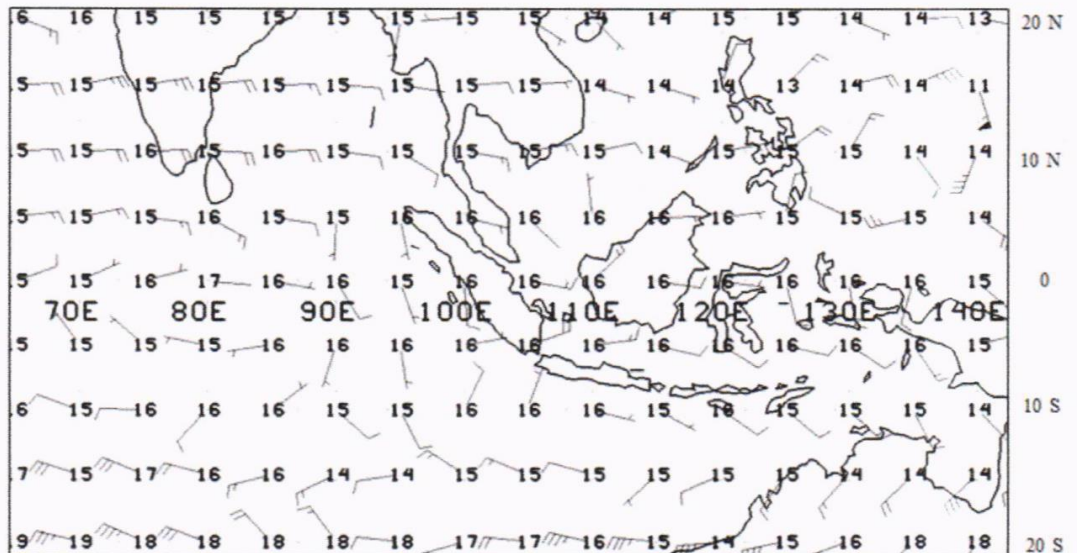
Figure 6: Wind direction around the occurrence area (red circle)

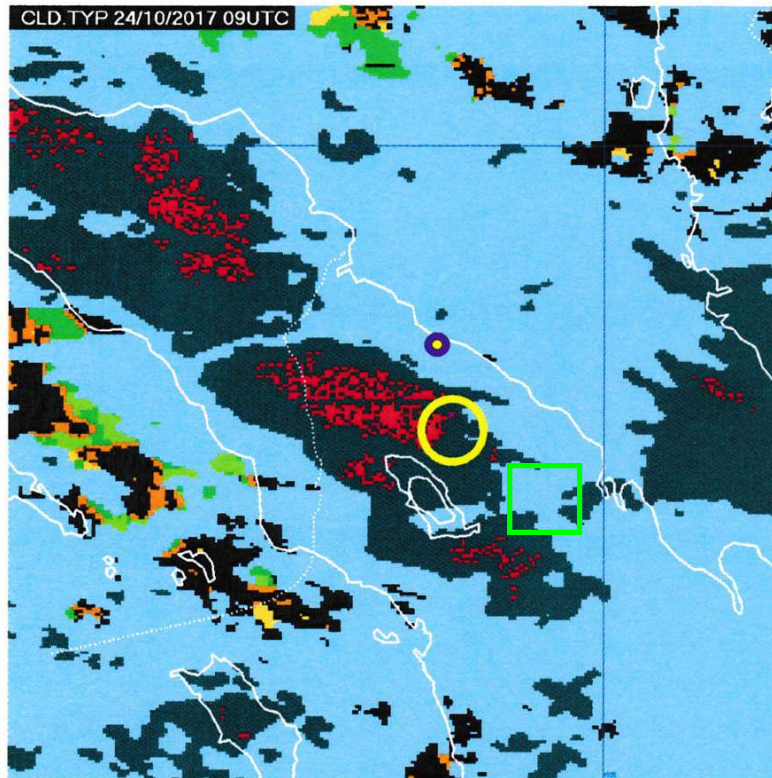
Figure 7: satellite image at 0900 UTC

The satellite images were provided by BMKG indicated that at surrounding area including the accident site (red square) at 0900 UTC, 1000 UTC and 1100 UTC was cloudy with development of cumulonimbus and high clouds.

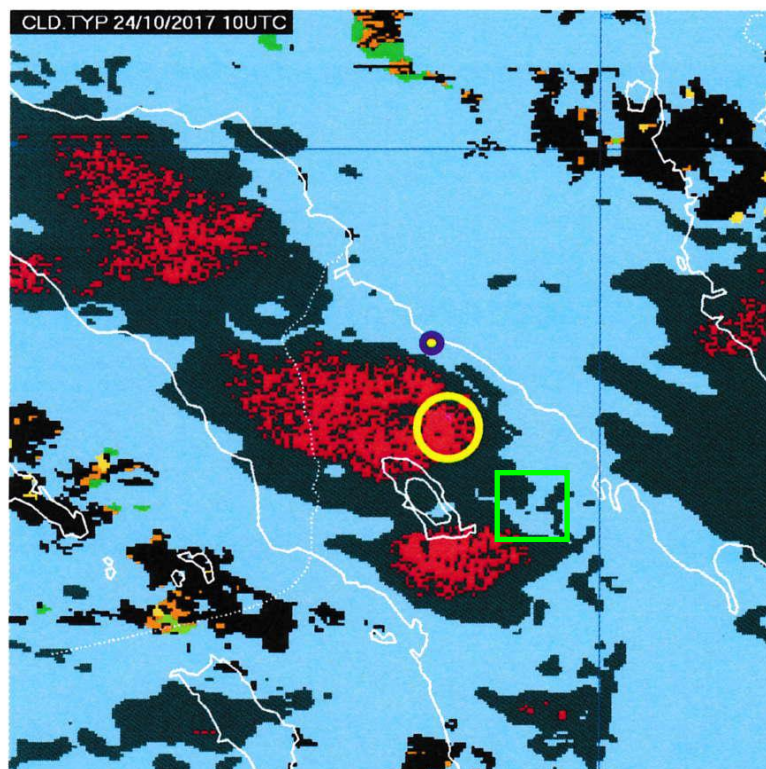
Figure 8: satellite image at 1000 UTC

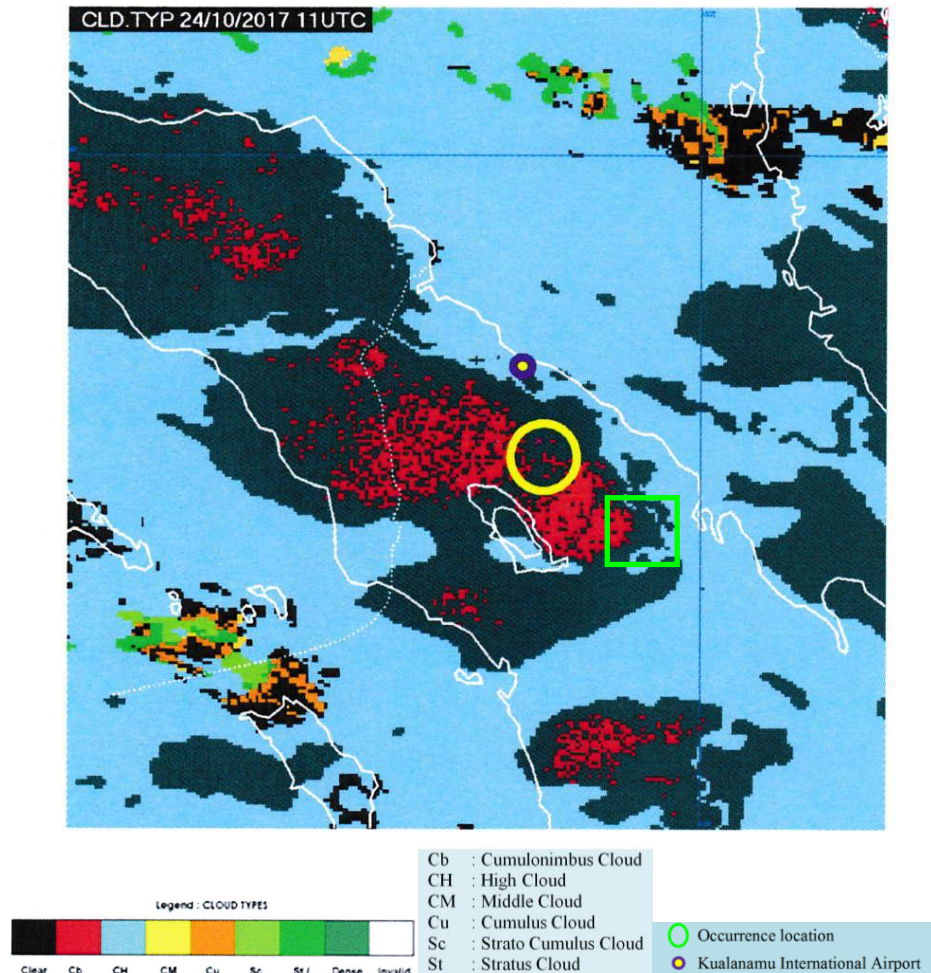
Figure 9: satellite image at 1100 UTC

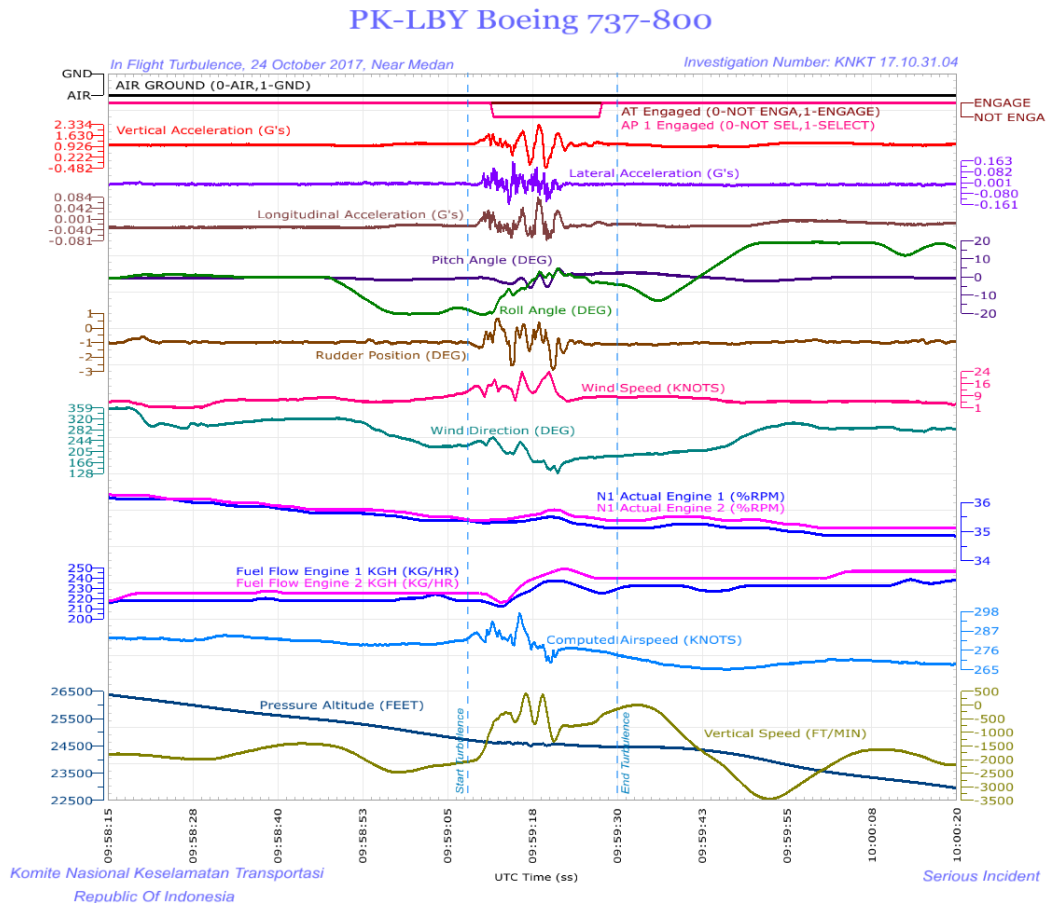
At 0959 UTC, the aircraft encountered severe turbulence³ and the autopilot disengaged. The turbulence lasted for approximately 20 seconds. The vertical acceleration recorded on the Flight Data Recorder (FDR) was between 2.334 G and -0.482 G at altitude approximately 24,500 feet. The pilot flew manually for 17 seconds, continued descend and reengaged the autopilot.

Figure 10: relevant parameter of the FDR
