**KOMITE NASIONAL KESELAMATAN TRANSPORTASI
REPUBLIC OF INDONESIA**

Aircraft Accident Investigation Report

Cessna 172S; PK-MUA

Blimbingsari Airport, Banyuwangi, East Java

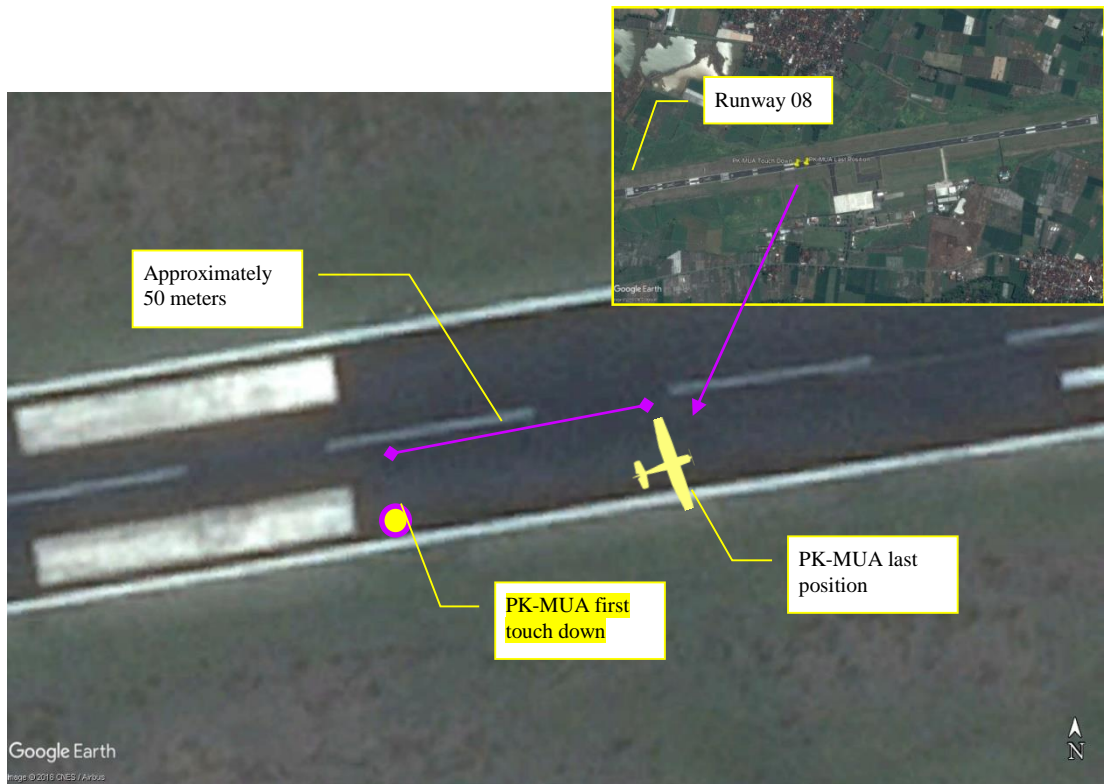
Figure 1: The sketch of PK-MUA position after stop and catch on fire

The aircraft stop approximately 400 meters from the threshold and fire appeared on the front right side of the aircraft. The student pilot was not injured and self-evacuated from the left door.

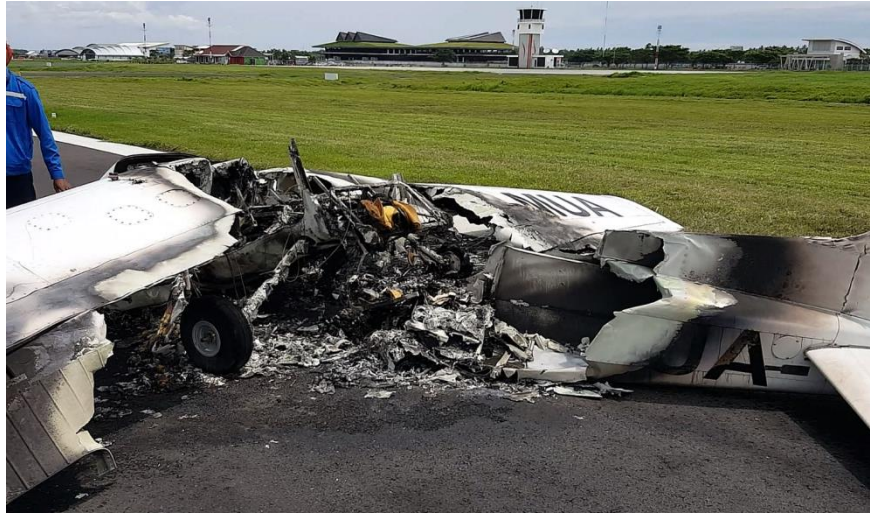
Figure 2: Damage to the fuselage

The aircraft destroyed as result of impact forces and post impact fire. The fire consumed most part of the fuselage. The detail of the damages was as follow:

- The center fuselage damaged by post impact fire;
- The nose landing gear collapsed;
- The propellers bent and scratch.

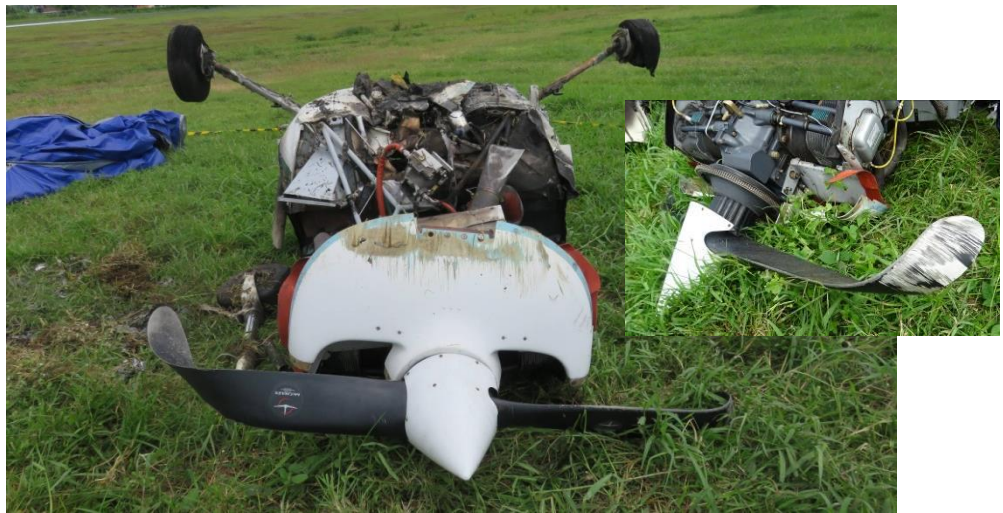
Figure 3: The propeller, engine and engine cowling condition after the accident

Three propeller marks found on the runway and from the third propeller mark, scratch marks found approximately 50 meters long until the position of the aircraft stopped. The propeller found bent, the lower engine cowling scratch and the nose landing gear collapsed.

These marks indicated that the aircraft nose down at an angle that enabling the propeller strike to the runway. The scratch marks found approximately 50 meters long indicated that the nose landing gear had collapsed. This also indicated by the scratch on the lower engine cowling.

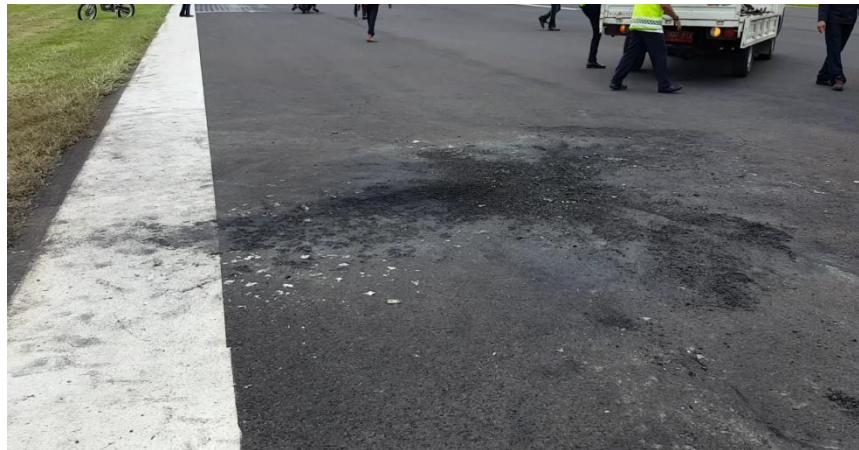
Figure 4: Heat damage on the runway

Part of the runway surface at the position of aircraft stop had heat damage.

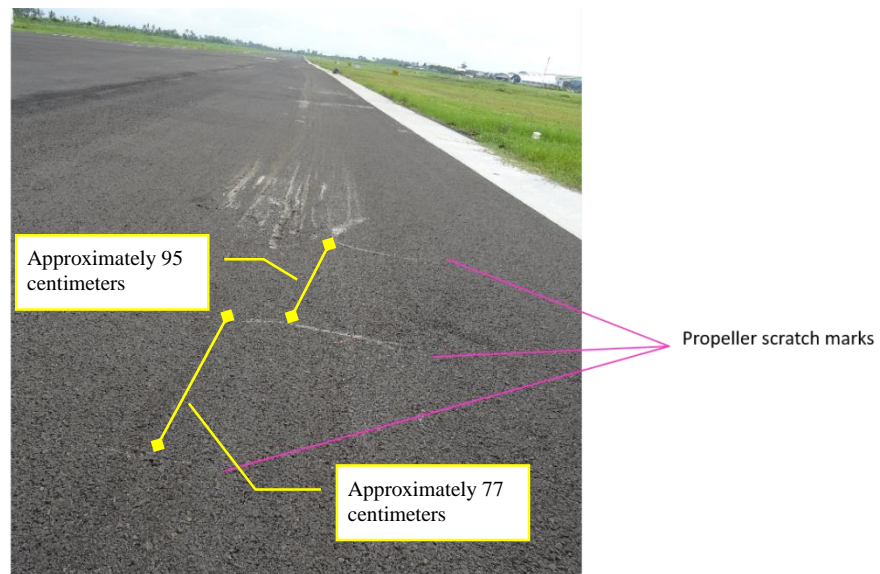
Figure 6: The marks found on the runway

Several scratch marks found on the runway, including propeller scratch marks, the detail as follows:

- The first mark found approximately of 348 meters from the beginning runway 08
- The second mark found approximately of 77 centimeters from the first mark
- The third mark found approximately of 95 centimeters from the second mark

From the third propeller mark, scratch marks found approximately 50 meters long until the position of the aircraft stopped.

The aircraft stopped at approximately 400 meters from the beginning runway 08 on heading 080°.

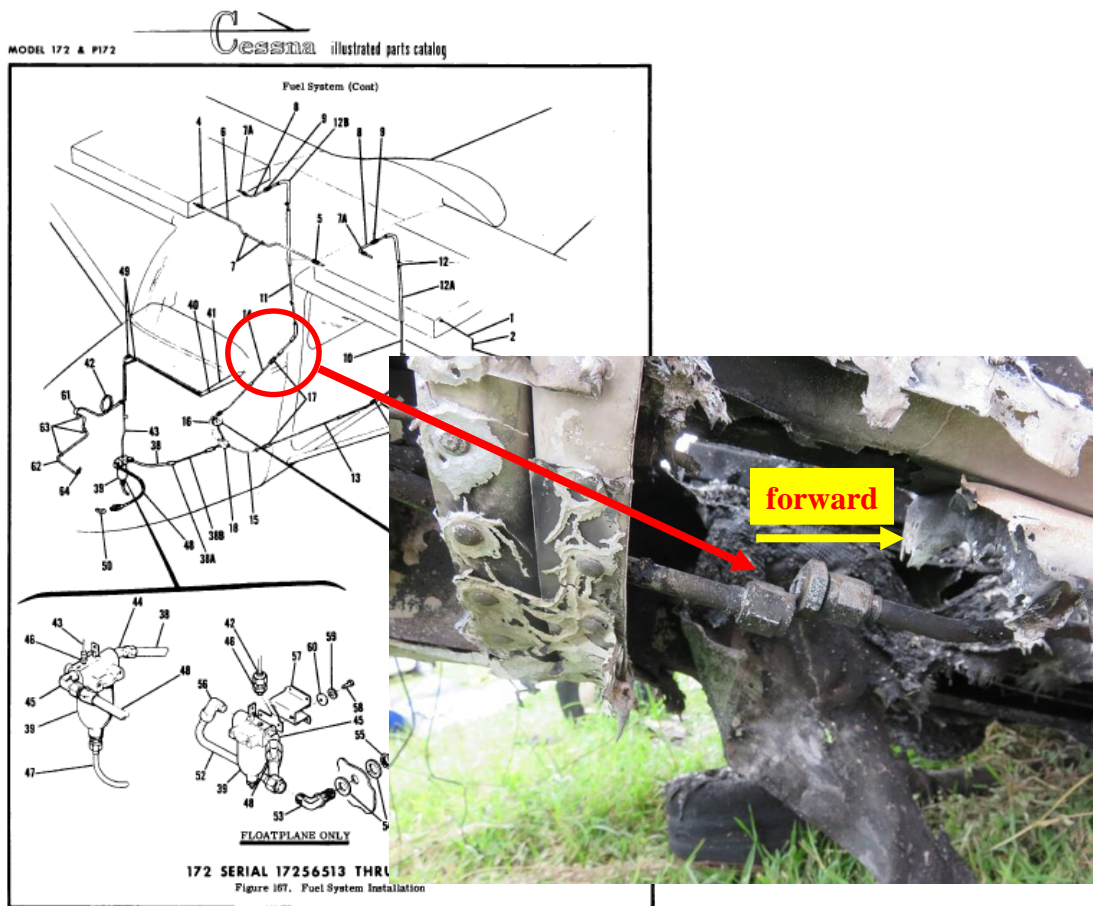
Figure 7: Broken fuel line under the right cockpit seat

The fuel line below the right cockpit area was broken most probably due to impact. The figure below showed the position and condition of the broken fuel line.

The wreckage examination found fuel line broken on the right lower fuselage that most likely caused by the impact. The fuel spill from the broken fuel line and the spark that possibly created by the friction of the aircraft part with the runway might have ignited the fire.

The controller saw that the fire was initiated at the right lower fuselage and developed to bigger fire. The position of the origin of fire consistent with the location of the broken fuel line. The rapid growing of fire caused by the fuel spillage on the broken fuel line.

6. The fuel line on the right lower fuselage was found broken that most likely caused by the impact. The fuel spill from the broken fuel line and the spark of the friction of the aircraft part to the runway might have ignited the fire.

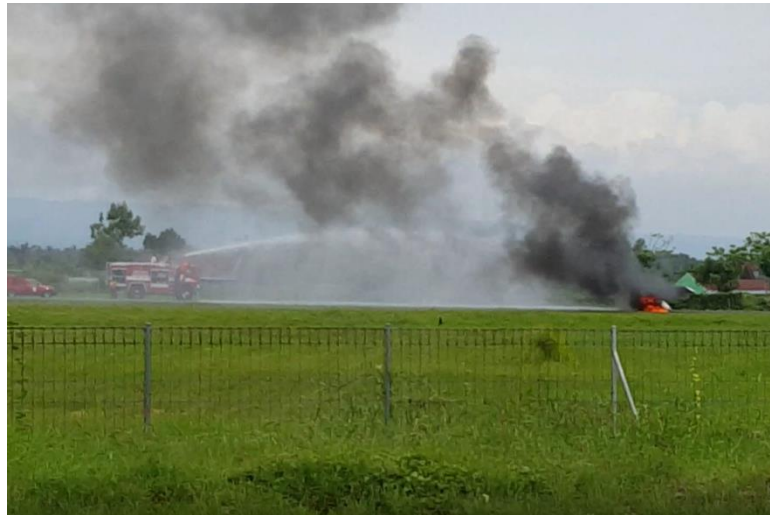
Figure 8: The extinguishing process by the ARFF

After sprayed all of the water from fire truck type V and IV, the fire had not been extinguished. The fire truck type V returned to the fire station and refilled with water then returned to the accident site. The fire extinguished took about 20 minutes after the accident.

Based on the picture when the ARFF discharged the fire agent, showed that the foam tender was spraying at a distance approximately 15 meters and against the wind. These conditions resulted in the extinguisher agent blown by the wind and less extinguisher agent reached the fire base, hence reduced the extinguishing effectiveness.

8. The distance and wind conditions resulted in the extinguisher agent blown by the wind and turned into water particles and less extinguisher agent reached the fire base, hence reduced the extinguishing effectiveness.

KNKT recommend to improve the rescue and firefighting personnel training to ensure the personnel ability to handle the actual emergency.

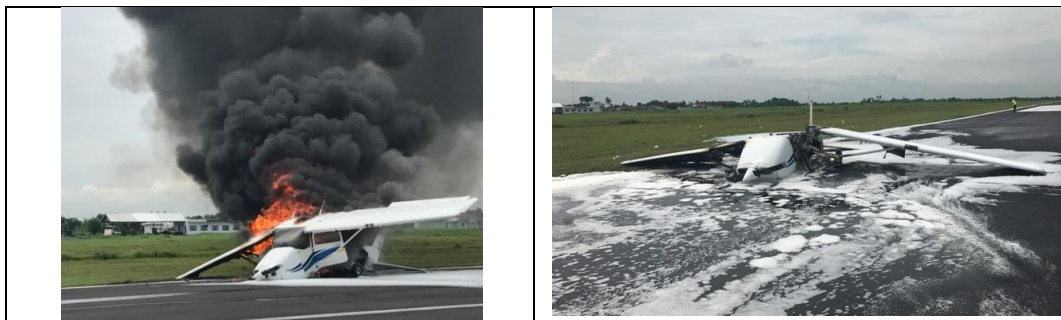
Figure 9: The aircraft condition during the fire and after extinguished

The figures below show the aircraft caught fire after landing and after the fire extinguished.

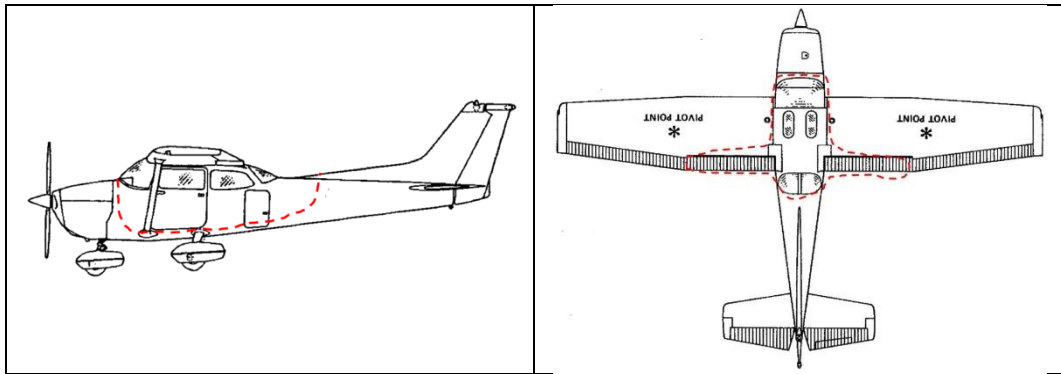
Figure 10: The area of fire damage showed with dash lines

The cabin destroyed by post impact fire. The tail section was relatively intact including the horizontal and vertical stabilizer. There was no sign of post impact fire on the engine. Some engine parts such as fuel heater and exhaust damaged due to impact.
