KNKT.17.03.09.04

Aircraft Serious Incident Investigation Report

ATR 72-212; PK-PAV

19 March 2017

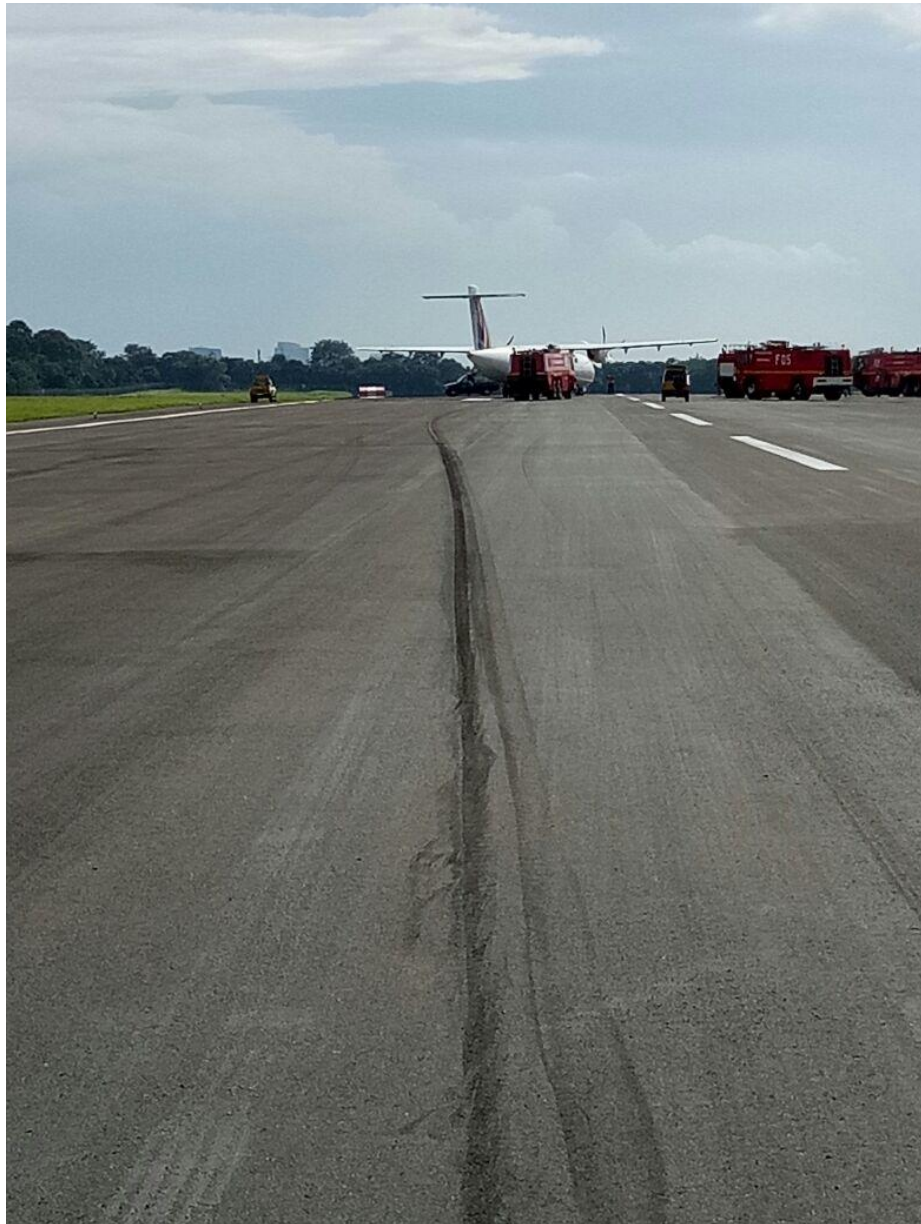
The Halim Tower controller noticed that the aircraft touched down near the intersection taxiway G at approximately 800 meters from the runway threshold and bounced. The aircraft stopped on runway near the intersection taxiway A.

Figure 1: final aircraft position and mark on the runway

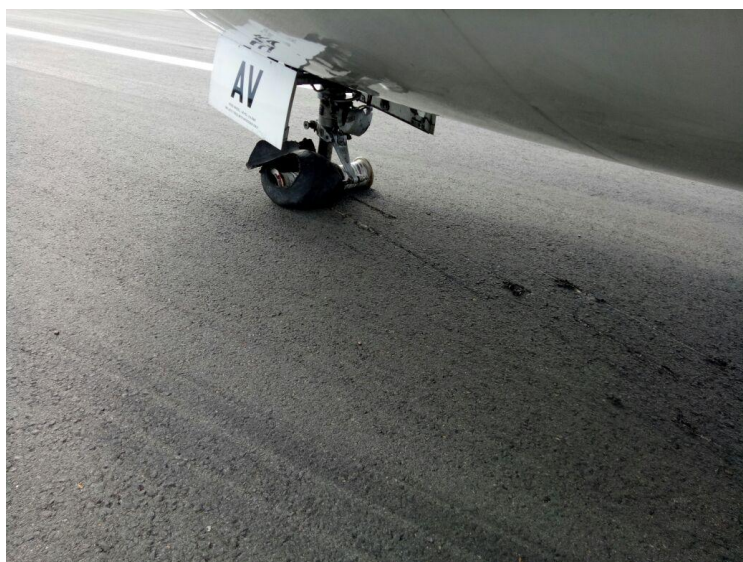
The aircraft was substantially damaged. The nosewheel tires blown out, both nose wheel hubs scraped by the runway and the nosewheel axle bent.

Figure 2: nose landing gear damaged

The inspection after the occurrence found cracked on the mounting strut bar and the shock mount of engine number 1 and number 2.

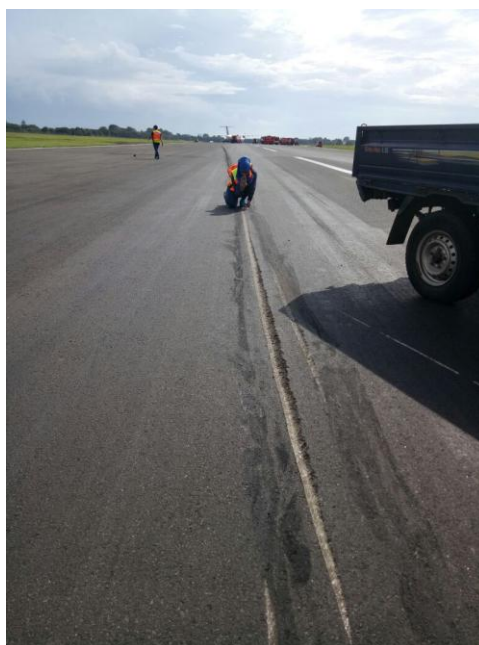
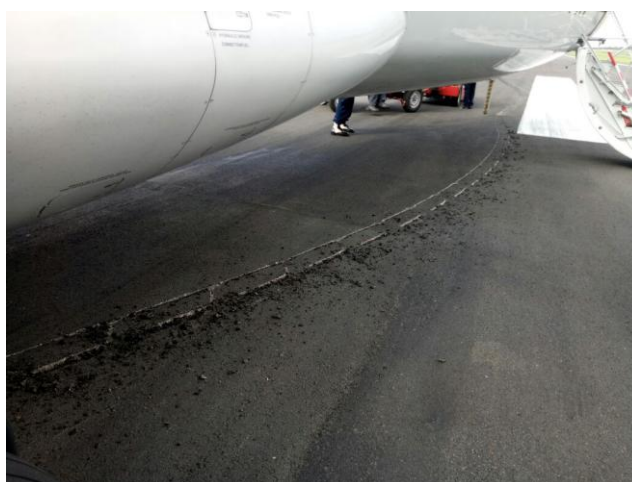
The runway surface was scratched along the aircraft movement with the depth of approximately five centimeters.

Several metal and tire scratch marks were found on the runway, the scratch marks found at intersection taxiway B or about 1,500 meters from runway threshold.

Figure 4: Scratch marks found on runway Survival Aspect
