Serious Incident Investigation Short Summary Report

Perkasa Flying School

Piper PA-28 Warrior; PK-PBO

Nusawiru Airport, Pangandaran

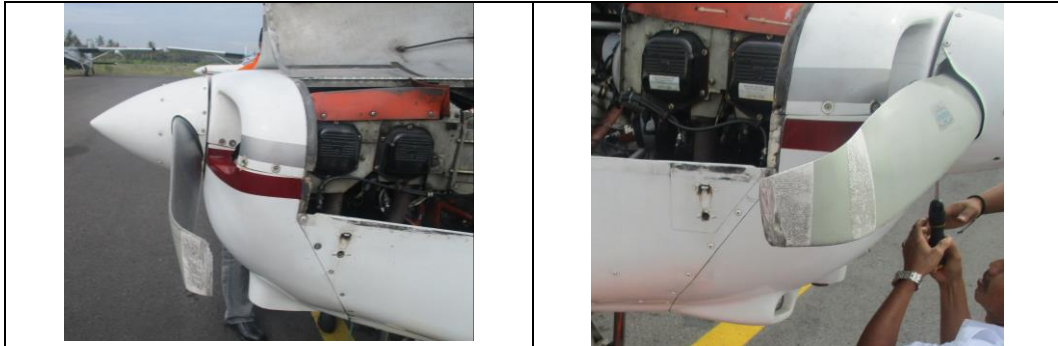
Figure 1: Left and right propeller tips

The bounce recovery as described in the ALAR briefing described several factors that may contribute to the bounce landing including incorrect flare technique. The evidence of propeller tips bent, lower engine cowl scratch and nose wheel damage, indicated that the aircraft had experienced nose wheel touch down with low nose attitude.

This incident highlights the in-correct flare technique led to the aircraft bounce and improper recovery. The flying school requires ensure adequate training and assessment for the ability of student pilot in handling the aircraft in normal and abnormal condition.

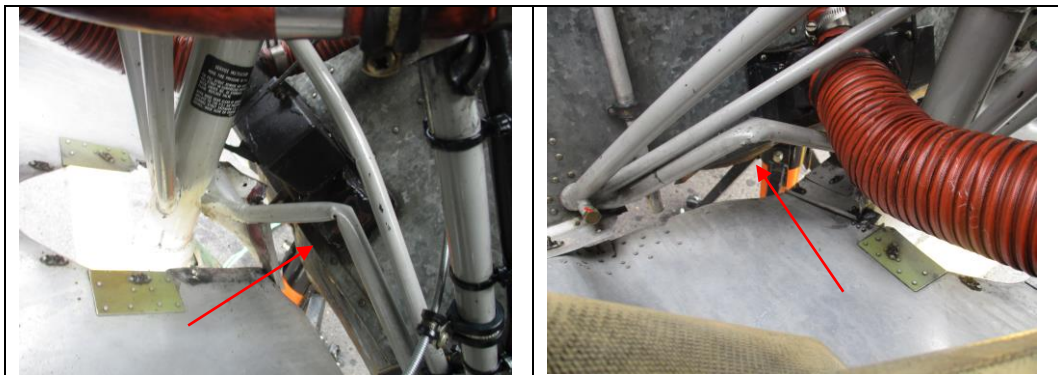
Figure 2: Left and right engine strut

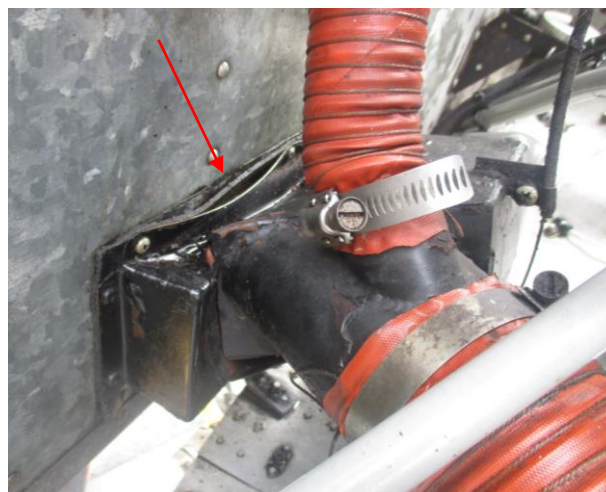
Figure 3: Fan blower deformation
