**KOMITE NASIONAL KESELAMATAN TRANSPORTASI
REPUBLIC OF INDONESIA**

Aircraft Accident Investigation Report

**PT. Lion Mentari Airlines PT. Wings Abadi Airlines
Boeing 737-900ER; PK-LJZ and ATR 72-500; PK-WFF**

Kualanamu International Airport, Medan

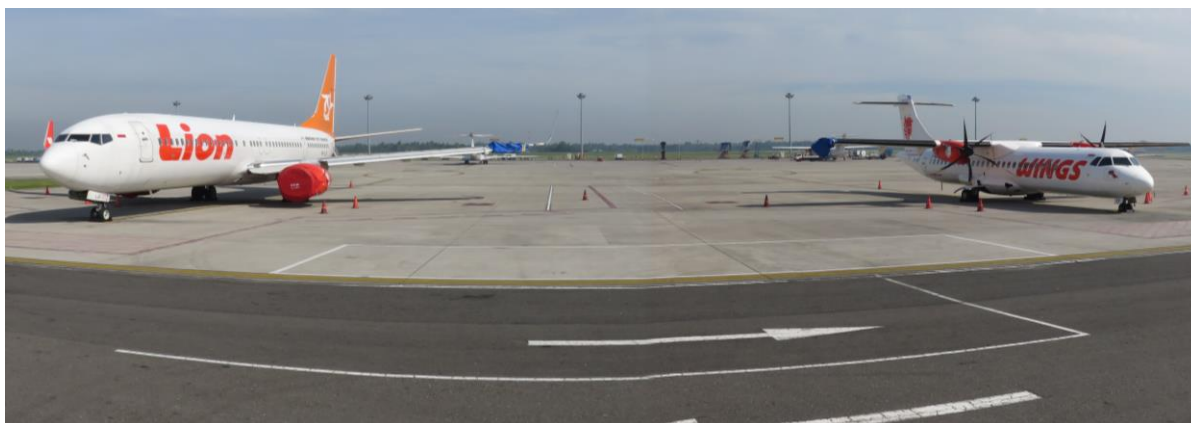
Figure 2: JT197 and IW1252 after the accident

Both aircraft were substantially damaged. The damage was found on the left wing of JT197 and the right wing of IW1252, as well as the nose section of IW1252.

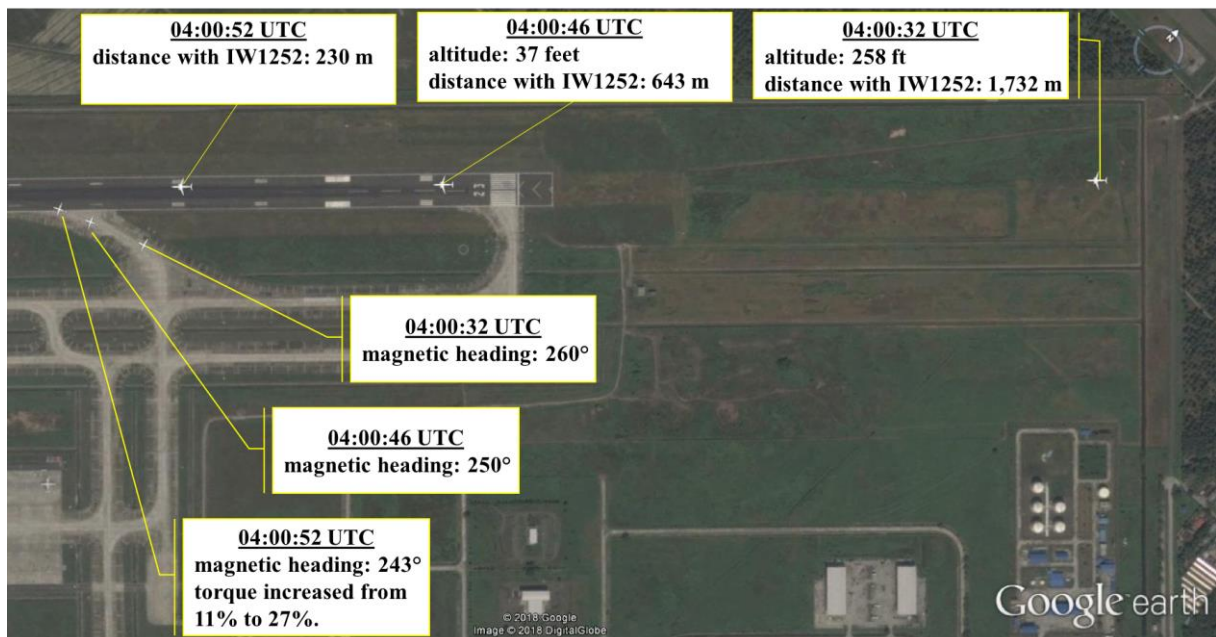
Figure 5: The FDR data superimposed with Google Earth

- 04:00:52 UTC, the aircraft crossed the runway side stripe marking (white line) at magnetic heading 243°, the torque increased from 11% to 27%.
- 04:00:56 UTC, the magnetic heading was 237°.

- 04:01:21 UTC, the ground speed recorded 0.
- 04:05:21 UTC, the ground speed started to increase.

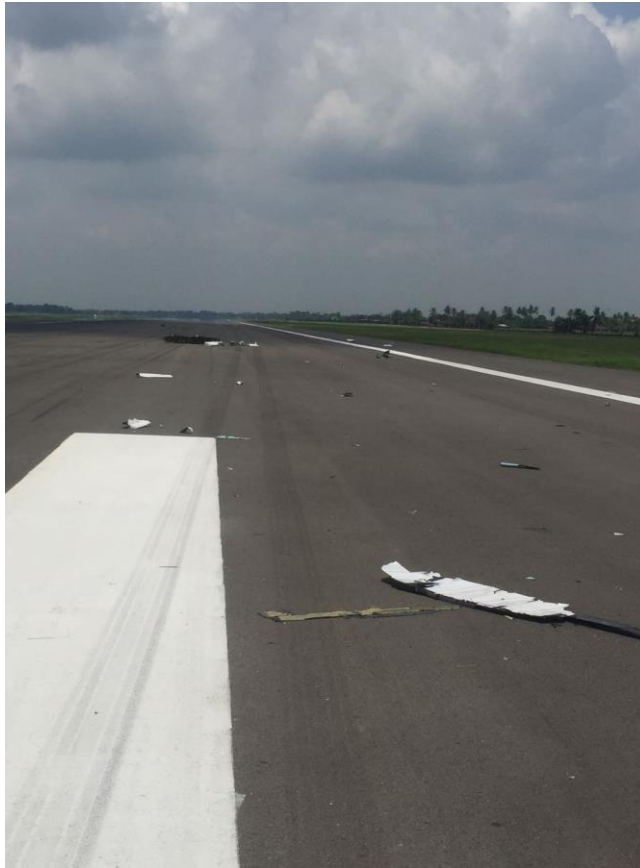
Figure 6: The debris on runway

After receiving the information of debris on the runway, the Medan Tower supervisor contacted the Airport Runway and Accessibility unit to check the runway condition. The runway inspection team proceeded to the runway and found debris on the runway, mostly on the right side of the runway 23 centerline.

Debris found on the runway are shown on the following figure that was taken by Airport Runway and Accessibility personnel.

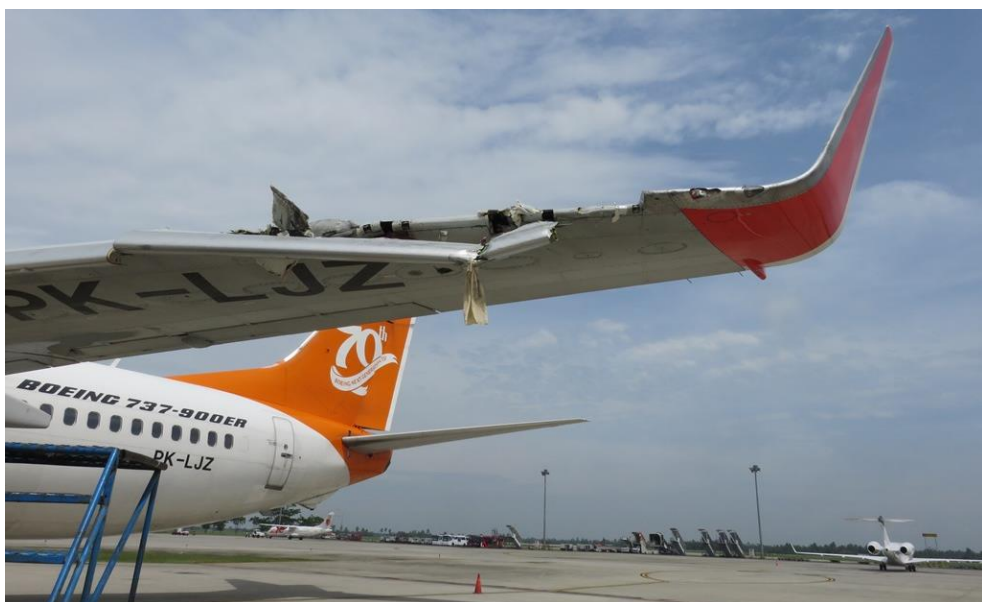
Figure 7: The damaged wing of JT197

The left wing was damaged on the wing leading edge approximately 3.4 meters long. The slat number 1 was damage approximately 3.4 x 0.4 meters. Part of the slat with dimension approximately 65 × 40 centimeters was detached.

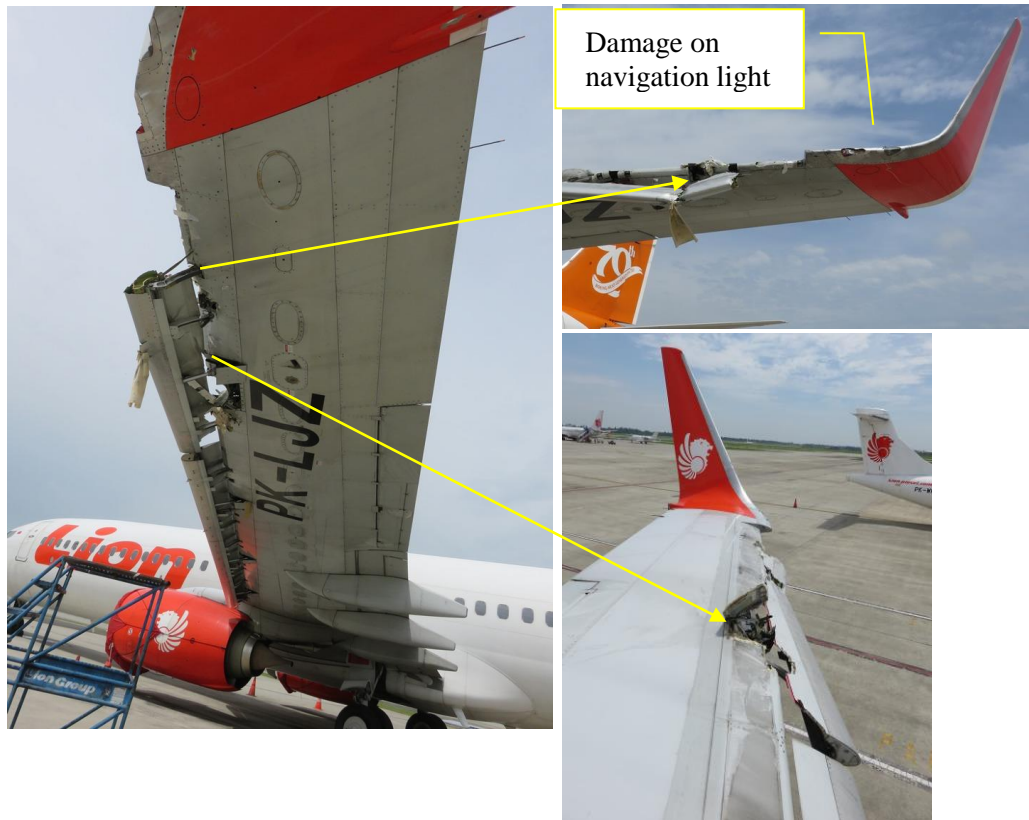
Figure 8: The damage on the left wing of JT197

The winglet area had several dents including damaged on the navigation light. The damages were as follows:

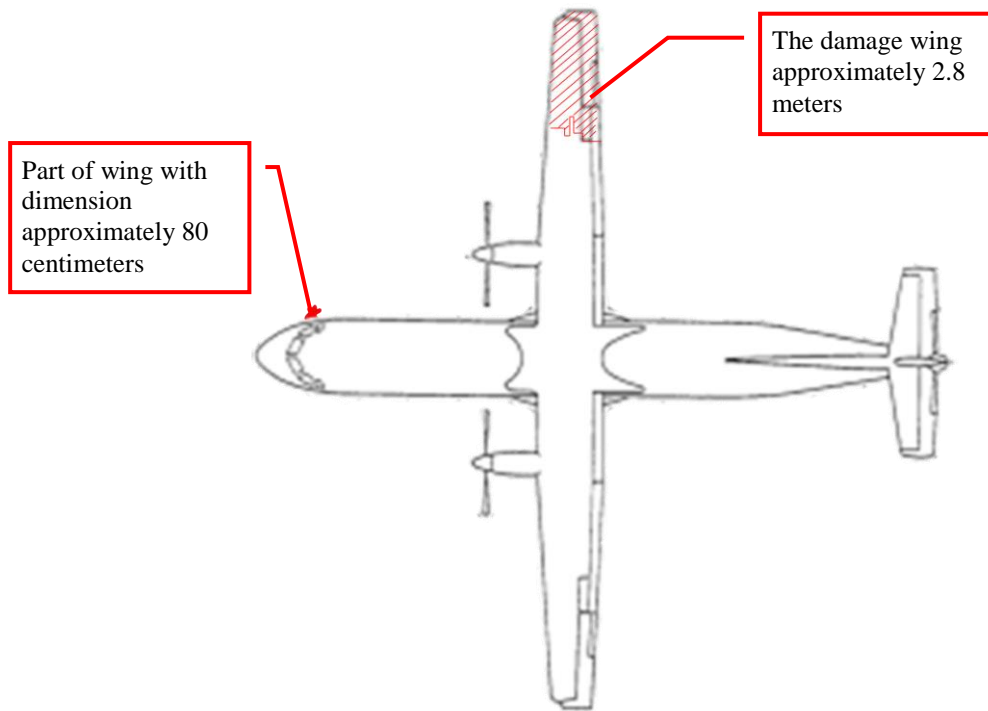
Figure 10: The IW1252 damage

The right wing from wing rib 24 until the wing tip was broken and detached with the length approximately of 2.8 meters. Part of the broken wing was found stuck on the right pitot tube. The illustration of the damage is shown in the following figure.

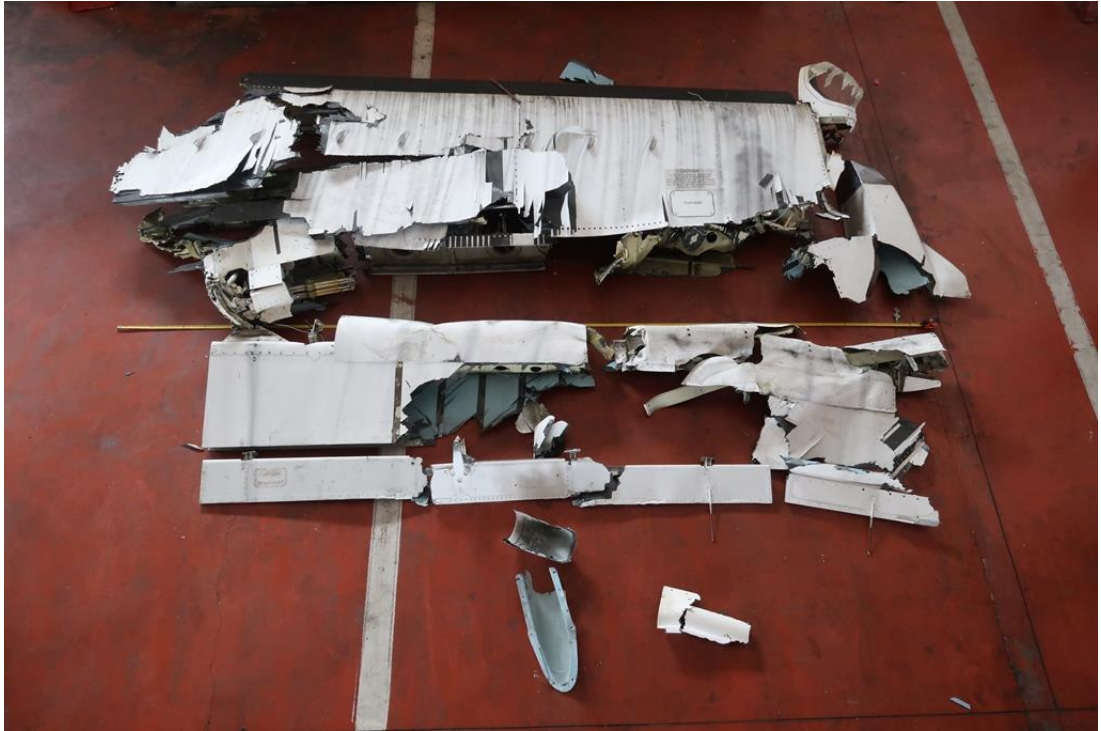
Figure 14: The reassembled wing

During the investigation, the KNKT reconstructed the broken wing of IW1252. The reconstruction of the broken wing is shown in the following figure.
