KOMITE NASIONAL KESELAMATAN TRANSPORTASI REPUBLIC OF INDONESIA

PRELIMINARY KNKT.18.06.25.04

Aircraft Serious Incident Investigation Report

PT. Wings Abadi Airlines ATR 72-212;PK-WHF Sintang, West Kalimantan Republic of Indonesia 19 June 2018

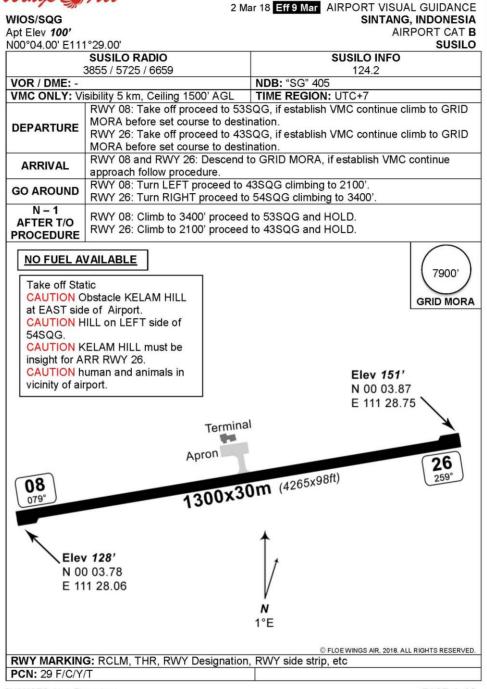
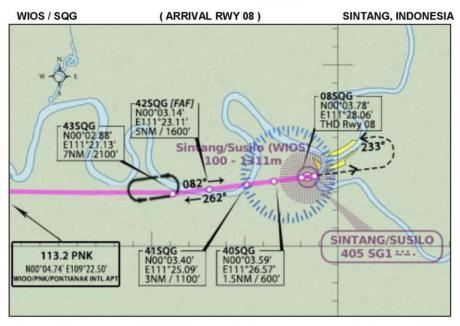
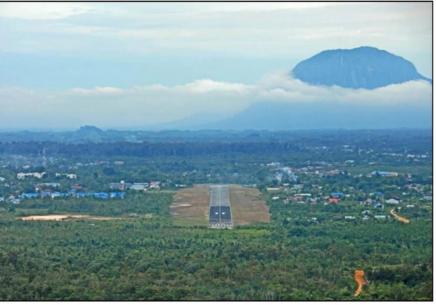
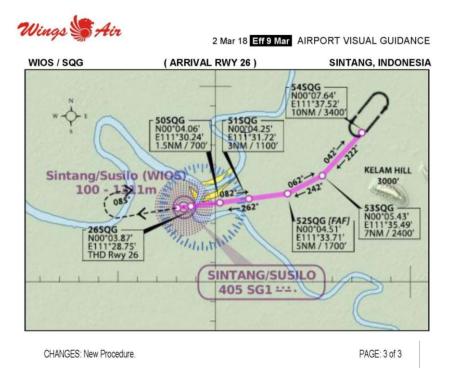
Figure 1: The charts available on the aircraft that were used by the pilot

The information on the AVG related to Sintang Airport available on the aircraft was published on 2 March 2018 and effective since 9 March 2018 with reason for revision was new procedure. These documents were used by the pilots during the serious incident flight.

The aircraft had document library which contained several documents including Airport Visual Guidance (AVG). The aircraft document library was updated on January 2018, while the AVG revision status was number 5 dated 25 August 2017. The AVG of the Sintang Airport available on the aircraft library and utilized by the pilot was published on 2 March 2018 and effective since 9 March 2018, therefore KNKT recommends to ensure all the document provided for the flight operation up to date and properly documented.
