**KOMITE NASIONAL KESELAMATAN TRANSPORTASI
REPUBLIC OF INDONESIA**

Aircraft Accident Investigation Report

Cessna 172 S; PK-BYK

Blimbingsari Airport, Banyuwangi, East Java

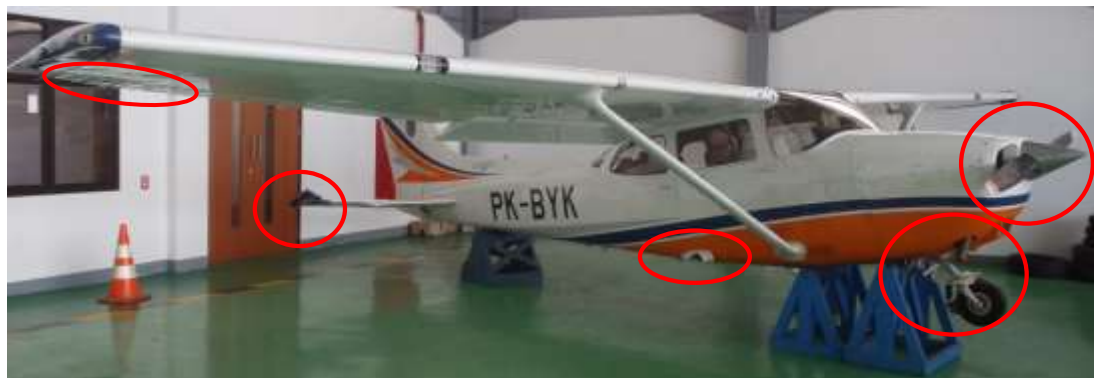
Figure 1: Damaged of the aircraft

- Right main landing gear detached;
- Nose landing gear collapse and wheel fairing broken;
- Right wing tip and elevator tip wrinkled;
- Both propeller blade tips scratched; and
- Lower fuselage scratched.

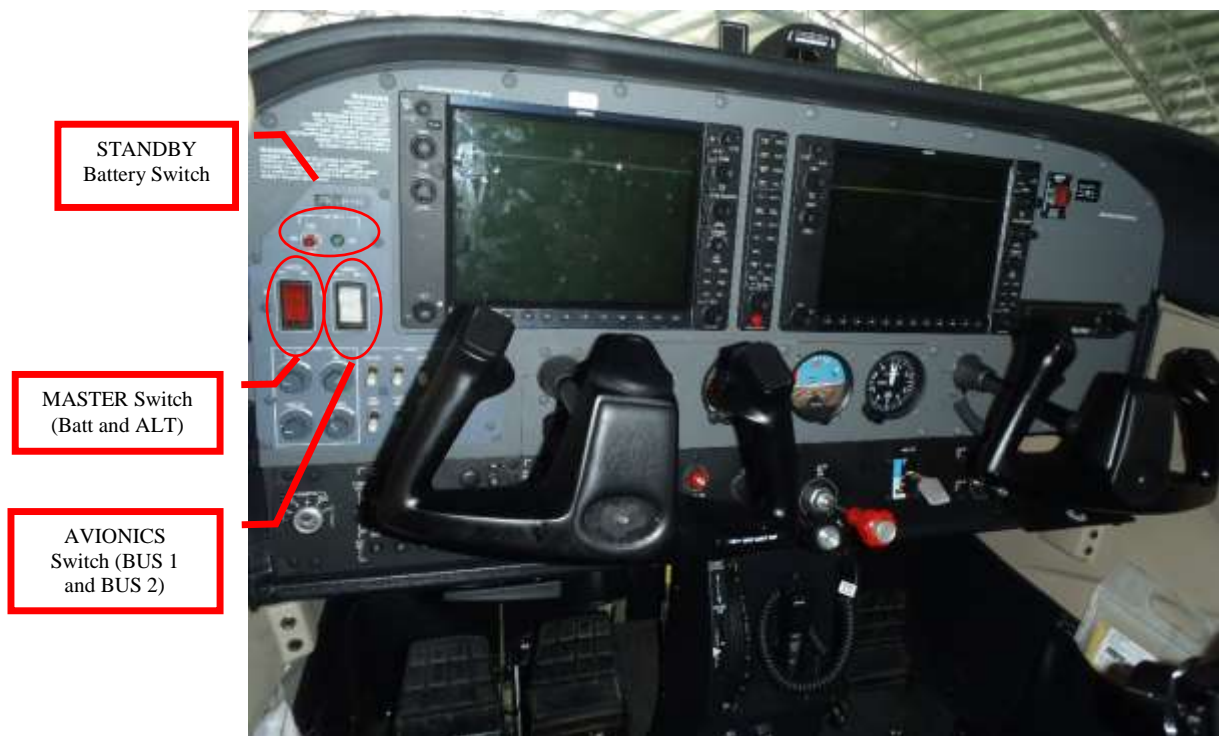
Figure 5: The electrical system switch position

The master switch position on the aircraft was shown on the following figure:

The master switch is located on the left of cockpit instrument panel while the FI seated on the right seat. The FI left hand required to cross the student pilot in order to reach the master switch.

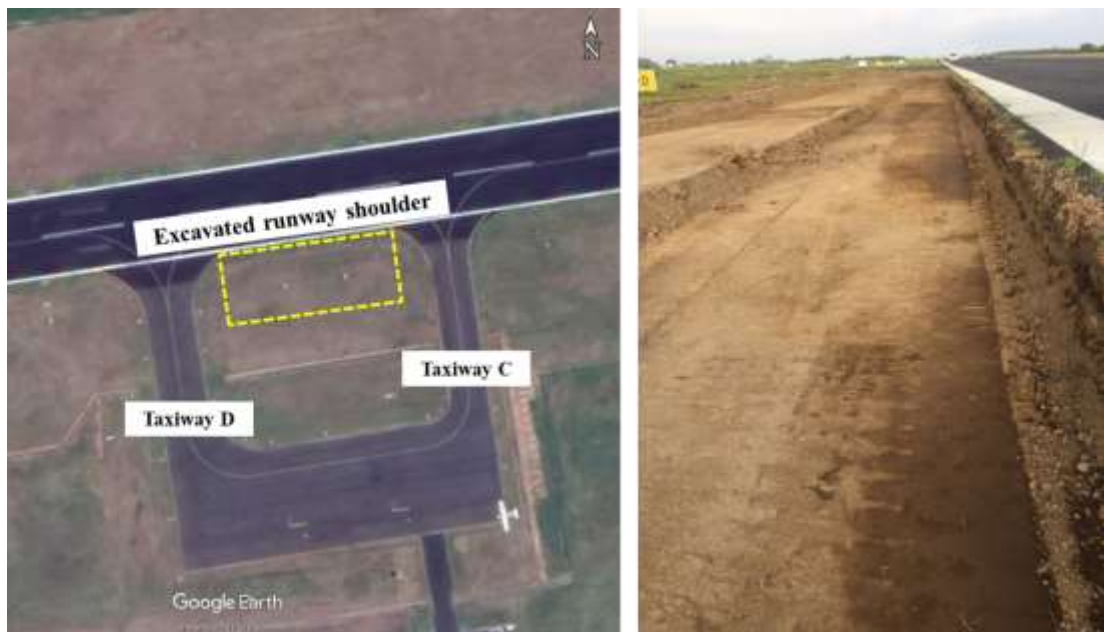
Figure 6: The excavated runway shoulder position and condition

According to the Notification to Airmen (NOTAM) number C5426/18, effective since 21 May 2018 until 20 August 2018, stated that the taxiway C was close due to work in progress. At the time of the occurrence, the surface in the left side of the runway between taxiway C and D was excavated about 50 centimeters depth.

The closing of taxiway C had been informed in the Notam that was effective for two months before the occurrence. However, there was no sign or indication available to the pilot that there was an excavated area in the runway strip. The MOS 139 requires the surface of the runway strip adjacent to the runway, shoulder or stopway shall be flush with the runway surface, shoulder or stopway. However, due to the work on the runway shoulder without properly marked for day and night operation, may reduce the pilot awareness resulted in the aircraft damage when passed by the veered off aircraft.

The closing of taxiway C had been informed in the Notam that was effective on the day of the occurrence. There was no sign or indication available to the pilot that there was an excavated area in the runway strip. The MOS 139 requires the surface of the runway strip adjacent to the runway, shoulder or stopway shall be flush with the runway surface, shoulder or stopway. However, due to the work on the runway shoulder without properly marked for day and night operation may reduce the pilot awareness, resulted in the aircraft damage when passed by the veered off aircraft. Therefore, KNKT recommends to ensure the hazard surround the movement area are properly mitigated and marked.

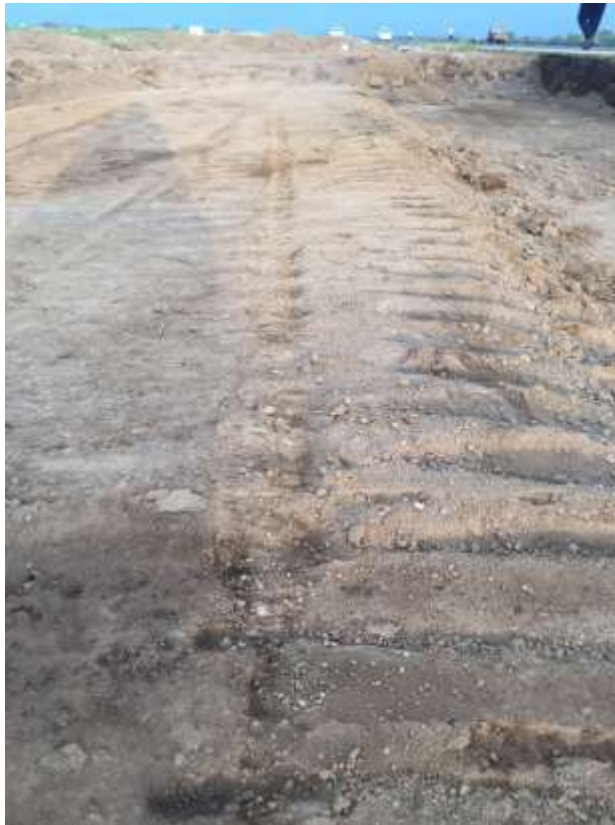
Figure 7: The right and left main landing gear marks

Tire marks found on the runway showed that after touchdown, the aircraft veered to the left and travelled out from the runway into the excavated area on the left side of the runway. The mark of the right main wheel passed the mound at the end of excavated runway shoulder. The ground scars mark showed the aircraft travelled out of the excavated area and crossed taxiway D and continued exited the taxiway pavement. Afterwards, the tyre mark showed the aircraft passed taxiway and runway lights then travelled back to runway surface.

- Right and left main landing gear marks on left excavated runway 26 shoulder;
- Scratch mark on taxiway D;
- Propeller scratch marks on runway near the location of aircraft stopped.

The tire marks found indicated that aircraft travelled in excavated area on the left shoulder of the runway then the right main landing gear impacted mound of land before the aircraft re-enter the runway and stopped. The impact might have made the right main landing gear collapsed and turned the aircraft heading almost opposite to the landing direction.

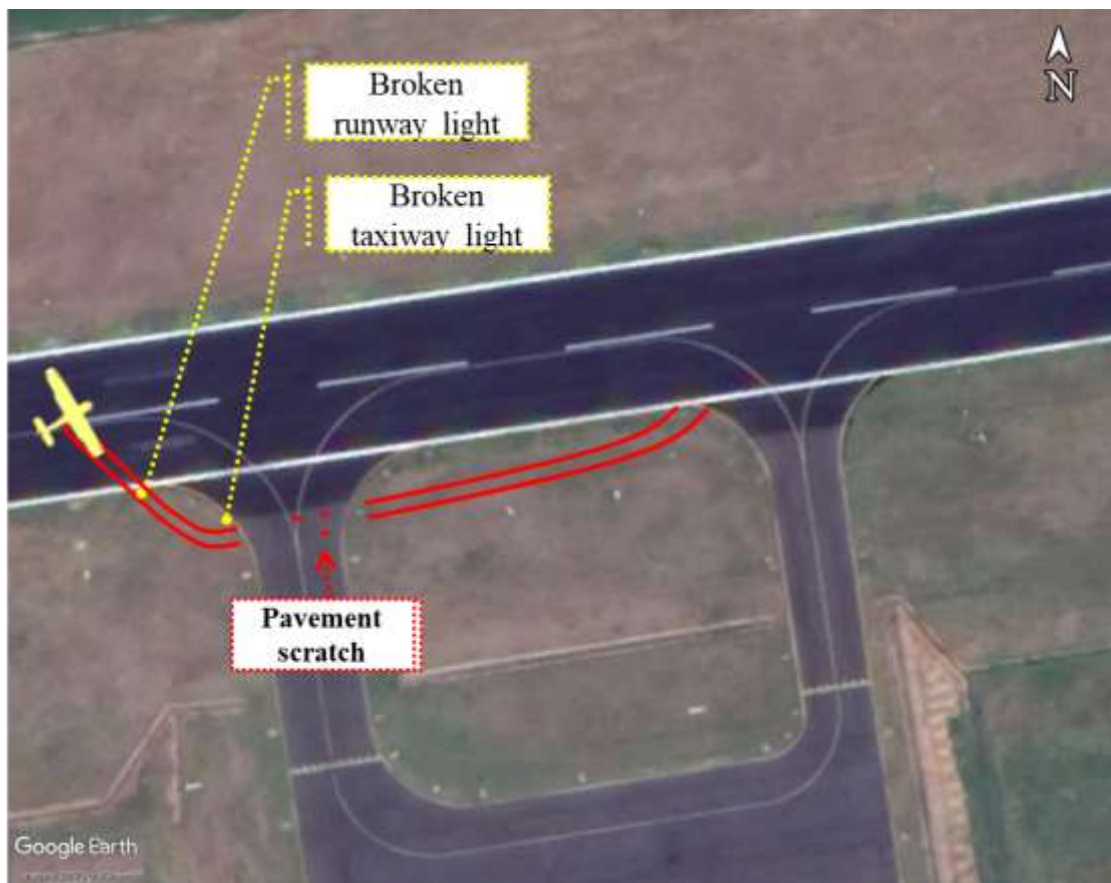
Figure 9: Illustration of the aircraft movement

The aircraft stopped on runway about 1,200 meters from beginning runway 26 on heading approximately 060° and tilted to the right.
