KNKT.18.12.43.04

Aircraft Serious Incident Investigation Report

Cessna 208; PK-ASE

Kasonaweja Airstrip

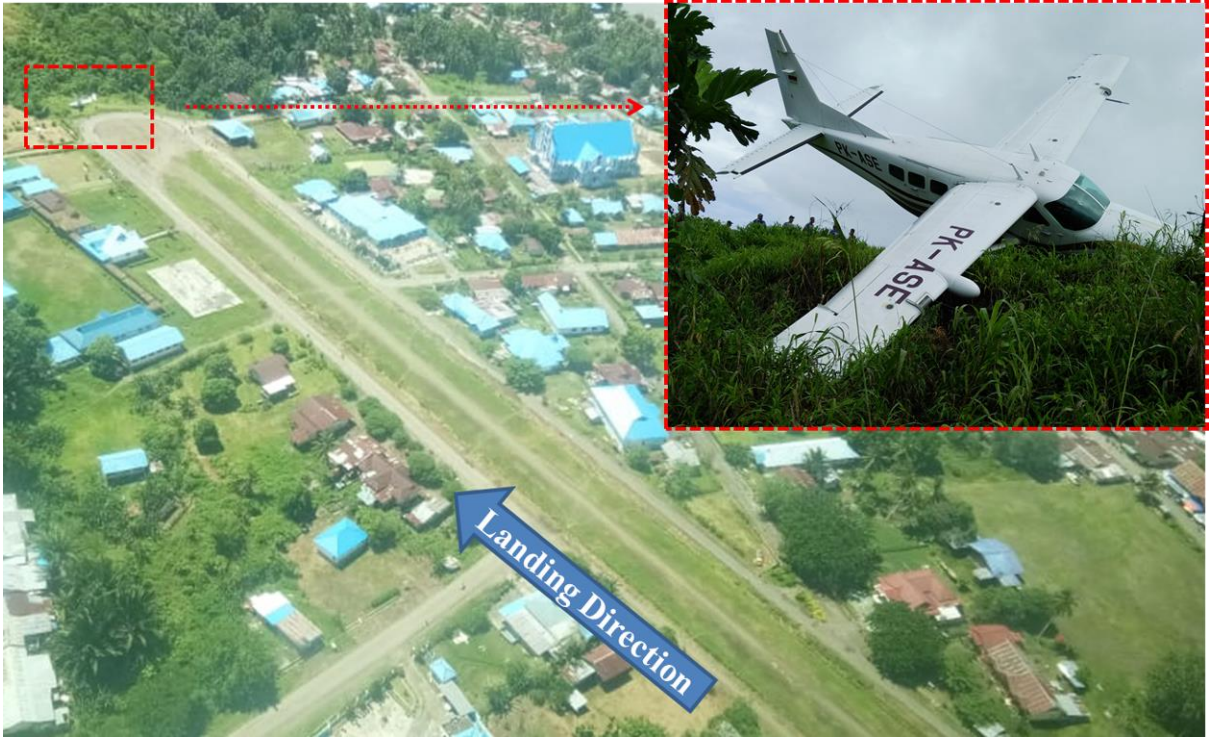
The aircraft stopped outside the runway about 14 meters from the end of runway 17, the right landing gear was on downslope. The aircraft tilted to the right about 45°. The propeller and the right wing impacted ground. The propeller blades bent backward and the right wing was damaged.

Figure 2: The occurrence site

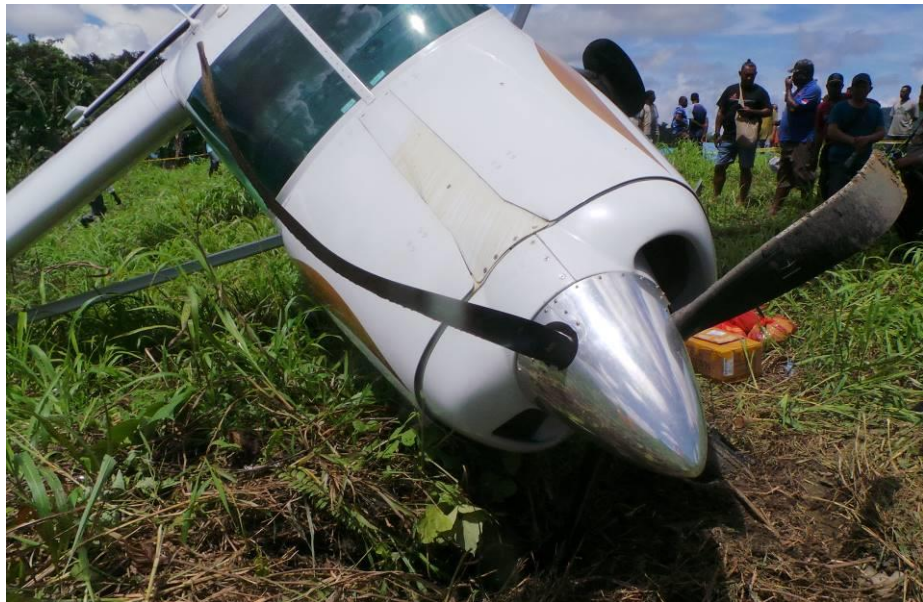
Figure 3: The propeller bent backward

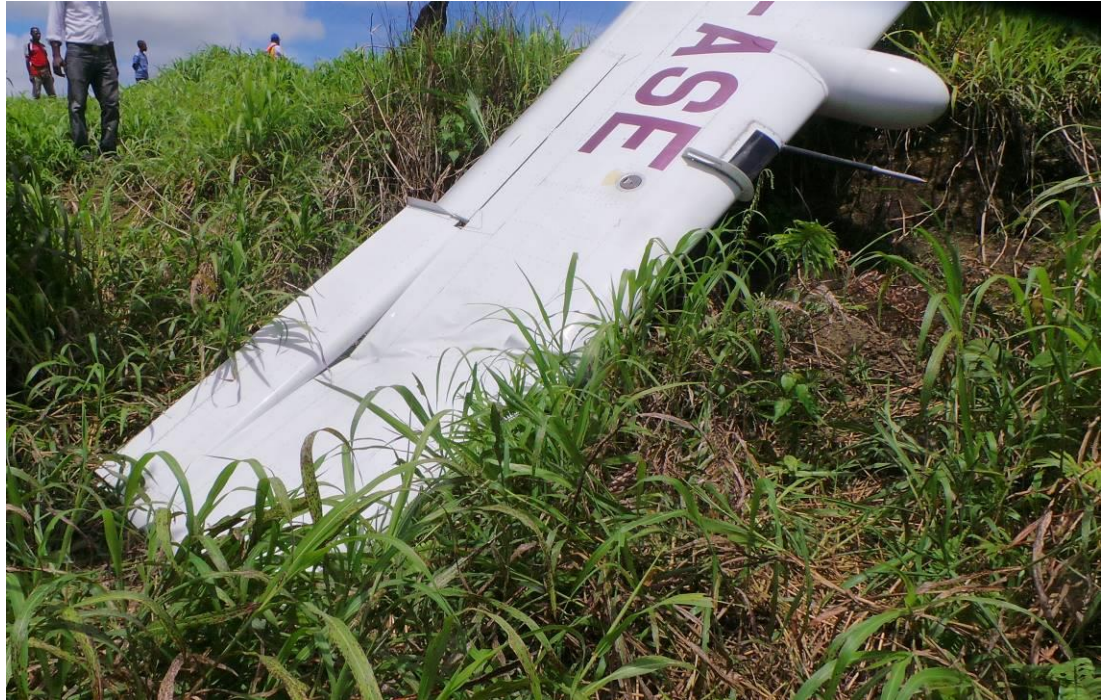
Figure 4: The damaged right wing
