**KOMITE NASIONAL KESELAMATAN TRANSPORTASI
REPUBLIC OF INDONESIA**

Aircraft Serious Incident Investigation Report

PT. Spirit Avia Sentosa (FlyingSAS)

Cessna 208B, PK-FSL

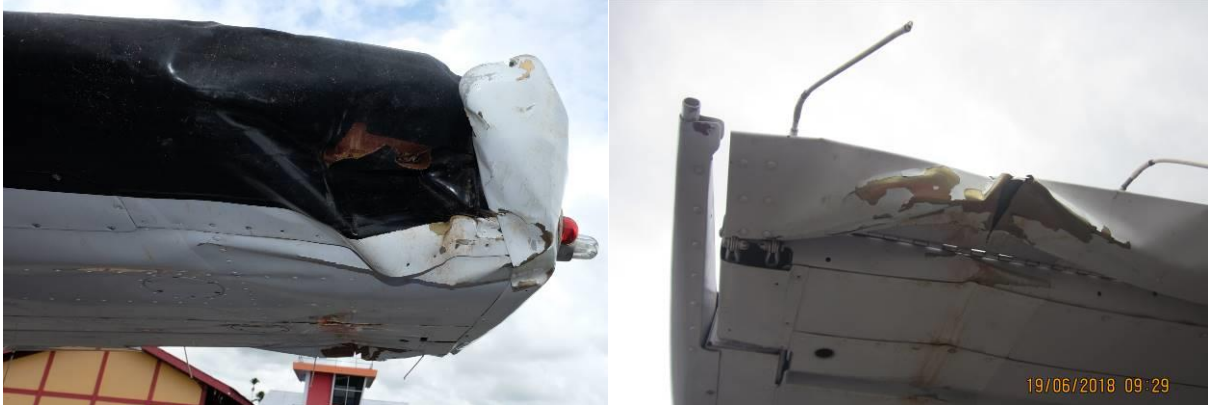
The aircraft was substantially damaged. The left-wing tip including the left aileron were damaged and several dents found on the left wing and on the left horizontal stabilizer.

Figure 2: The damage on the left-wing tip and left aileron

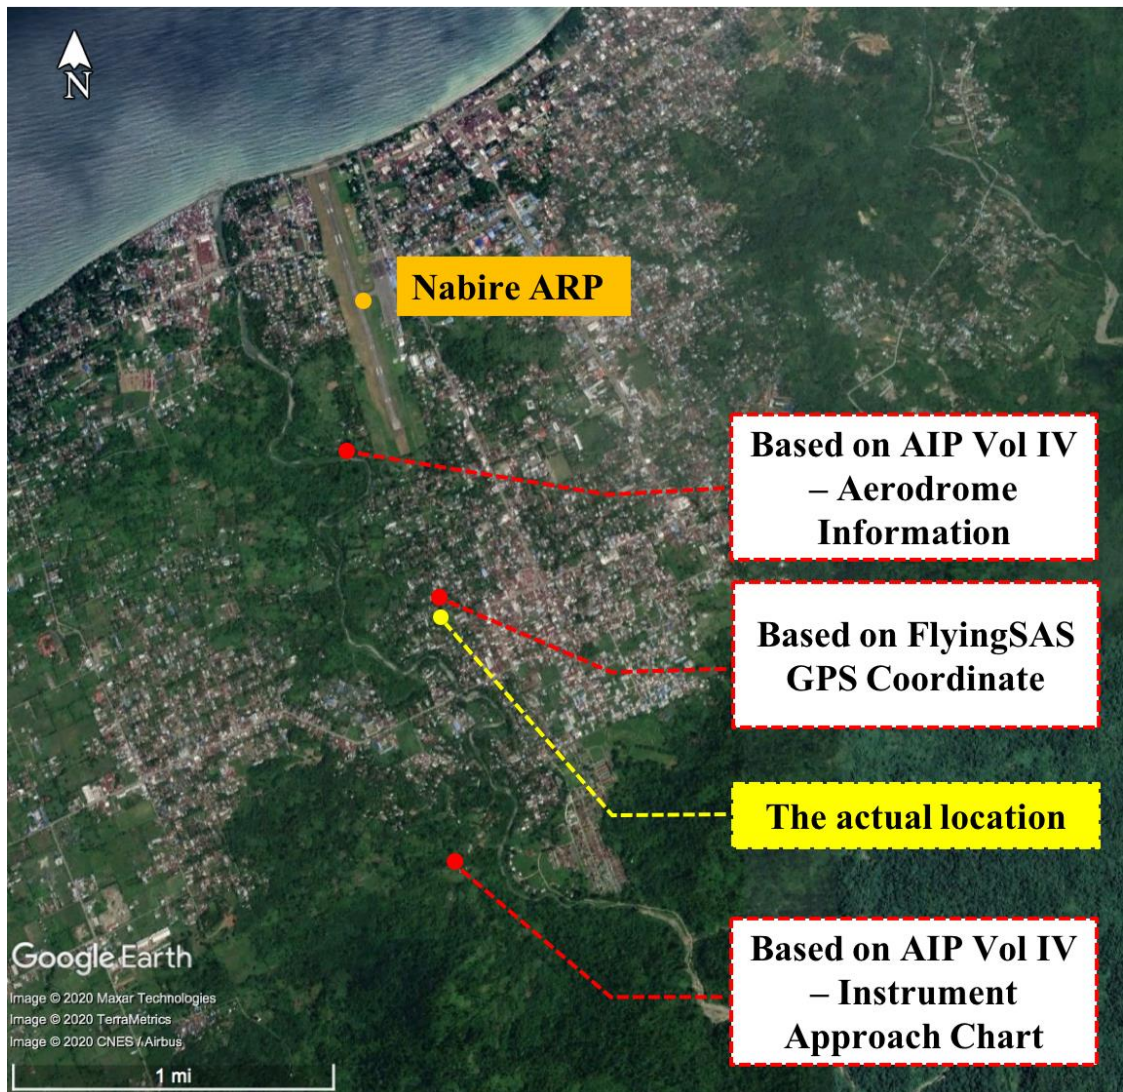
Figure 10: The NBR VOR/DME locations

The FlyingSAS GPS stored the position of the NBR VOR/DME on coordinate 03°22'55.05" S; 135°30'04.04" E. Referred to this coordinate, the NBR VOR/DME was about 0.9 Nm from Nabire ARP on bearing 164°.

After the occurrence, the AirNav Indonesia rechecked the NBR VOR/DME location and updated the actual location with the following coordinate 03°22'59.0"S; 135°30'05.1"E. The update location had been amended in the AIP Volume IV.

Responding to those safety recommendation number 04.A-2018-24.2, the AirNav Indonesia rechecked the actual location of the NBR VOR/DME location, and updated the actual location in the new amendment of AIP Volume IV for Nabire.

Responding to the safety recommendation number 04.R-2018-24.4 above, the DGCA had been amended the NBR VOR/DME location information in the AIP Volume IV.

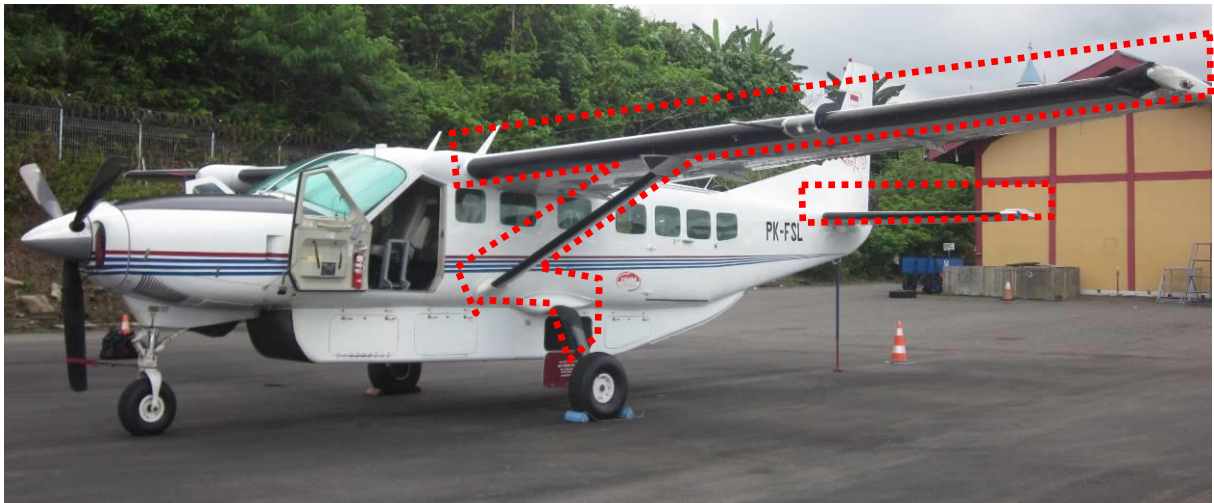
Evidence of impact marks were found on the left side of the aircraft which were on the main landing gear strut, wing strut fairing, wing and horizontal stabilizer.

Figure 13: The impact marks on the aircraft found in the area inside red dot lines

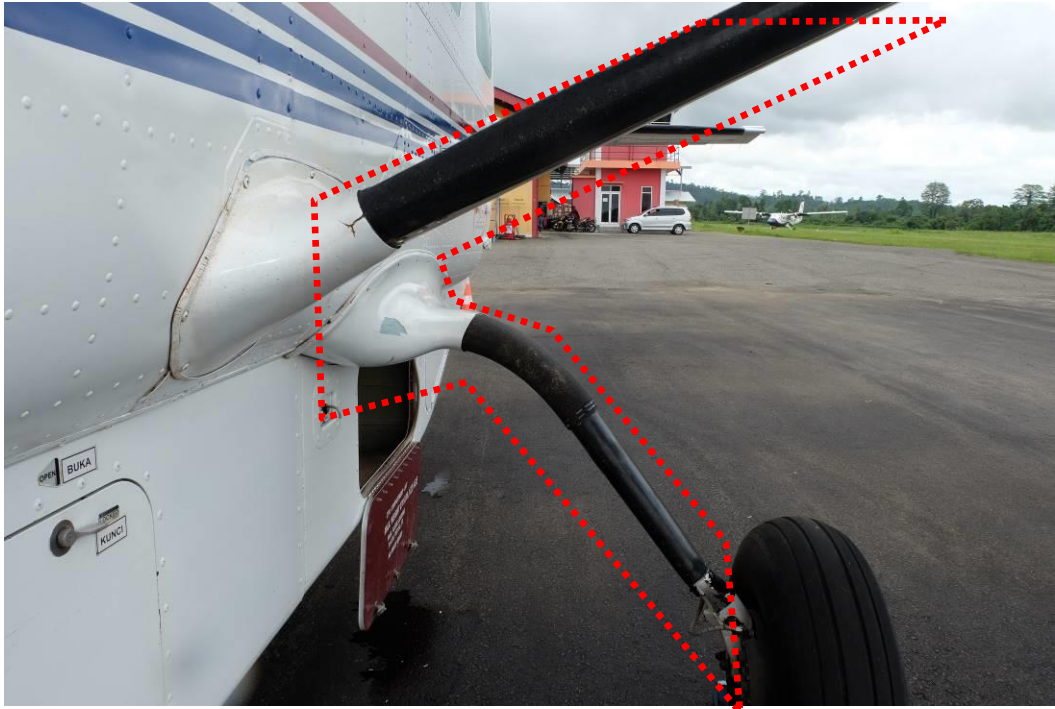
Figure 14: The impact marks on left hand main landing gear strut and wing strut fairing (inside the red dot line)

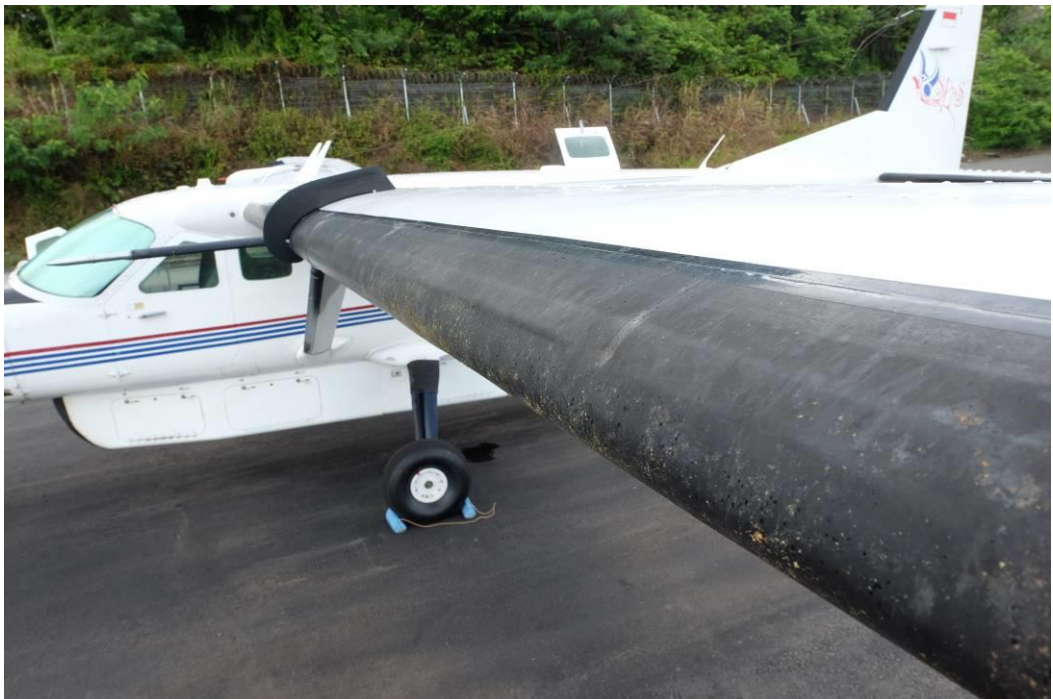
Figure 15: The wood impact marks on left wing leading edge

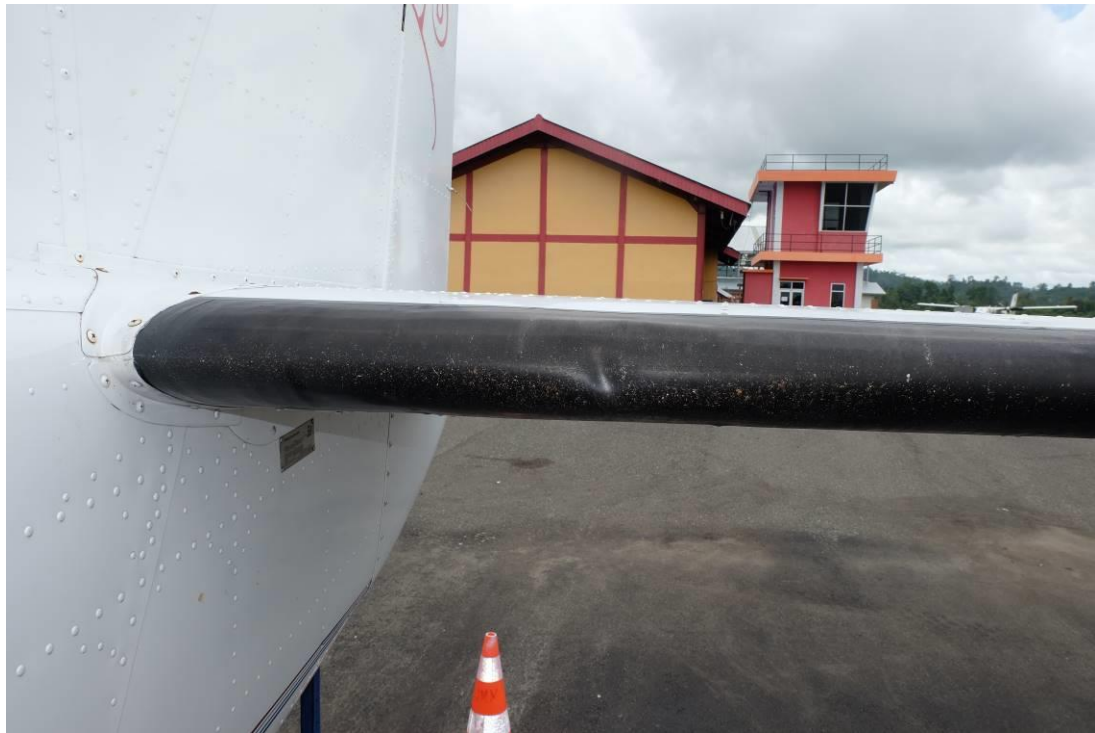
Figure 16: The dent and impact marks on left horizontal stabilizer
