**KOMITE NASIONAL KESELAMATAN TRANSPORTASI
REPUBLIC OF INDONESIA**

Aircraft Accident Investigation Report

PT. Spirit Avia Sentosa (FlyingSAS)

Cessna 208B, PK-FSL

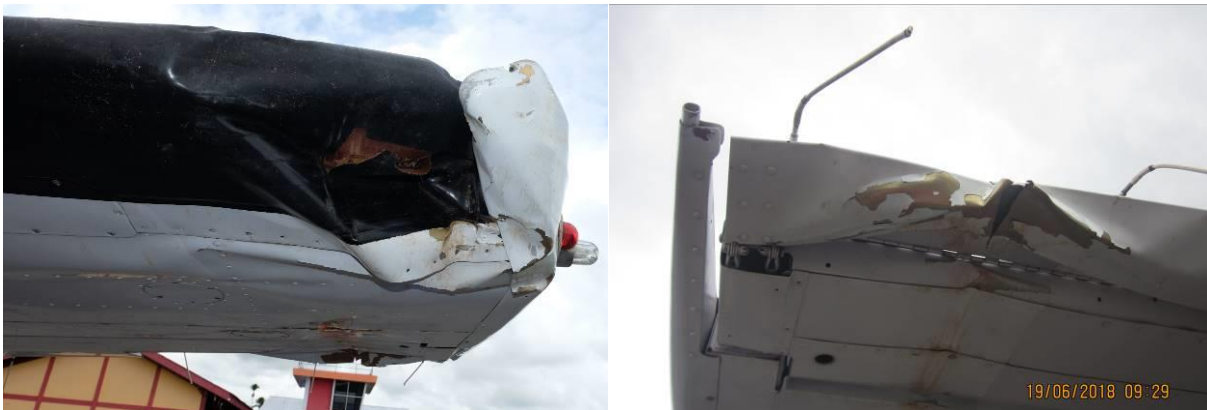
The aircraft was substantially damaged. The left wing tip was damaged and several dent found on the left wing and on the left horizontal stabilizer.

Figure 2: The damage on the left wing tip

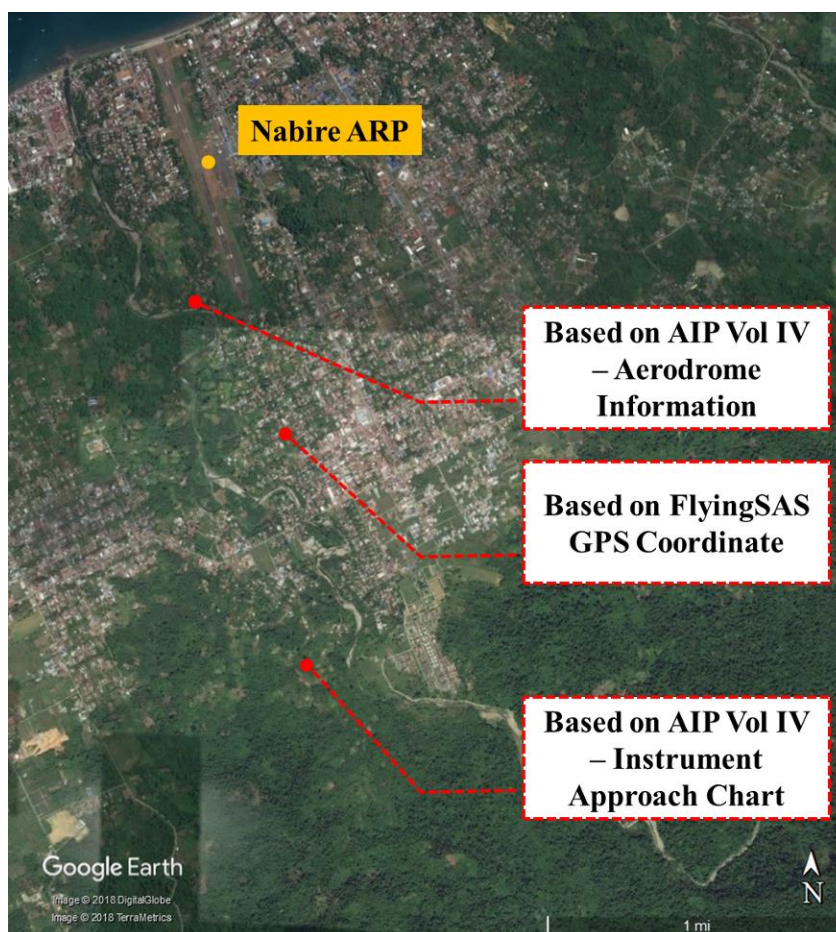
Figure 7: The NBR VOR/DME locations

The location of the NBR VOR/DME on the airport information was on coordinate $03^{\circ}23'38.1''$ S; $135^{\circ}30'08''$ E which was about 1.6 Nm from aerodrome reference point (ARP) of Nabire on bearing 169° . Meanwhile, the coordinate of NBR VOR/DME on the instrument approach chart was on $03^{\circ}22'30.00''$ S; $135^{\circ}29'47.00''$ E, which was about 0.43 Nm from Nabire ARP on bearing 185° .

The FlyingSAS GPS stored different position of the NBR VOR/DME which was on coordinate $03^{\circ}22'55.05''$ S; $135^{\circ}30'04.04''$ E. Referred to this coordinate, the NBR VOR/DME was about 0.9 Nm from Nabire ARP on bearing 164° .

KNKT recommends the AirNav Indonesia to provide correct information of the NBR VOR/DME location to the DGCA and also review the possibility of other incorrect coordinate of navigation aid prior to publish in the AIP.

KNKT recommends the DGCA to determine the correct coordinate of NBR VOR/DME and also review the possibility of other incorrect coordinate of navigation aid in the AIP.

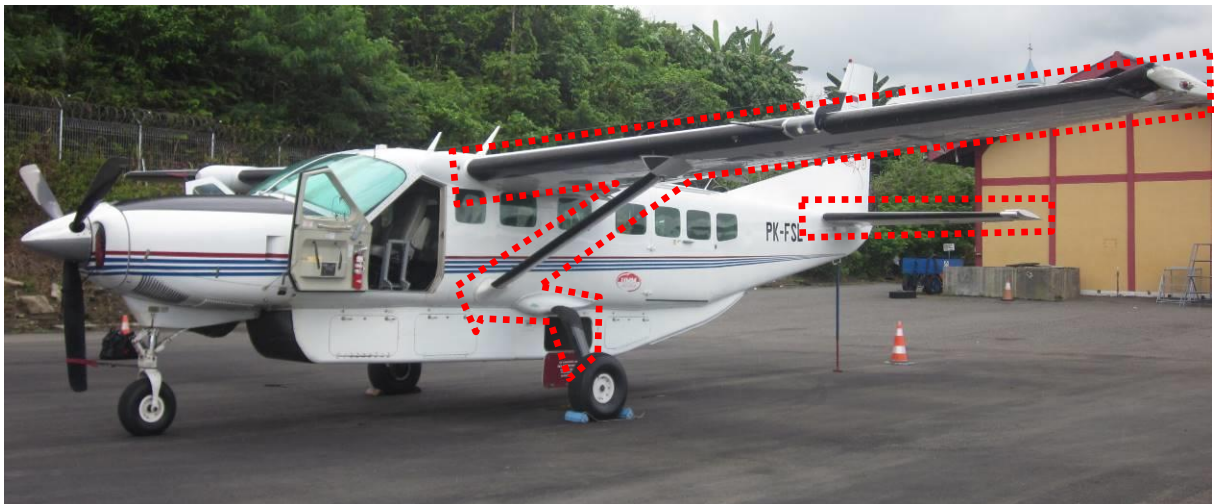
Evidence of impact marks were found on the left side of the aircraft which were on the main landing gear strut, wing strut fairing, wing and horizontal stabilizer.

Figure 9: The impact marks on the aircraft (inside the red dot line)

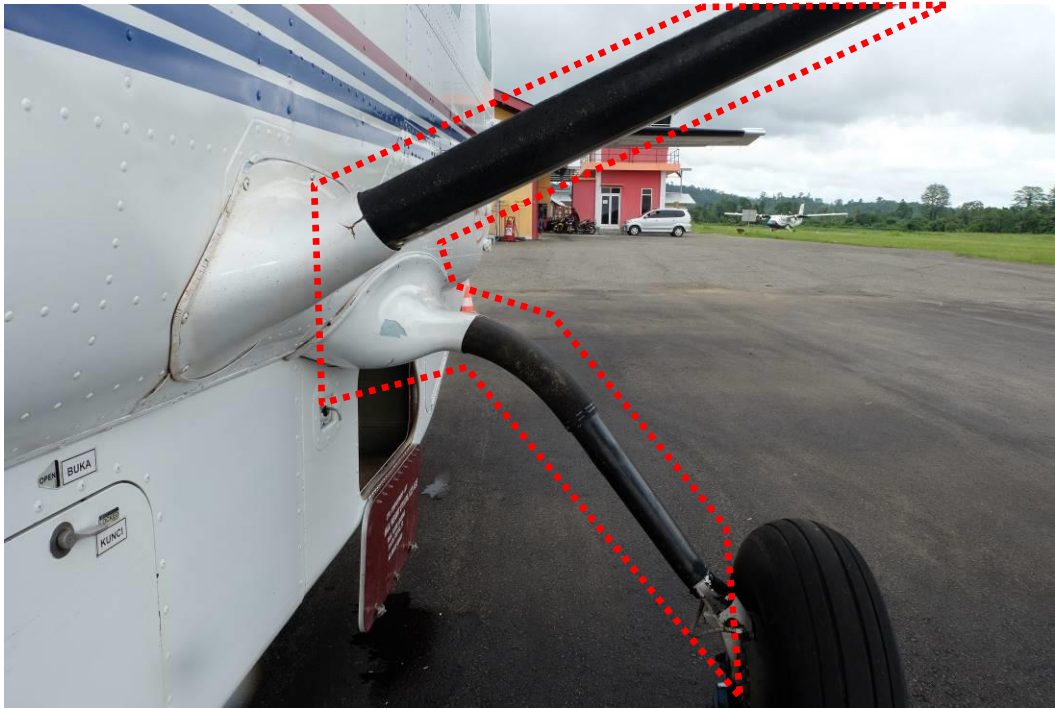
Figure 10: The impact marks on left hand main landing gear strut and wing strut fairing (inside the red dot line)

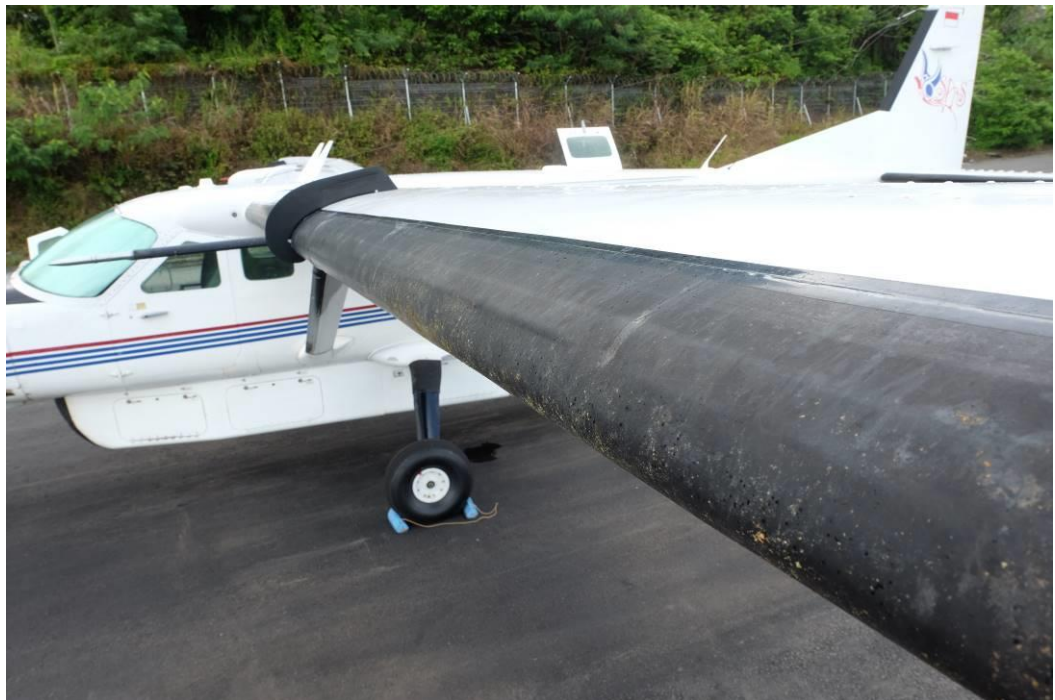
Figure 11: The wood impact marks on left wing

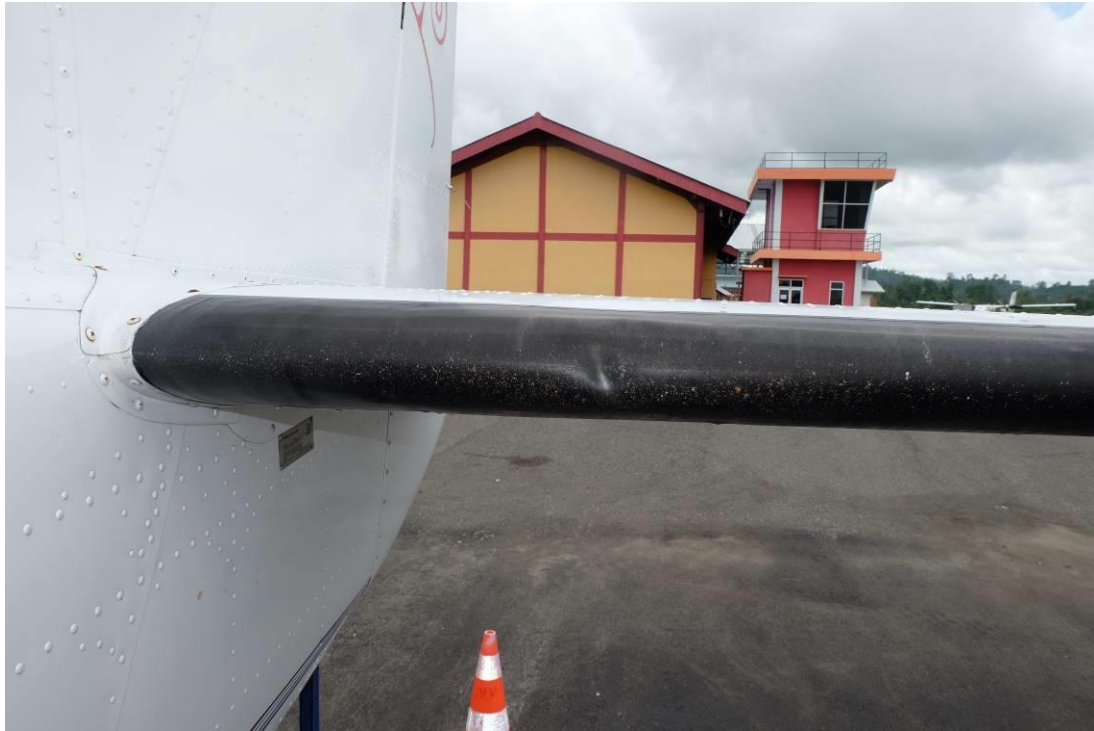
Figure 12: The dent and impact marks on left horizontal stabilizer

17. The aircraft was substantially damaged. The left wing tip was damaged and several dent found on the left wing and on the left horizontal stabilizer. Impact marks were found on the left side of the aircraft which were on the main landing gear strut, wing strut fairing, wing and horizontal stabilizer.
