**KOMITE NASIONAL KESELAMATAN TRANSPORTASI
REPUBLIC OF INDONESIA**

Aircraft Serious Incident Investigation Report

CRJ 1000; PK-GRJ

ATR 72-500; PK-WFW

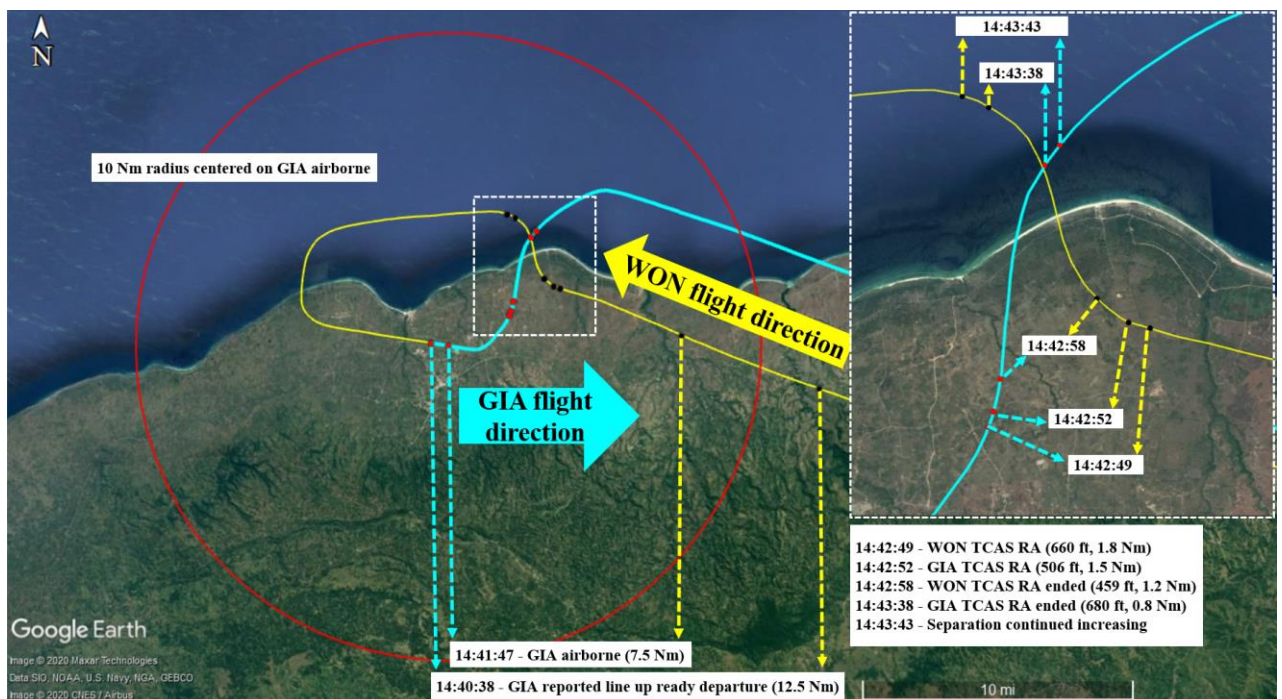
Figure 1: The flight profile based on FDR data superimposed on Google Earth

14:42:24	<ul style="list-style-type: none"> • The aircraft was climbing and passed altitude of 1,547 feet. • The aircraft was turning to the left and passed heading 048°. 	<ul style="list-style-type: none"> • The aircraft was descending and passed altitude of 3,514 feet. • The aircraft was turning to the left and passed heading 289°. 	<ul style="list-style-type: none"> • Horizontal: 4 Nm • Vertical: 1,967 feet

14:42:35	<ul style="list-style-type: none"> • The aircraft was climbing and passed altitude of 1,846 feet. • The target heading selector on the FCU was changed from 041° to 024°. • The aircraft was turning to the left and passed heading 041°. 	<ul style="list-style-type: none"> • The aircraft was descending and passed altitude of 3,158 feet. • The aircraft was turning to the left and passed heading 284°. 	<ul style="list-style-type: none"> • Horizontal: 3 Nm • Vertical: 1,312 feet

14:42:40	<ul style="list-style-type: none"> • The aircraft was climbing and passed altitude of 1,953 feet. • The aircraft was turning to the left and passed heading 039°. • The TCAS TA activated 	<ul style="list-style-type: none"> • The aircraft was descending and passed altitude of 3,005 feet. • The aircraft was turning to the left and passed heading 283°. 	<ul style="list-style-type: none"> • Horizontal: 2.6 Nm • Vertical: 1,052 feet

14:43:38	<ul style="list-style-type: none"> • The aircraft was descending and passed altitude of 1,624 feet. • The aircraft was turning to the right and passed heading 043°. • The TCAS RA changed to TCAS TA. 	<ul style="list-style-type: none"> • The aircraft was descending and passed altitude of 2,304 feet. • The aircraft was turning to the left and passed heading 299°. 	<ul style="list-style-type: none"> • Horizontal: 0.8 Nm • Vertical: 680 feet.

Time (LT)	GIA460	WON1921	Separation ⁵
14:43:43	<ul style="list-style-type: none"> The aircraft was descending and passed altitude of 1,579 feet. The aircraft was turning to the right and passed heading 046°. 	<ul style="list-style-type: none"> The aircraft was descending and passed altitude of 2,245 feet. The aircraft was turning to the left and passed heading 285°. 	<ul style="list-style-type: none"> Horizontal: 1.1 Nm and continued to increase. Vertical: 666 feet
14:43:48	<ul style="list-style-type: none"> The aircraft started to climb from altitude 1,584 feet. The aircraft was turning to the right and passed heading 050°. 	<ul style="list-style-type: none"> The aircraft was descending and passed altitude of 2,147 feet. The aircraft was turning to the left and passed heading 213°. 	<ul style="list-style-type: none"> Horizontal: 1.5 Nm Vertical: 563 feet.
