**KOMITE NASIONAL KESELAMATAN TRANSPORTASI
REPUBLIC OF INDONESIA**

PRELIMINARY

Aircraft Serious Incident Investigation Report

Bombardier CRJ1000; PK-GRP

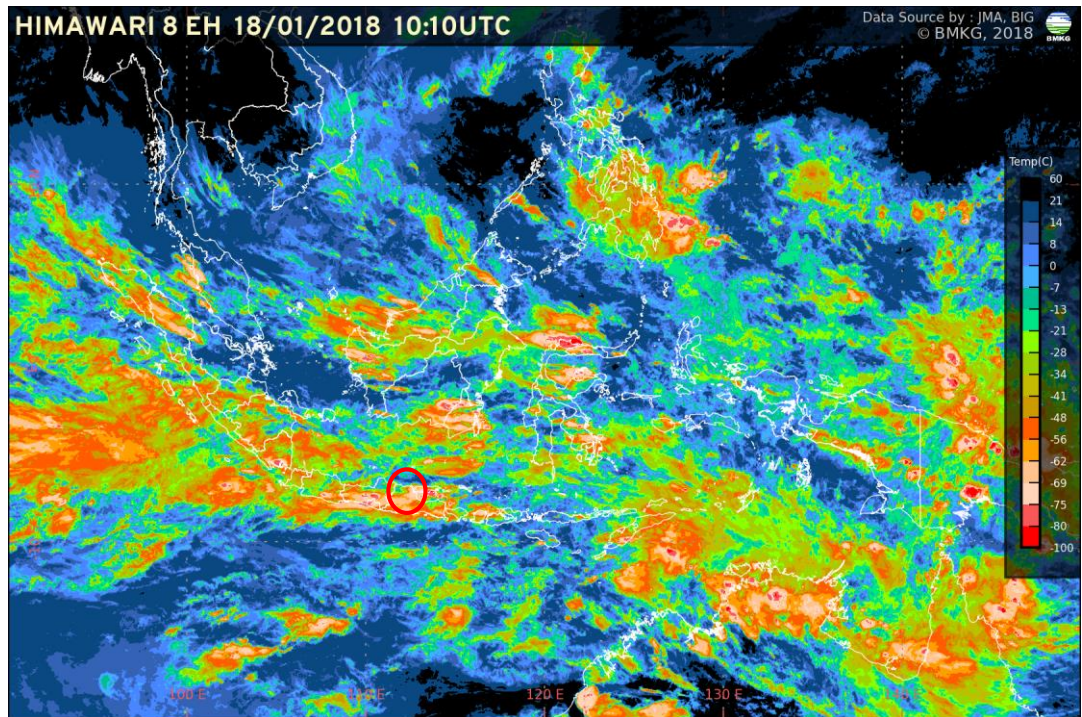
Figure 1: The satellite weather image at 1010 UTC

Juanda air traffic controller observed that during the aircraft approach, the weather condition was heavy rain. The rain moved from east to the west of the airport.

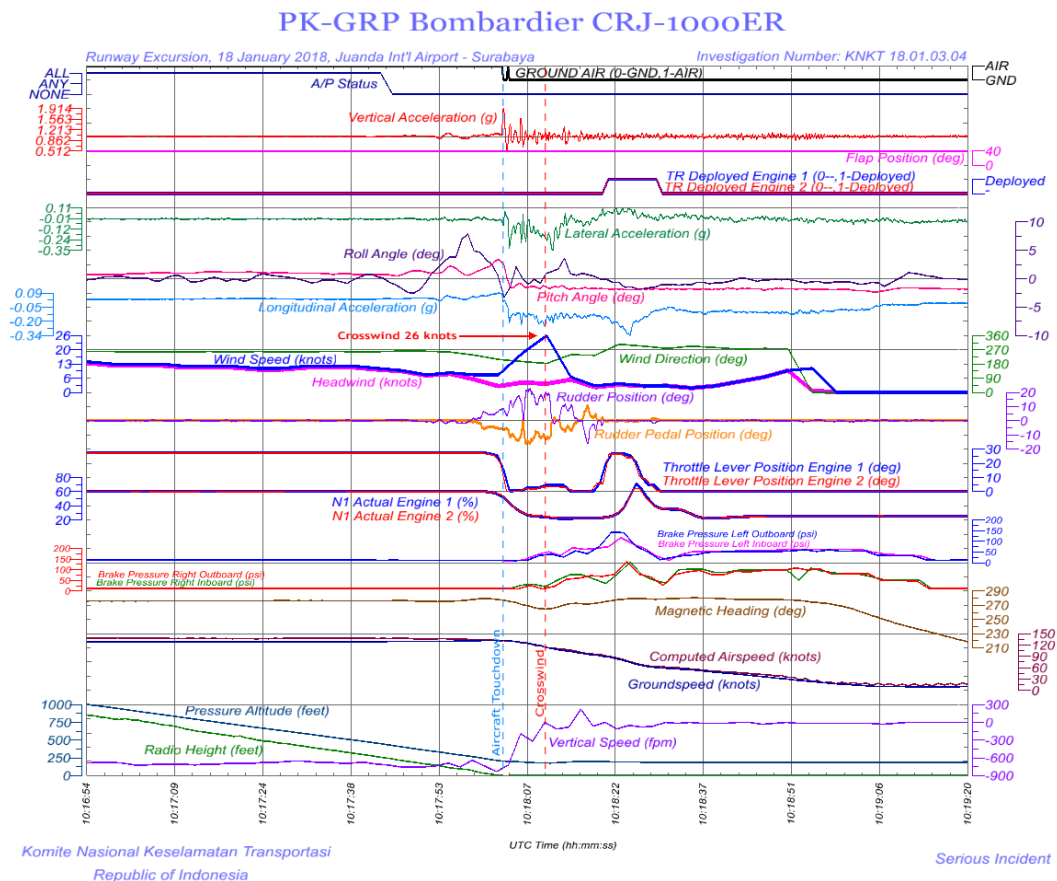
Figure 4: The relevant FDR parameters

At 1018 UTC, the aircraft touched down with the vertical acceleration of 1.9 g as recorded on the Flight Data Recorder (FDR). The aircraft veered off to the right and out of the runway pavement at position near taxiway N6. The pilot recovered by applying full left rudder and the aircraft returned to the runway near taxiway N5. After the aircraft returned to the runway, the pilot applied thrust reversers and brakes.

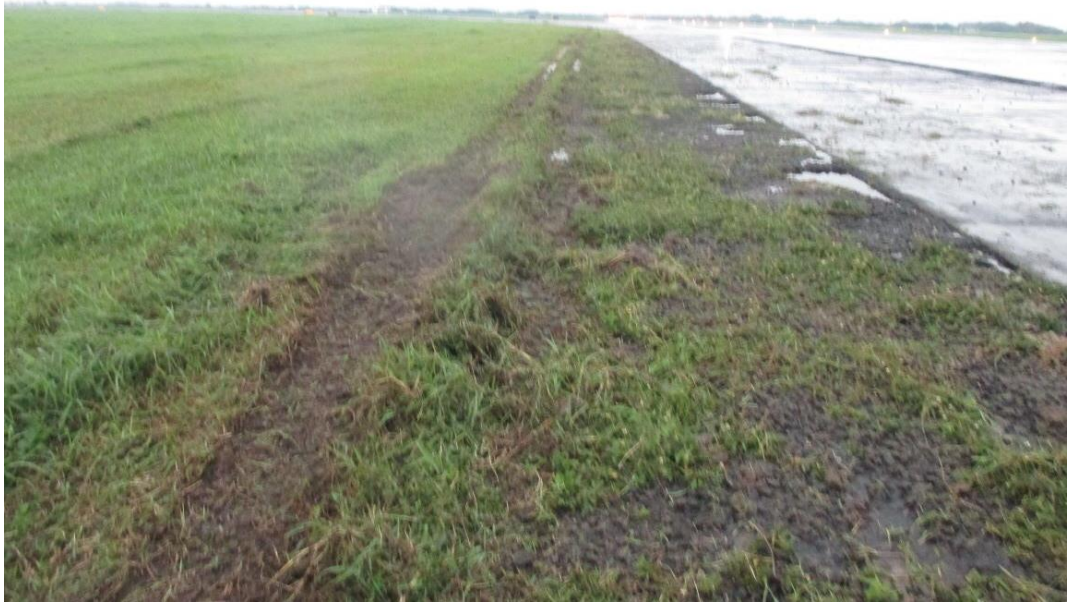
Figure 5: Wheel marks on the runway shoulder.

The wheel mark from the right main wheel was found at approximately 3 meters out of runway surface. The marks started from near taxiway N6 and reentered the runway pavement near taxiway N5.
