**KOMITE NASIONAL KESELAMATAN TRANSPORTASI
REPUBLIC OF INDONESIA**

KNKT.18.08.32.04

Aircraft Accident Investigation Report

PAC 750XL; PK-HVQ

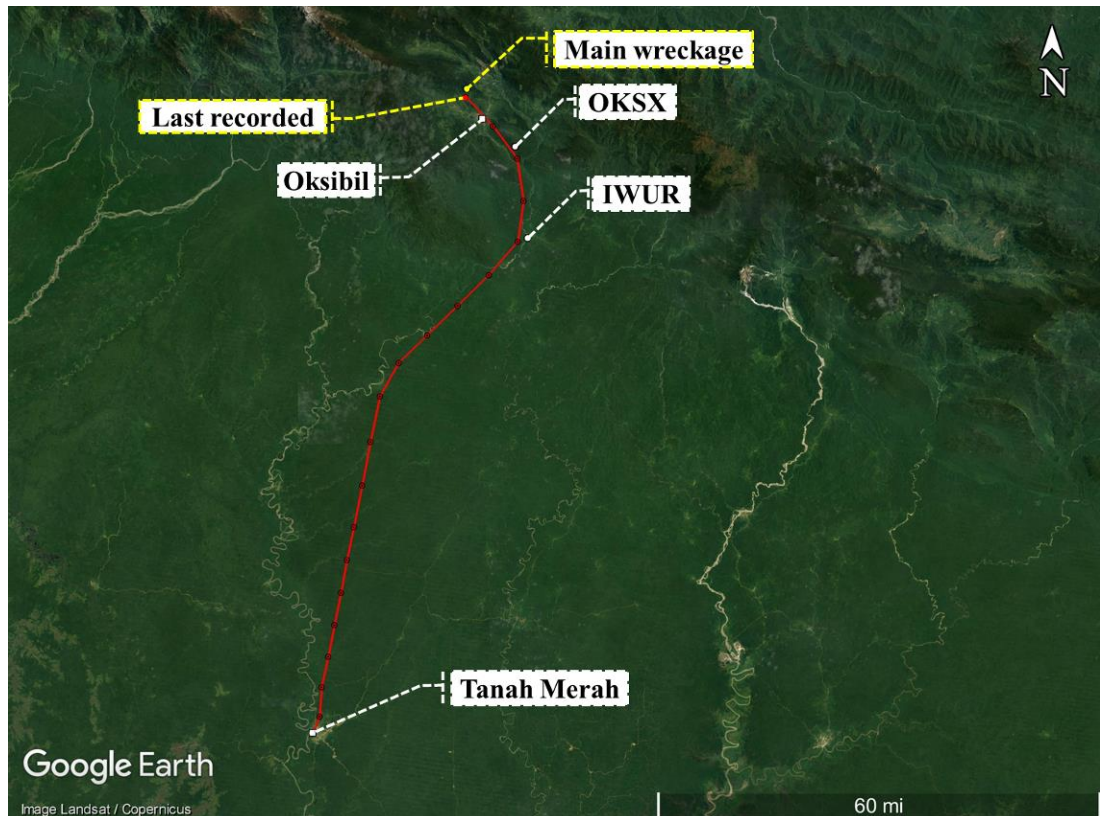
Figure 1: The PK-HVQ flight path based on Spidertracks

At 1419 LT, the flight following system⁶ of the Dimonim Air recorded the aircraft position was 3.1 Nm on bearing 321° from Oksibil with GPS altitude of 6,713 feet, ground speed 100 knots and the aircraft bearing 356°. This was the last record information on the flight following system. A few seconds later, the Oksibil Tower controller called the PK-HVQ pilot with call sign PK-HVX and asked the aircraft position several times with no answer.

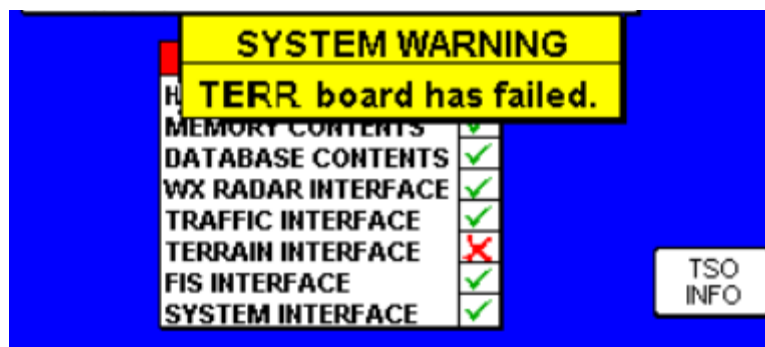
Figure 3: Typical of self-test on KMD 540 without GPWS function

The aircraft also equipped with Multi-Function Display (MFD) Bendix/King KMD 540. According to the Bendix/King installation manual, the KMD 540 could have a function as GPWS/TAWS if the MFD was installed with KAC 502 Enhanced Ground Proximity Warning System (EGPWS) Module and interfaced with EGPWS unit. If the KMD 540 did not have GPWS function, during powered the unit, the self-test page display would indicate the terrain interface did not pass the self-test.

The Pacific Aerospace Limited described that during the first delivery of the PAC 750 XL serial number 144, the KMD 540 installed in the aircraft was not configured as GPWS/TAWS. The investigation did not find any documentation of aircraft modification related to the KMD 540 nor any document that indicated an EGPWS unit had been installed in the aircraft since the delivery until the day of the accident.

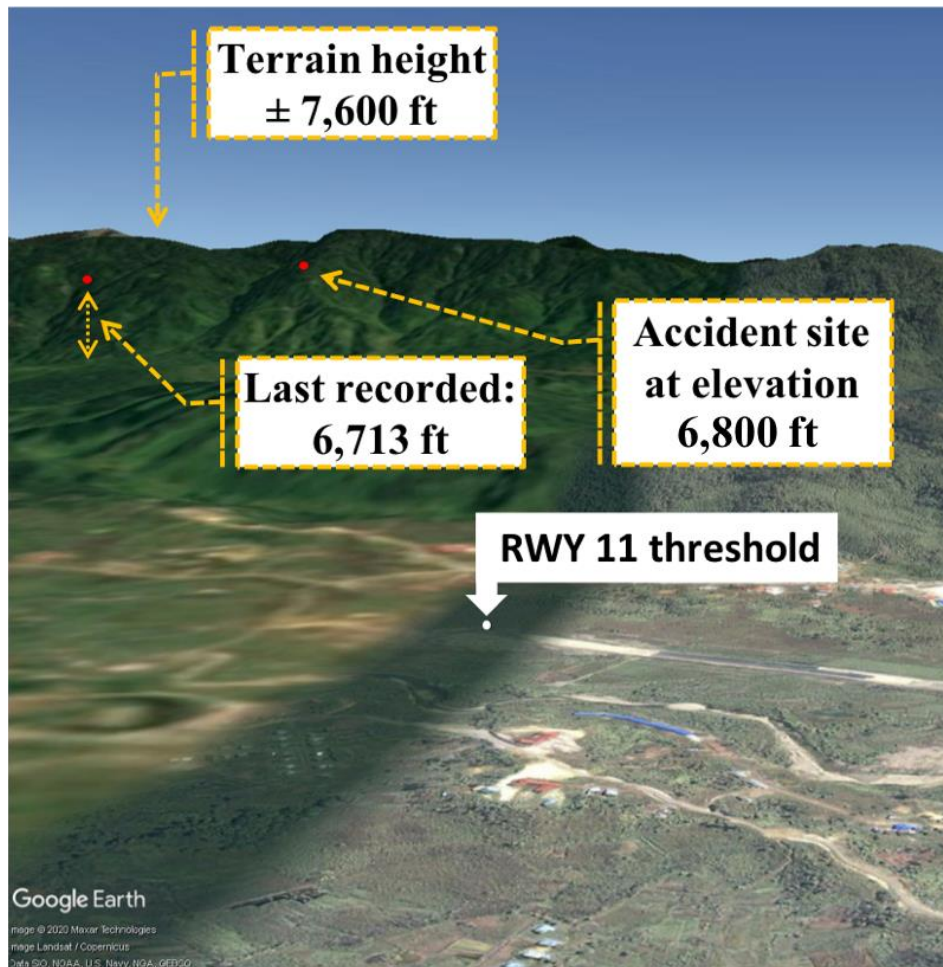
Figure 18: The view of accident site relative to the airport

The aircraft wreckage was found about 3.8 Nm north west of Oksibil on bearing 331° with elevation about 6,800 feet and the main wreckage was on bearing about 315°. The location was on a ridge of mountain with the height of about 7,600 feet.

The last recorded of flight data reporting on the flight following system indicated the aircraft was at altitude of 6,713 feet. The last reporting data to the accident site was about 1 Nm on bearing 008°.

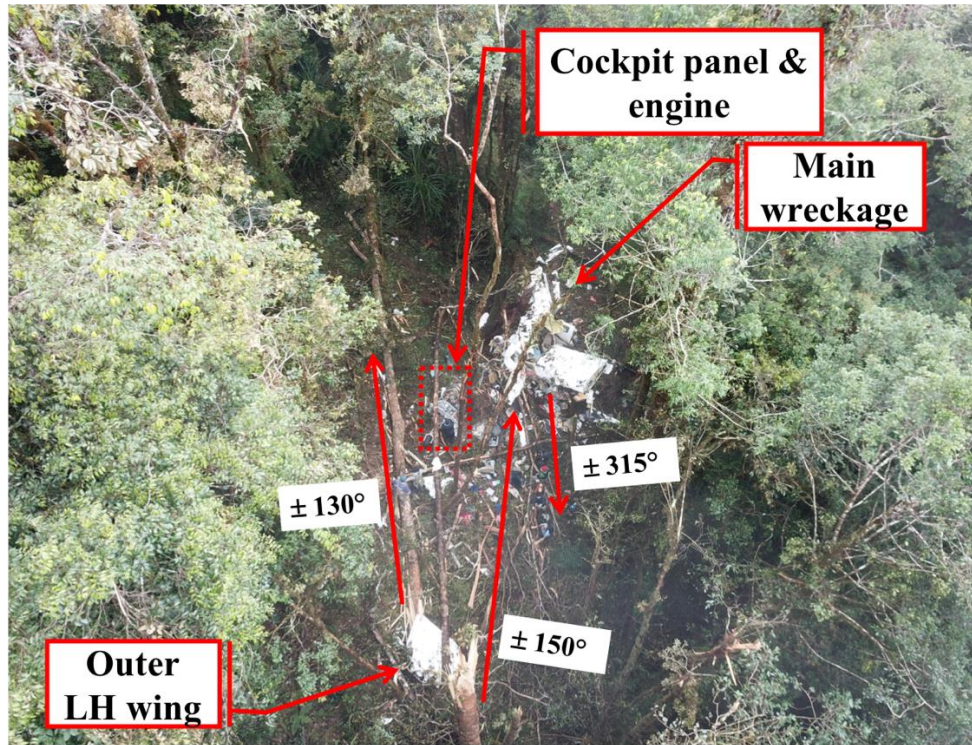
Figure 19: The wreckage distribution

The cockpit including the engine was separated at about 2 meters from the fuselage. The outer left wing detached and found about 17 meters from the main wreckage. Tree cuts were found at about 12 meters on bearing about 150° from to the main wreckage. There were two trees that cut down in direction about 130°.

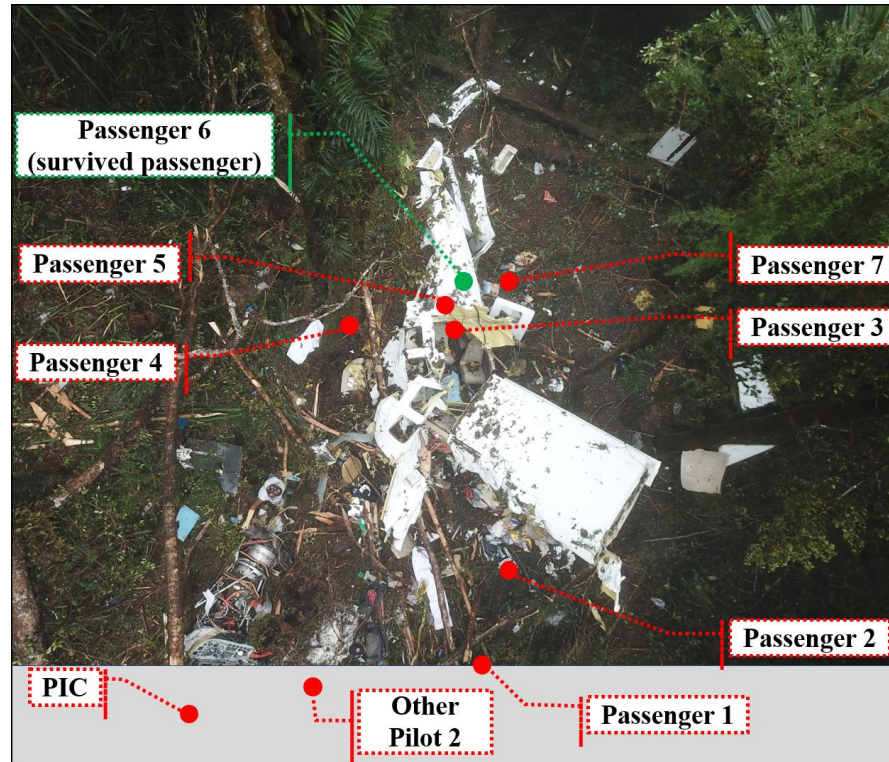
Figure 22: The occupant location

At 0812 LT, the ground search teams arrived on accident site and found eight occupants were fatally injured and one occupant was seriously injured. The six fatally injured occupants were found outside the aircraft wreckage while the rest were found insight the aircraft wreckage including the survived passenger.

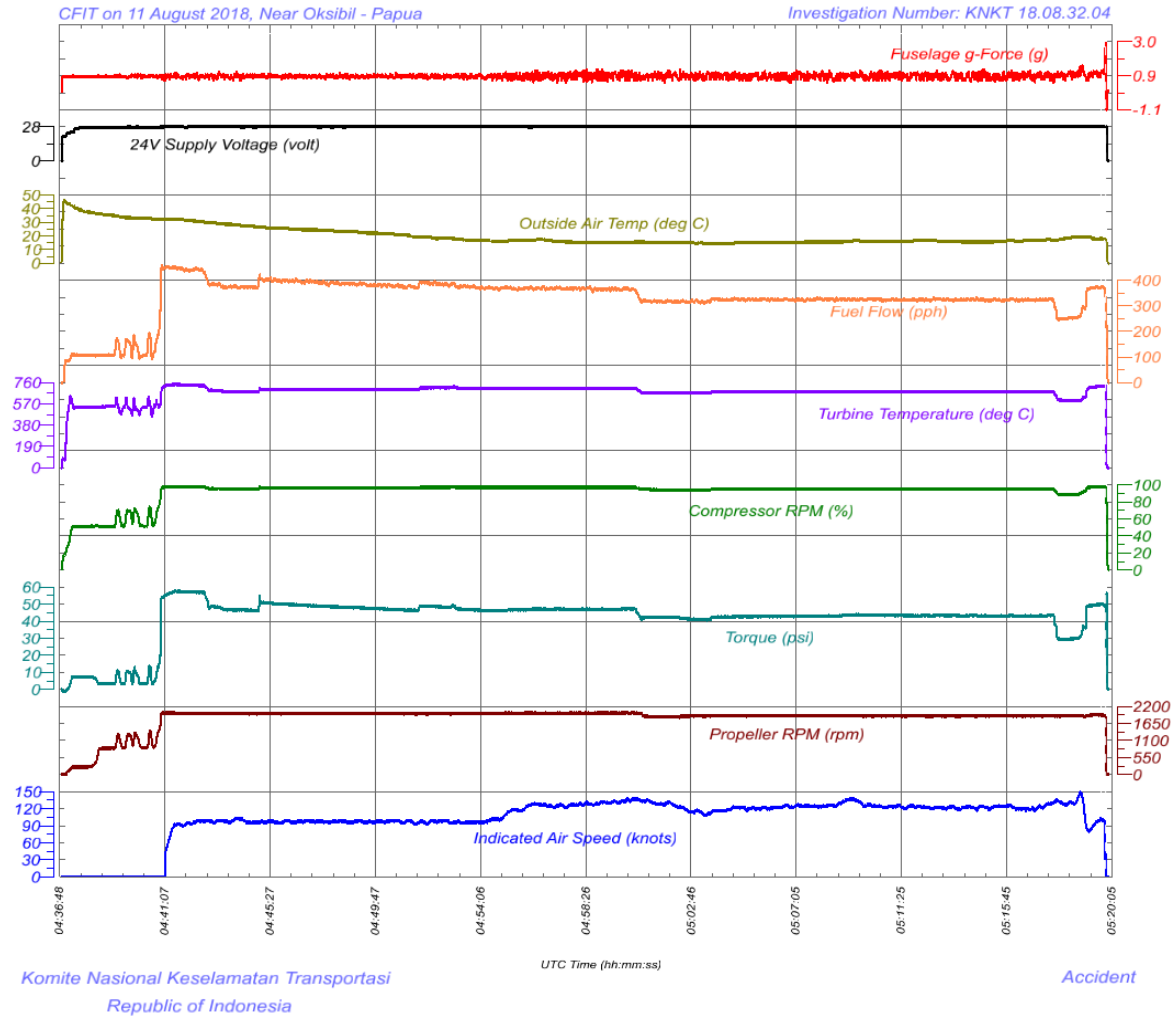
Figure 26: Graphic of the DAAM recorded data

The DAAM recorded data indicated that the aircraft engine operated normally. The pressure altitude value was at constant value of -990 feet, and the investigation considered the altitude data was unreliable. The investigation used the recorded GPS altitude from the aircraft flight following system, and synchronized the time parameter of the DAAM unit with the flight following system.

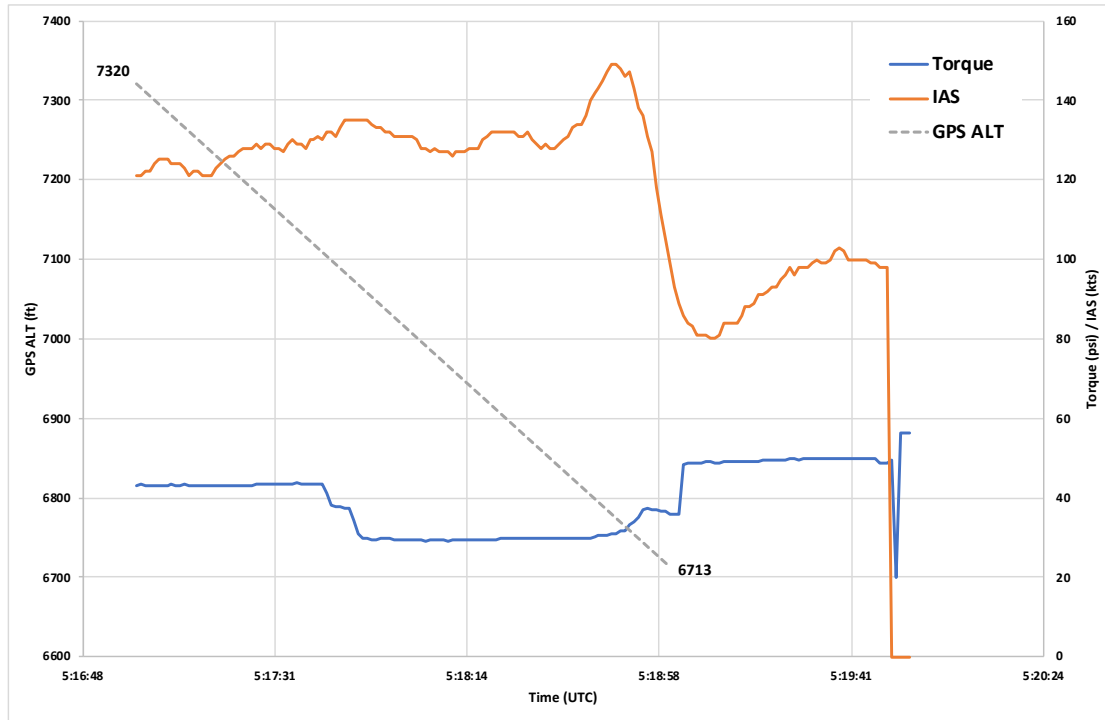
Figure 27: The GPS altitude of the flight following data and the last 3 minutes of the DAAM data

- 05:19:52 UTC, the fuselage g force increased from -4.4 g and maintained to -1.1 g. The compressor RPM reduced from 96% and maintained to 91% until the end of recording, while the torque increased from 19 and maintained to 56 psi until the end of recording.

- 05:19:54 UTC, the end of the DAAM data recording.
