**KOMITE NASIONAL KESELAMATAN TRANSPORTASI
REPUBLIC OF INDONESIA**

Aircraft Accident Investigation Report

PT. Marta Buana Abadi (Dimonim Air)

PAC 750XL; PK-HVQ

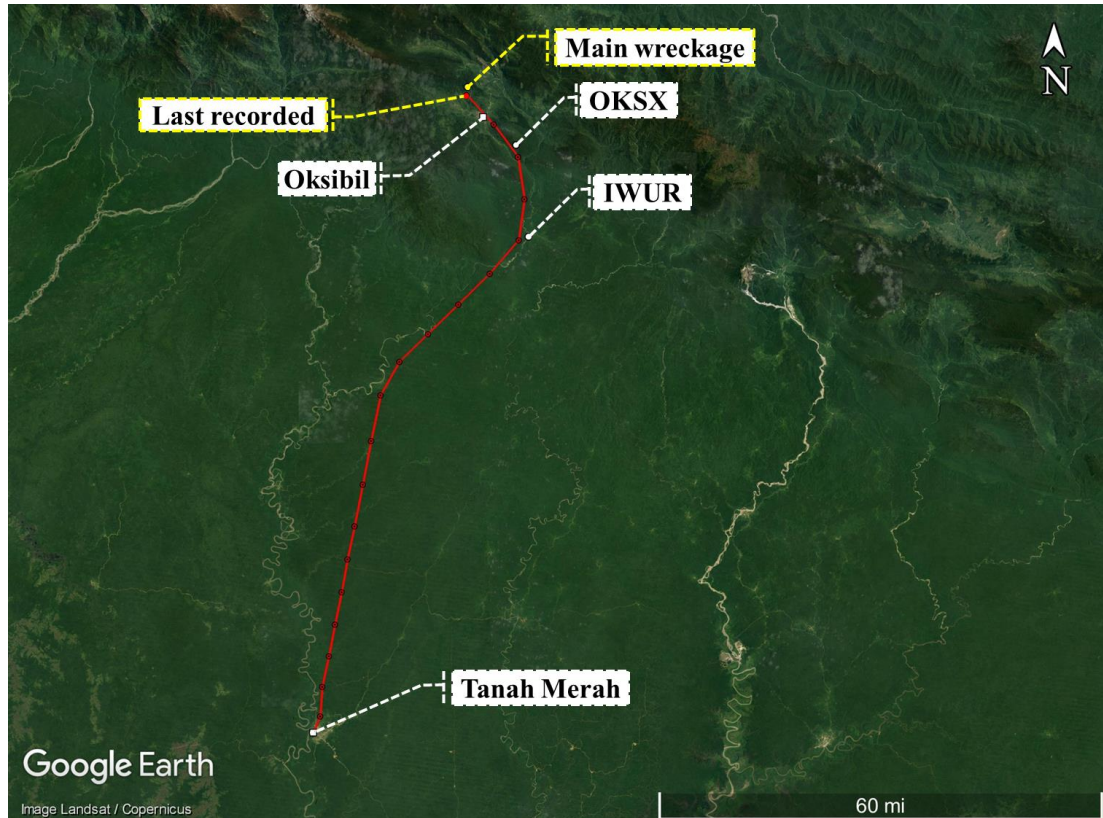
Figure 1: The PK-HVQ flight path based on Spidertracks

At 1419 LT, the flight following system⁴ of the Dimonim Air recorded the aircraft position was 3.1 Nm on bearing 321° from Oksibil at altitude 6,713 feet, ground speed 100 knots and the aircraft bearing 356°. This was the last record information on the flight following system. A few seconds later, the Oksibil Tower controller called the PK-HVQ pilot with call sign PK-HVX and asked the aircraft position several times with no answer.

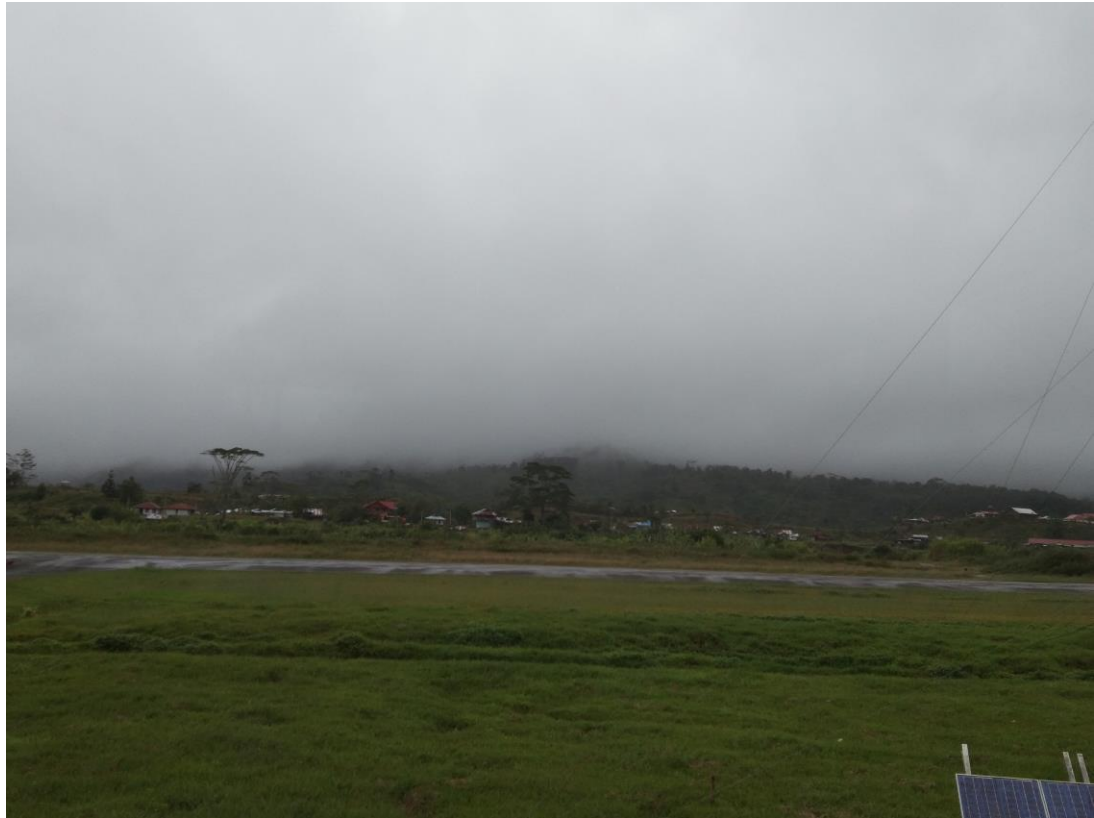
Figure 4: The right downwind runway 11 condition at 1507 LT

The following pictures were taken at 1507 LT by the Oksibil Tower controller showed the clouds condition.

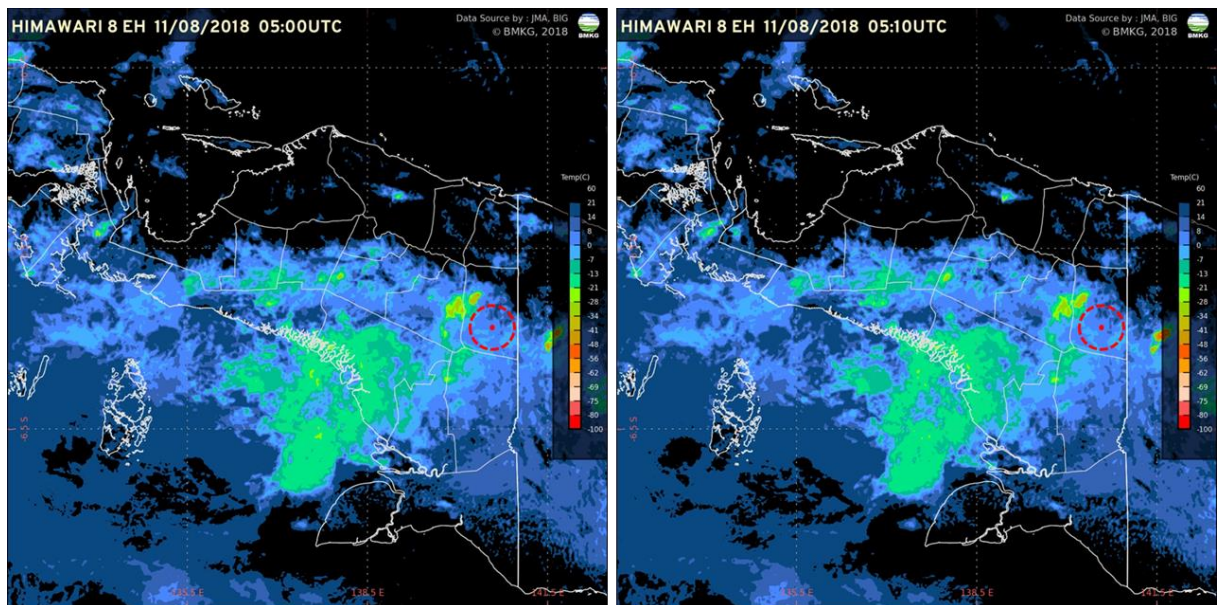
Figure 7: Enhanced infrared satellite image at 0500 UTC and 0510 UTC

The enhanced infrared satellite images at 0500 UTC (1400 LT) up to 0525 UTC (1425 LT) with interval 5 minutes indicated that the temperature on the accident site (red circle) was from 0 up to 8°C.

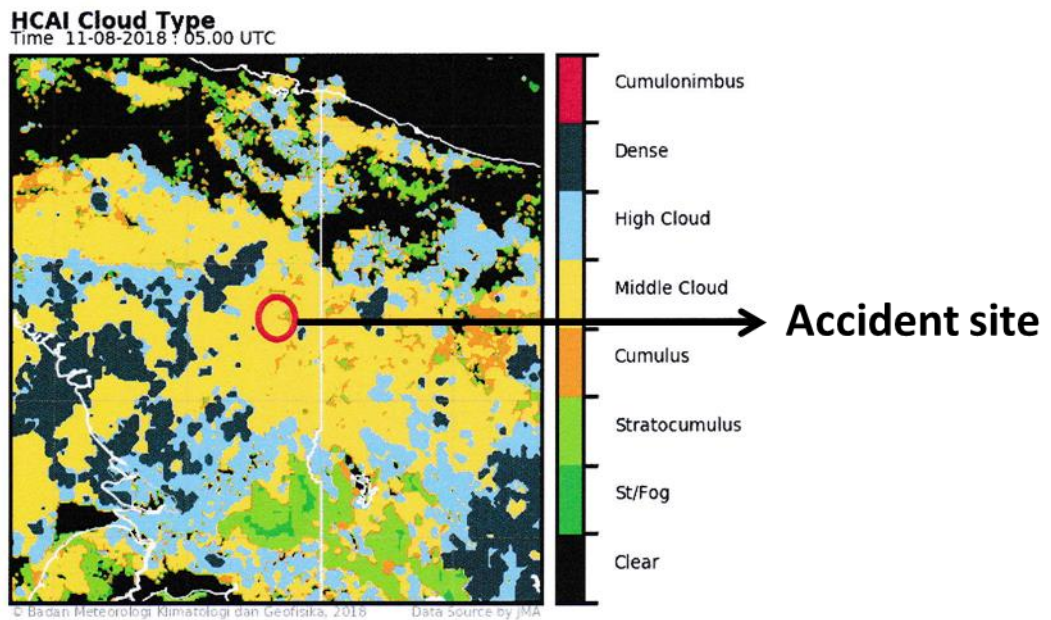
Figure 9: Cloud type satellite image at 0500 UTC (1400 LT)

The cloud type satellite images at 0500 UTC (1400 LT) and 0600 UTC (1500 LT) indicated middle cloud surrounded the accident site location.

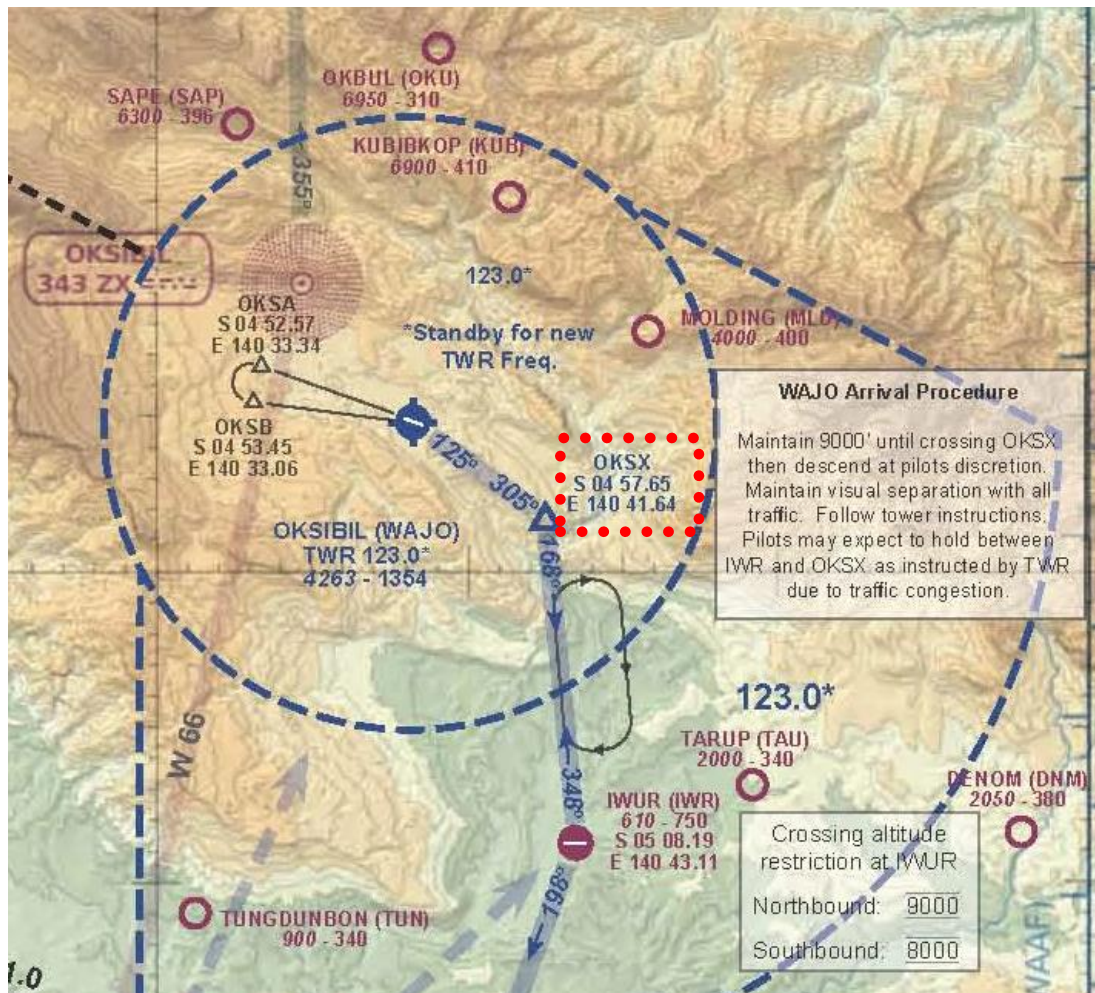
Figure 12: The OKSX location (red dot square) on visual guidance route published by other aircraft operator

A visual guidance route to Oksibil published by other aircraft operator for internal use contained GPS checkpoint OKSX. The OKSX located on coordinate 04° 57.65' S; 140° 41.64' E which was about 4.9 Nm on bearing 125° from Oksibil.

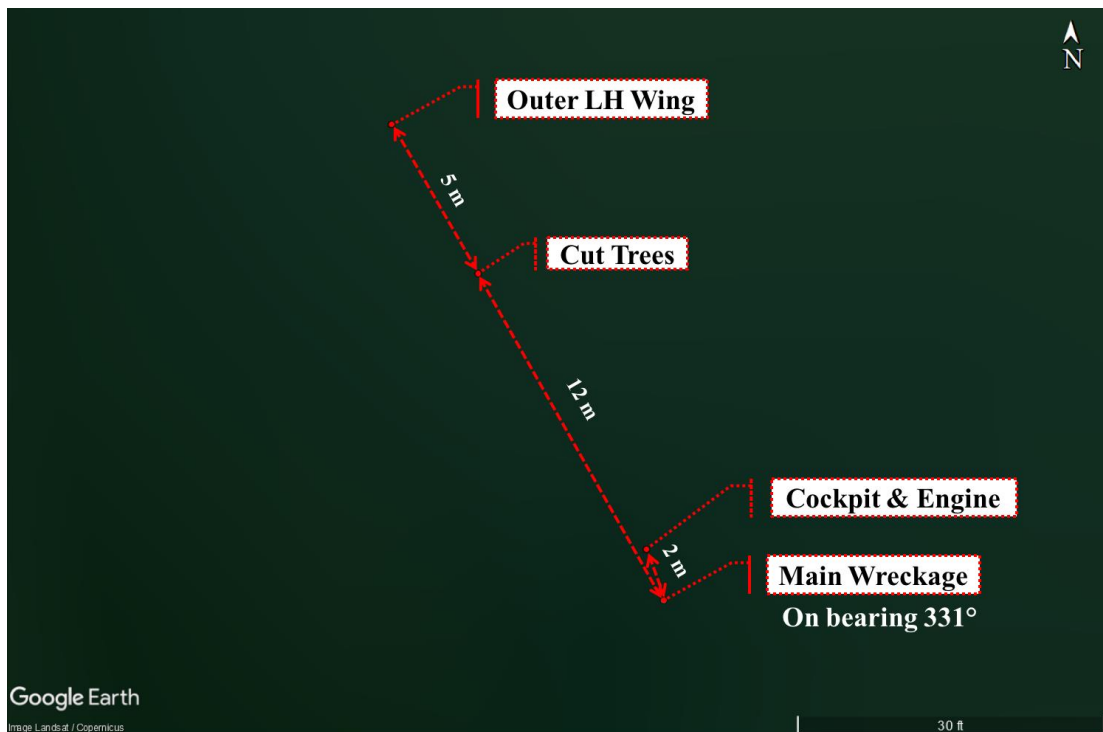
Figure 13: The wreckage distribution

The aircraft wreckage was found at about 3.8 Nm north east of Oksibil on bearing 331° with elevation about 6,700 feet. The cockpit including the engine was separated at about 2 meters from the fuselage. The outer left wing detached and found about 17 meters from the main wreckage. A tree cut was found at about 12 meters on bearing about 150° from to the fuselage.

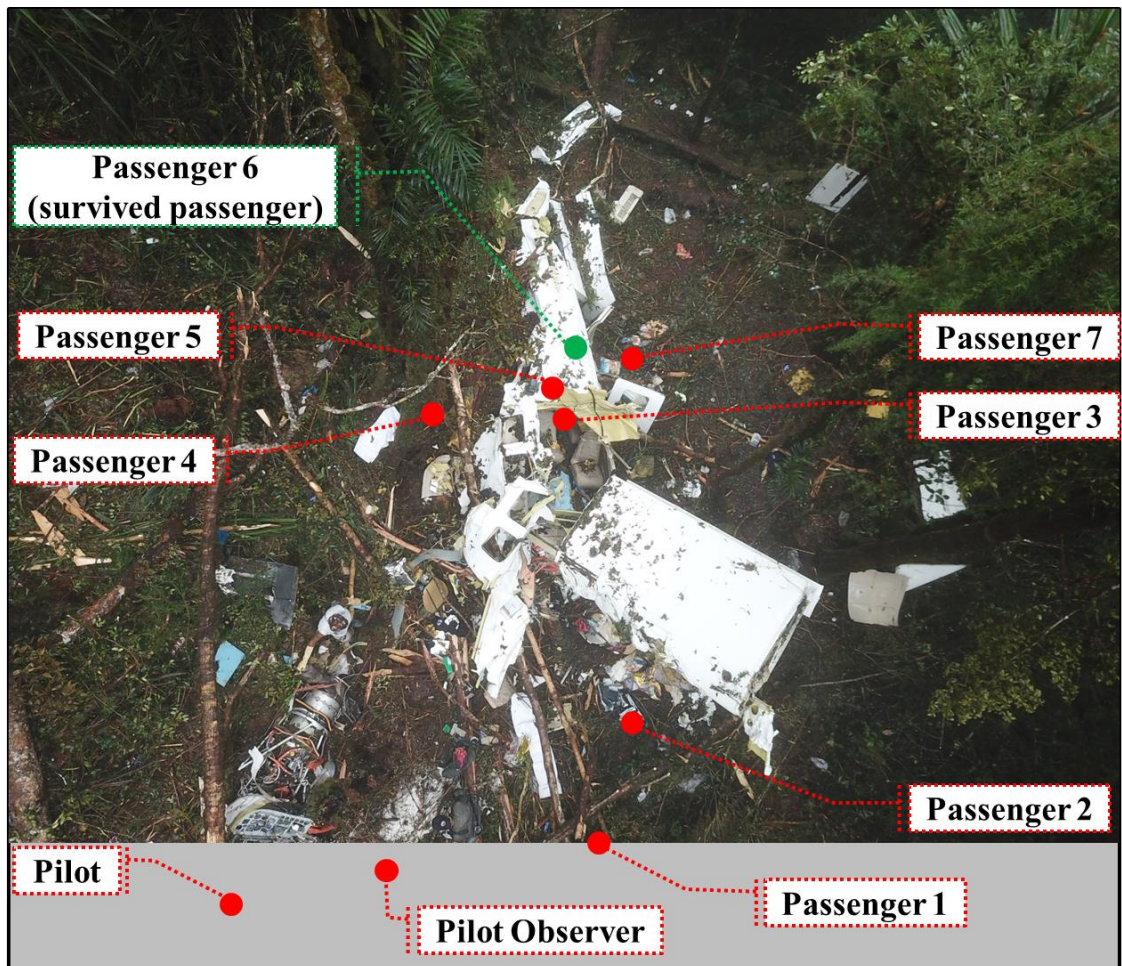
Figure 16: The occupant location

At 0812 LT, the ground search teams arrived on accident site and found eight occupants were fatally injured and one occupant was seriously injured. The six fatally injured occupants were found outside the aircraft wreckage while the rest were found inside the aircraft wreckage including the survived passenger.
