**KOMITE NASIONAL KESELAMATAN TRANSPORTASI
REPUBLIC OF INDONESIA**

Aircraft Accident Investigation Report

Boeing 737-800; PK-LOO

Djalaluddin Airport, Gorontalo

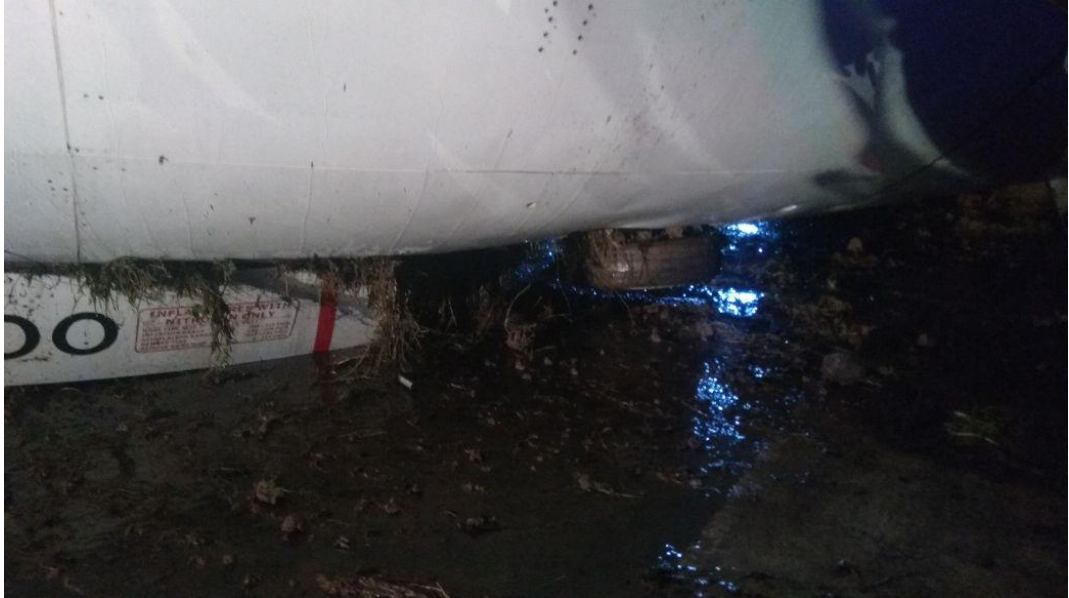
The aircraft substantially damaged. The nose landing gear collapsed backward and impacted the forward lower fuselage resulting in dent on this area. The engine cowlings were broken.

Figure 1: The nose landing gear collapsed backward

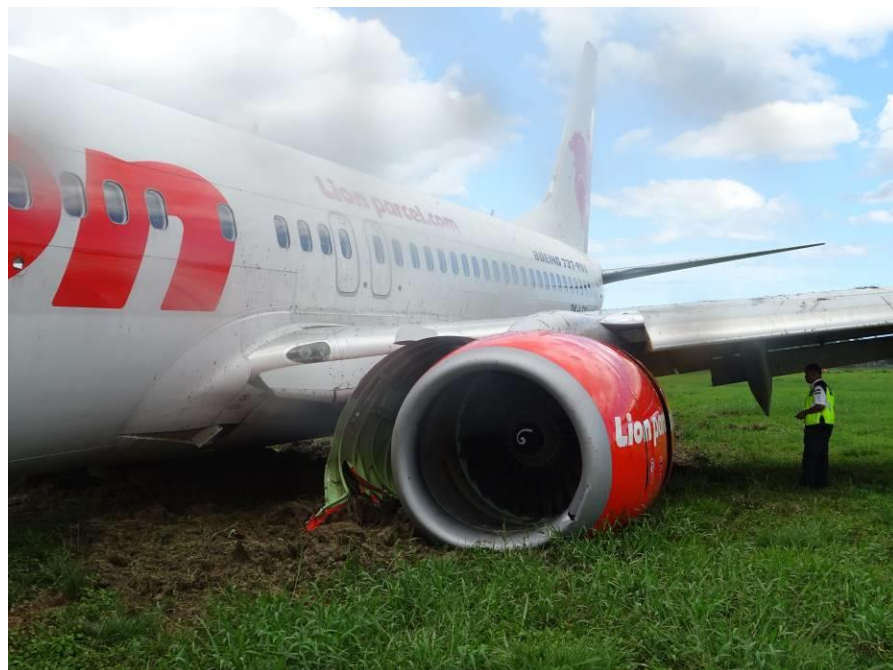
Figure 2: Damage on the right engine cowling

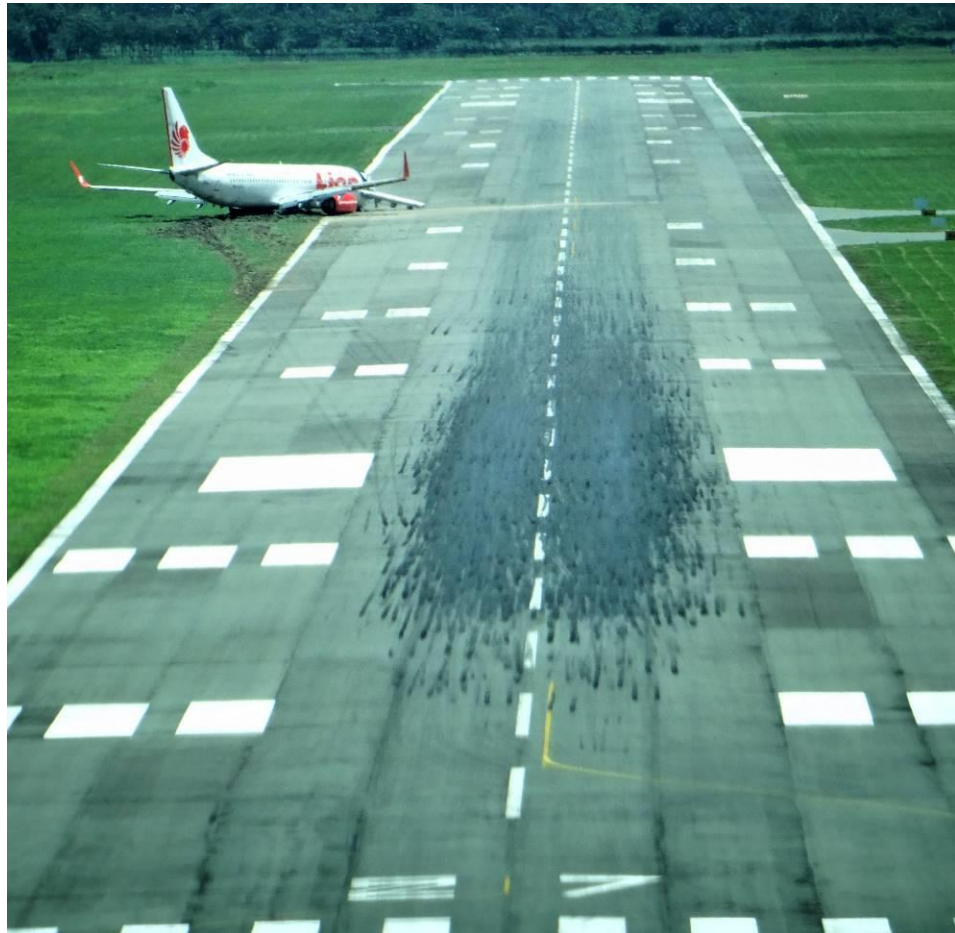
The touch down mark could not be determined. Based on the marks of the main wheel, it was likely that the aircraft touched down on the touchdown zone and on the center line.

Figure 8: The main wheel marks and the last aircraft position

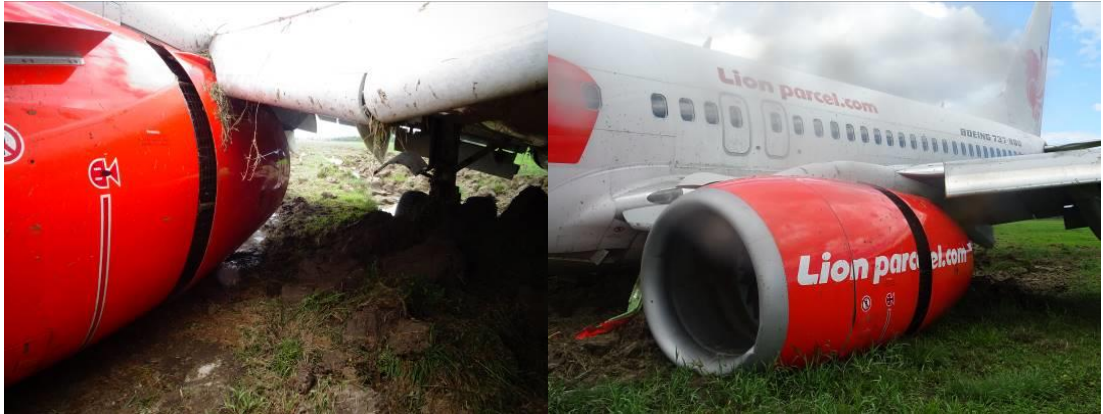
Both engine thrust reversers were on deploy position. Muds were found on both engine intakes and the thrust reverser doors, while the engine exhausts were clean of mud.

Figure 9: Left and right engine thrust reversers condition

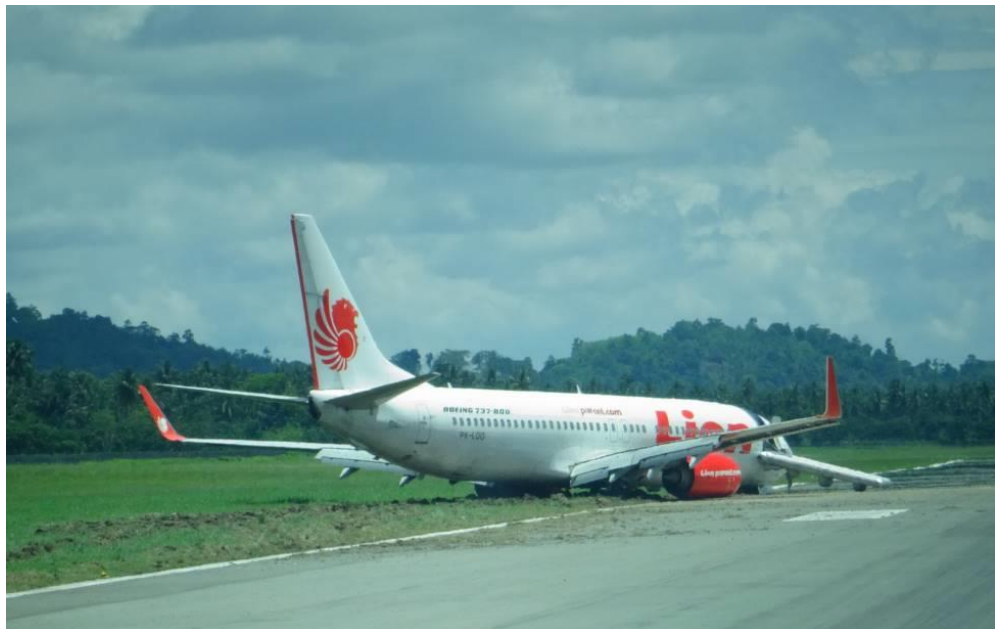
The left and right front door escape slides were deployed, while the over-wing exit windows and aft doors were close.

Figure 10: The emergency exits and deployed slide on the right side of the aircraft
