**KOMITE NASIONAL KESELAMATAN TRANSPORTASI
REPUBLIC OF INDONESIA**

Aircraft Accident Investigation Report

Super Decathlon 8KCAB; PK-RTZ

Tunggul Wulung Airport, Cilacap Central Java

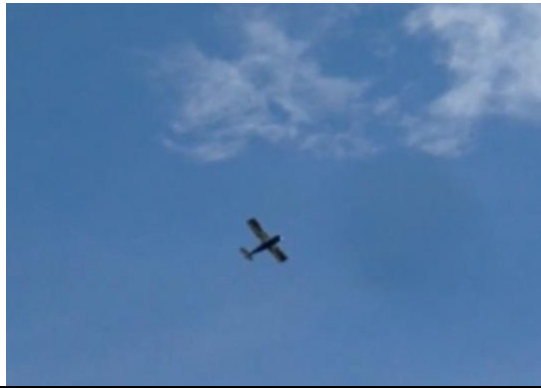
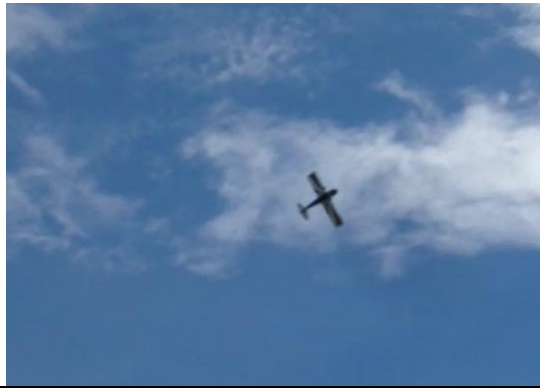
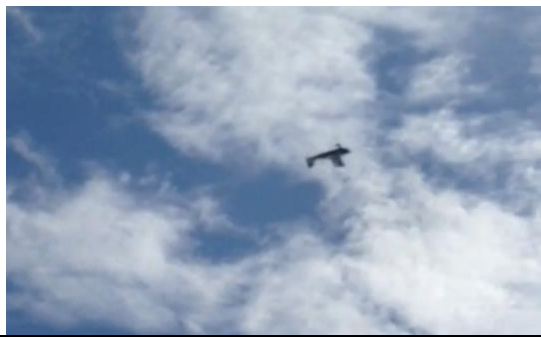
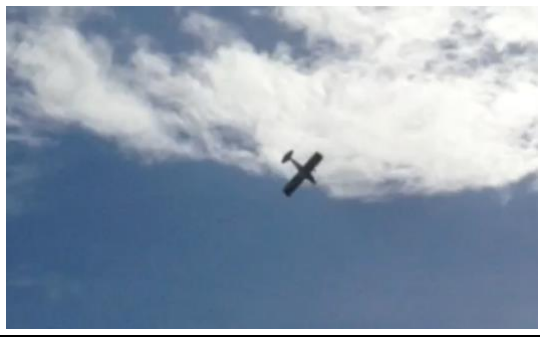
Figure 1: The aircraft attitudes on the beginning of the last maneuver

At the last maneuver, the aircraft flew align with the runway 31, climbed then made left roll continued with nose up until the aircraft became inverted (upside down), The aircraft then flew down, thereafter the pitch down decreased to near level flight and crossed the runway 31.

| The aircraft started to roll | The aircraft continued rolling to inverted position |
| The aircraft on to inverted position | The aircraft continued roll while on inverted position |

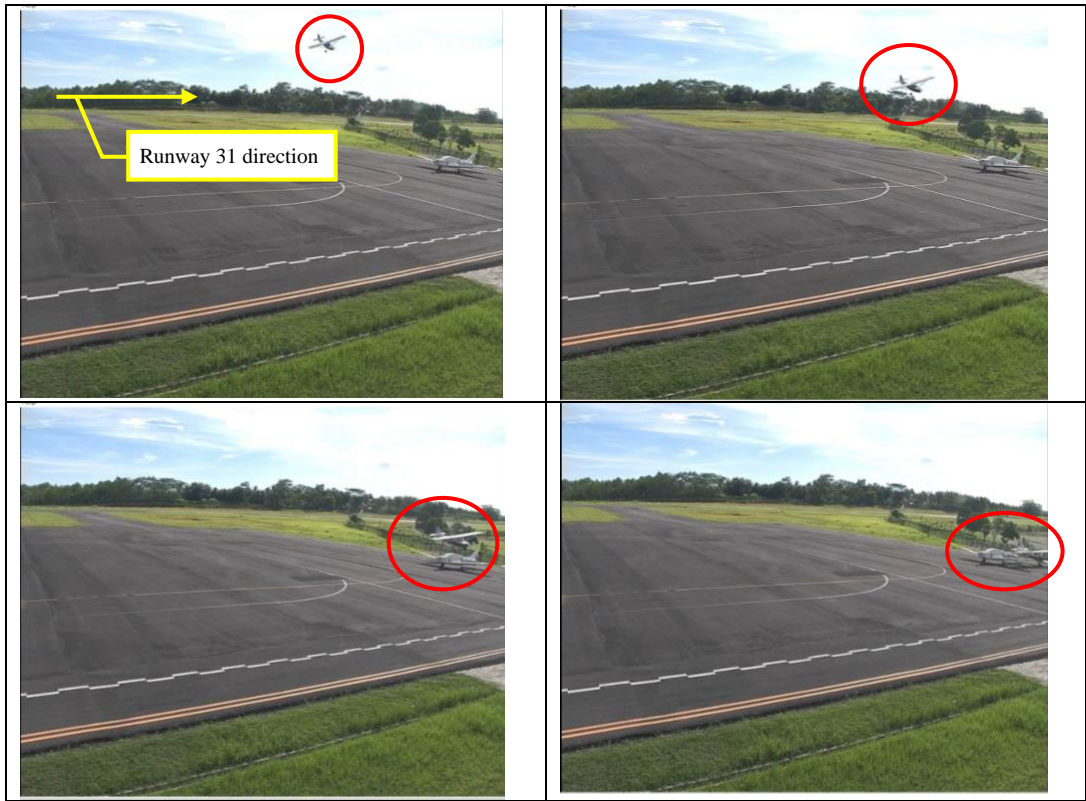
Figure 2: The aircraft on the last aerobatic maneuver

The Tunggul Wulung tower CCTV facing toward to the Perkasa Flying School hangar recorded the last phase of the flight. The video footage showed that the aircraft pitch down decreased to near level flight while approaching the apron at low altitude and slightly roll to the right. The aircraft impacted four aircraft on the apron then bounced before entered into the Perkasa Flying School hangar and damaged two aircraft in the hangar.

The sequence of the aircraft attitudes before entered the Perkasa Flying School hangar as recorded on the Tunggul Wulung Tower CCTV are shown in the figure 2.

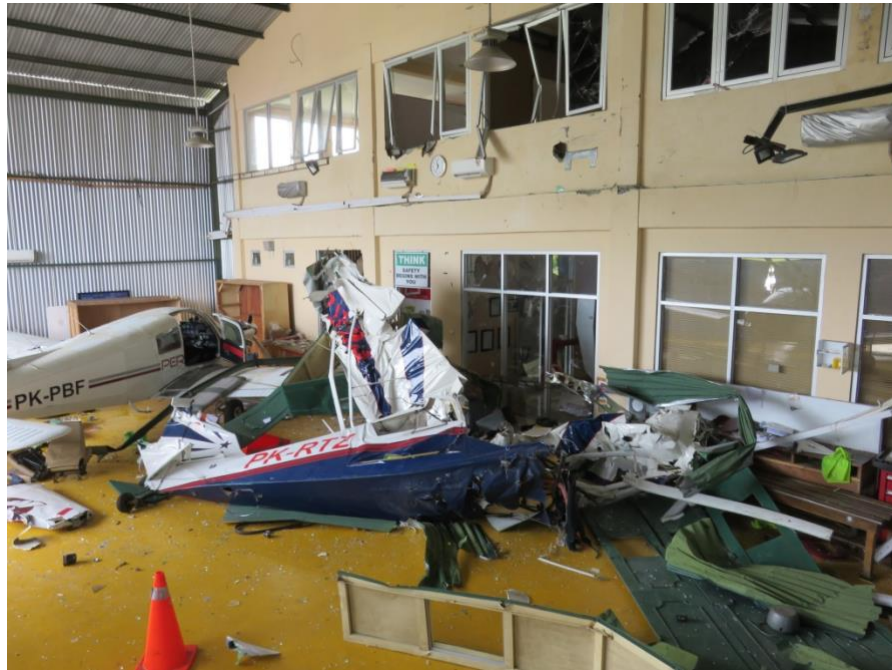
Figure 3: The damage to the aircraft

The aircraft was destroyed by impact forces.

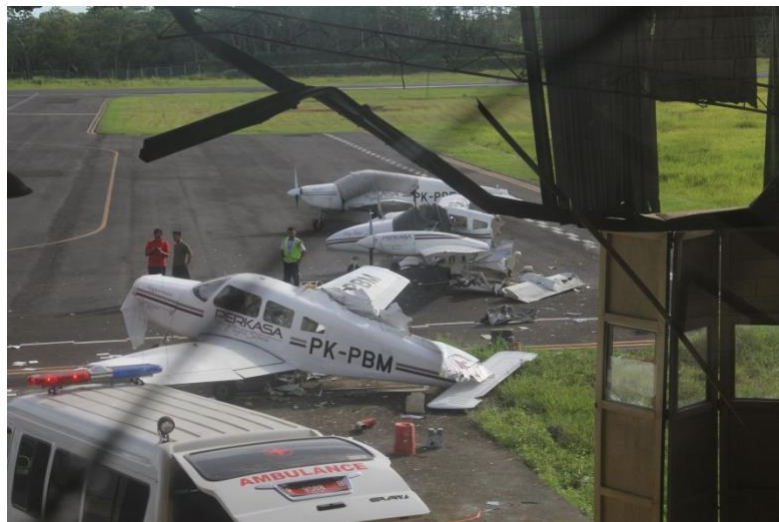
Figure 4: The damage to the three aircraft that were parked on the apron

The aircraft impacted to four aircraft that were parked on the apron and two aircraft in the Perkasa Flying School hangar. These six aircraft were substantially damage.

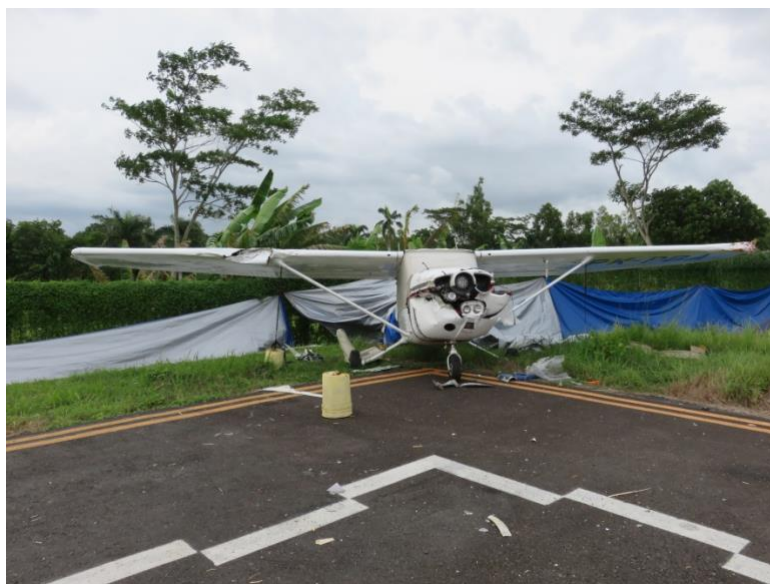
Figure 5: The one aircraft that was parked on the corner of the apron damage
The two aircraft damage inside the hangar is shown in the figure below.

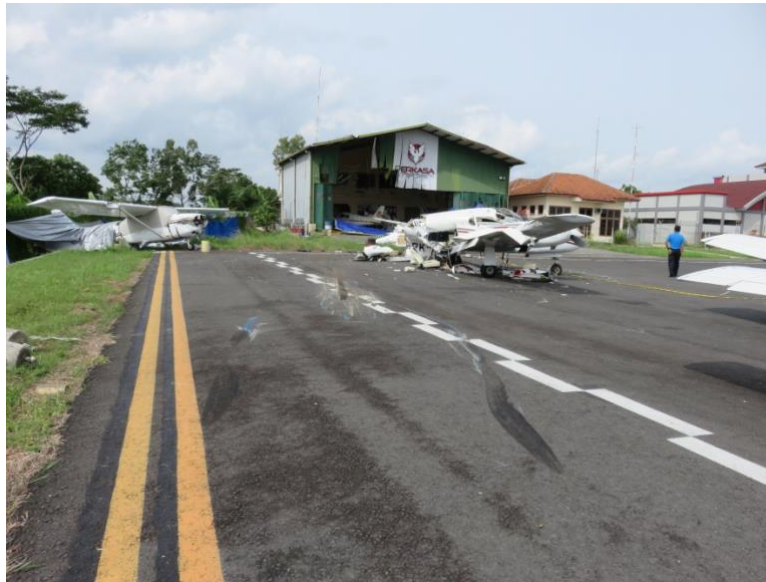
Figure 8: The landing gear and propeller marks toward the hangar

The landing gears and the propeller scratch marks were found on the apron behind the first impacted aircraft. The ground scar at the apron indicated the flight direction approximately 080°.

The distance between marks of both main wheels spread wide suggesting the main landing gear widen out indicated compression of the main wheels to the apron. Thereafter, the marks of mainwheels and propeller vanished.

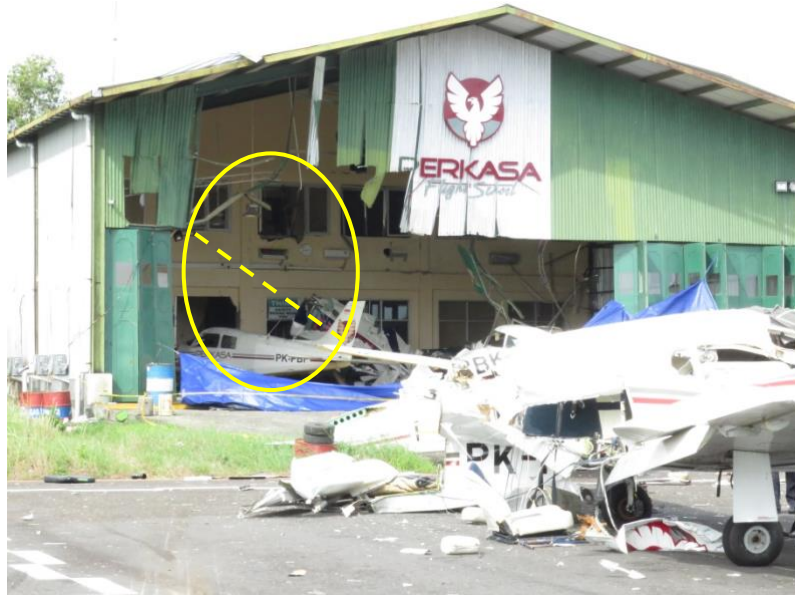
Figure 9: The Damage of the hangar

After the main wheel and propeller marks, three aircraft along the flight path were found damaged. Further damage was found on the hangar structure. The lower and upper windows inside the hangar showed damage as shown on the following figures. The aircraft stopped in the hangar.

The damage to the upper forward hangar wall, the lower and upper windows inside the hangar, indicated that the aircraft was on right roll during the impact into the hangar wall. The investigation utilized the GeoCam application to define the roll angle of the aircraft before impacted into the hangar wall. The relative line showed that the aircraft was rolling to the right approximately 30°.

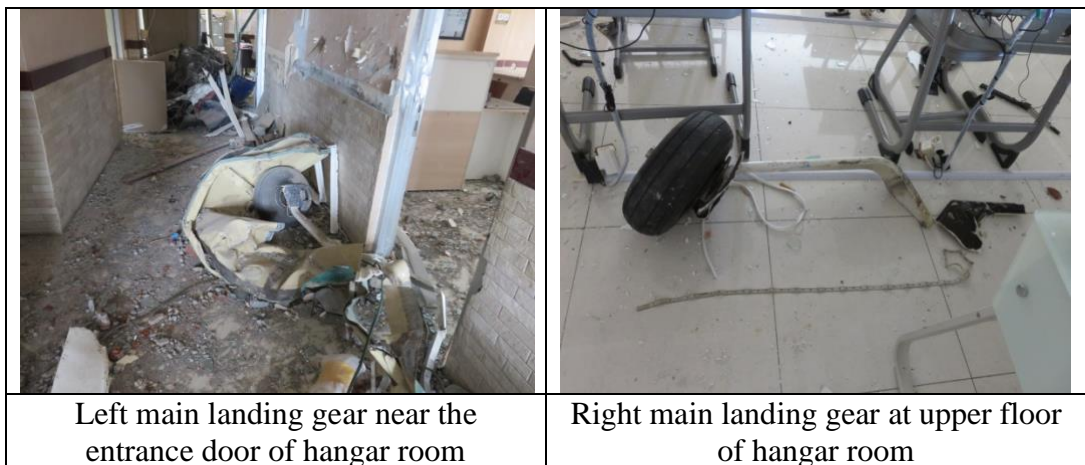
Figure 10: The landing gears

The tail wheel was still intact to the aircraft lain in the hangar space. Both landing gears were detached from the aircraft. The left main landing gear was found on the office of the first floor approximately 6.5 meters from the entry door. The right main landing gear was found at the upper floor as shown in the figure below.

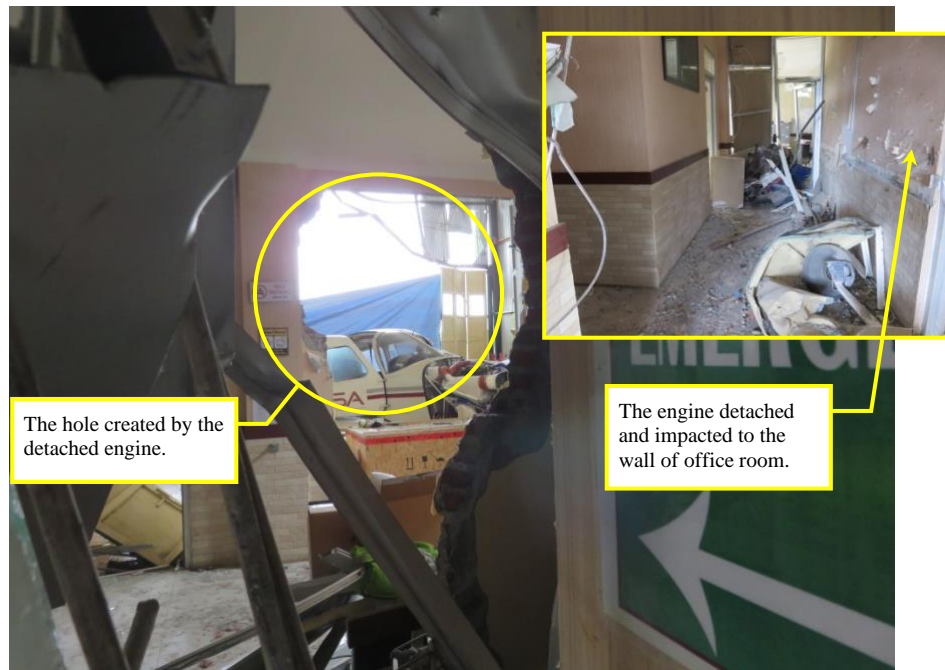
Figure 11: The trajectory of the thrown engine

The engine detached, break through the windows and entered into the office room, created a hole on the office wall as shown in the figure below.

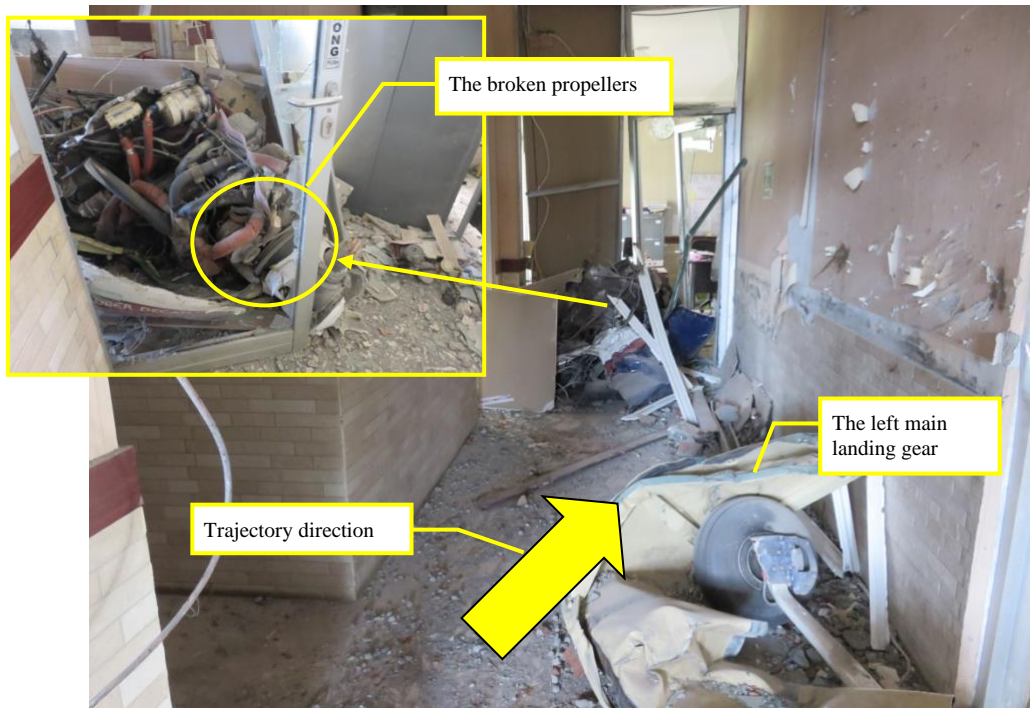
Figure 12: The engine and the left main landing gear found on first floor

The left main landing gear and the propeller was found broken on the first floor approximately 9 meters from the office entrance door, and the engine was found further away as shown in the figure below.

Visual engine examination to fuel line and leakage indication to any fluid concluded that there was no abnormality to the engine.

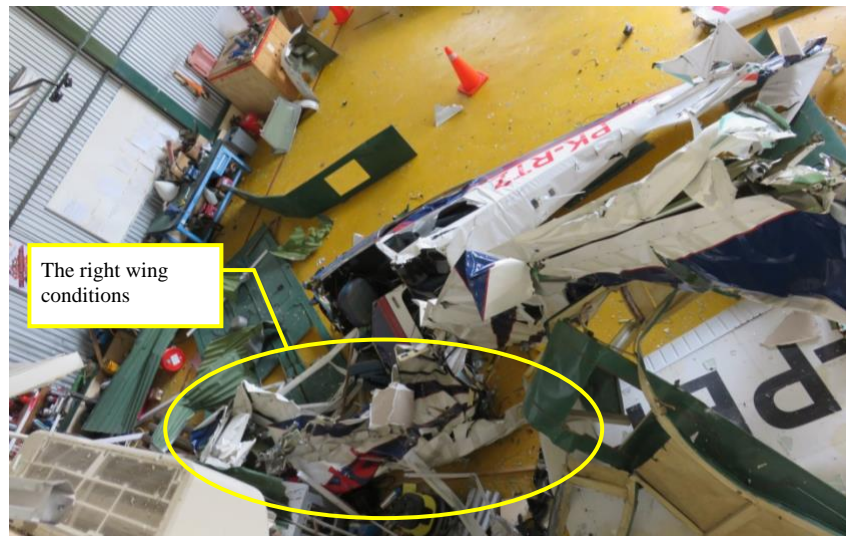
Figure 13: The right wing condition

The both wings were detached, the left wing was found on top of the fuselage and the

right wing was collapse underneath of the fuselage as shown in the figure below.

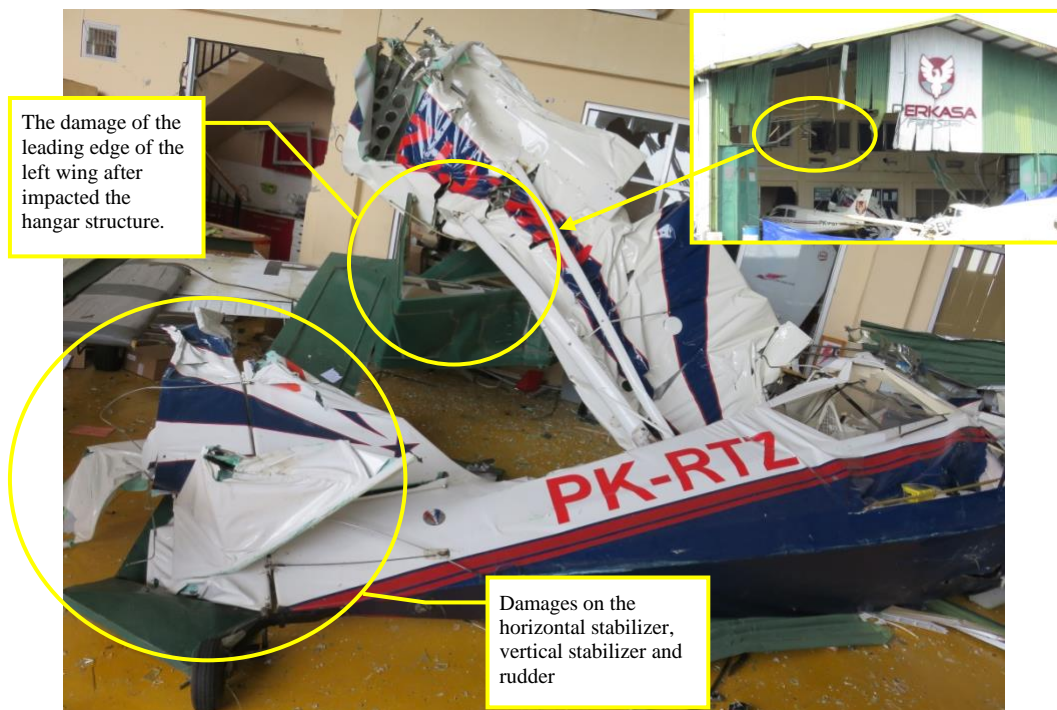
Figure 14: The left wing, horizontal stabilizer, vertical stabilizer and rudder condition

The damage on the leading edge of the left wing most likely due to impact to the hangar upper forward structure before impacted into the office wall.

The vertical stabilizer and the rudder were severely damage as shown in the figure below.

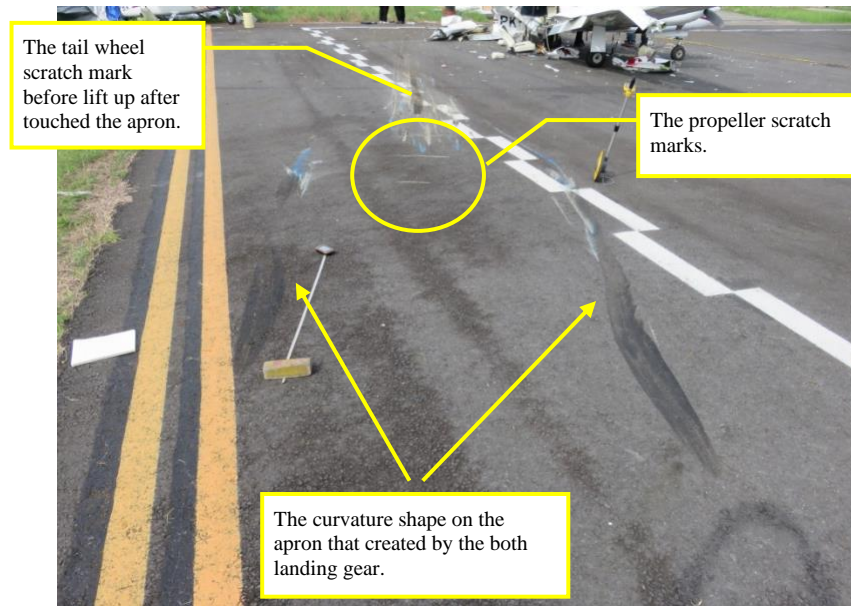
Figure 17: The ground marks found on the apron

The investigation estimated the speed of the aircraft based on the ground scratchesar found on the apron as shown on the figure below.
