**KOMITE NASIONAL KESELAMATAN TRANSPORTASI
REPUBLIC OF INDONESIA**

KNKT.18.04.10.04

Aircraft Accident Investigation Report

**PT. Whitesky Aviation
Helicopter Bell 429, PK-WSX
Morowali, Sulawesi Tengah
Republic of Indonesia
20 April 2018**

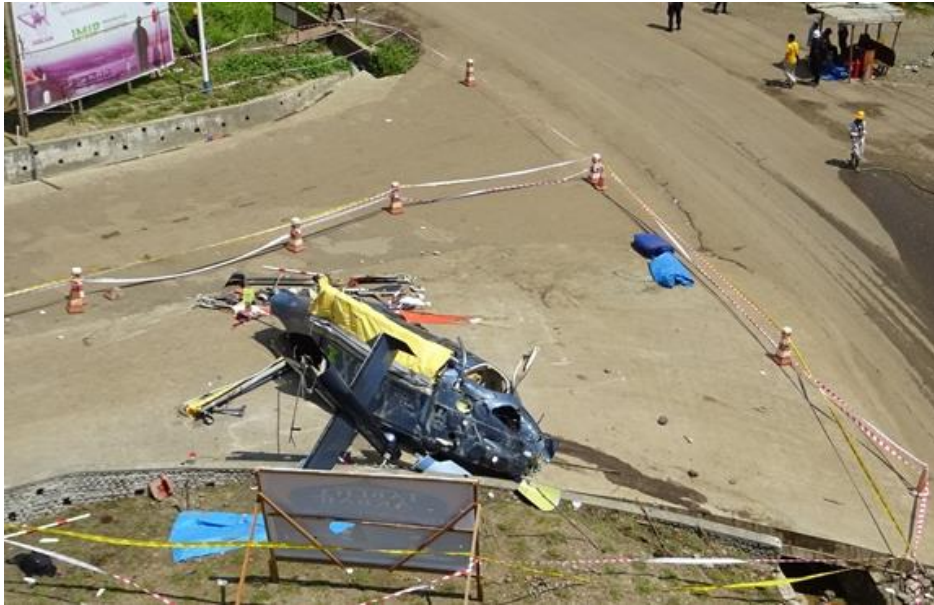
Figure 1: Aerial view of the helicopter

The helicopter last position was rolled over to the left with the last heading approximately of 080°. The wreckage occupied the dimension approximately 10 meters × 10 meters situated on the intersection IMIP factory access road as shown in the figure below.

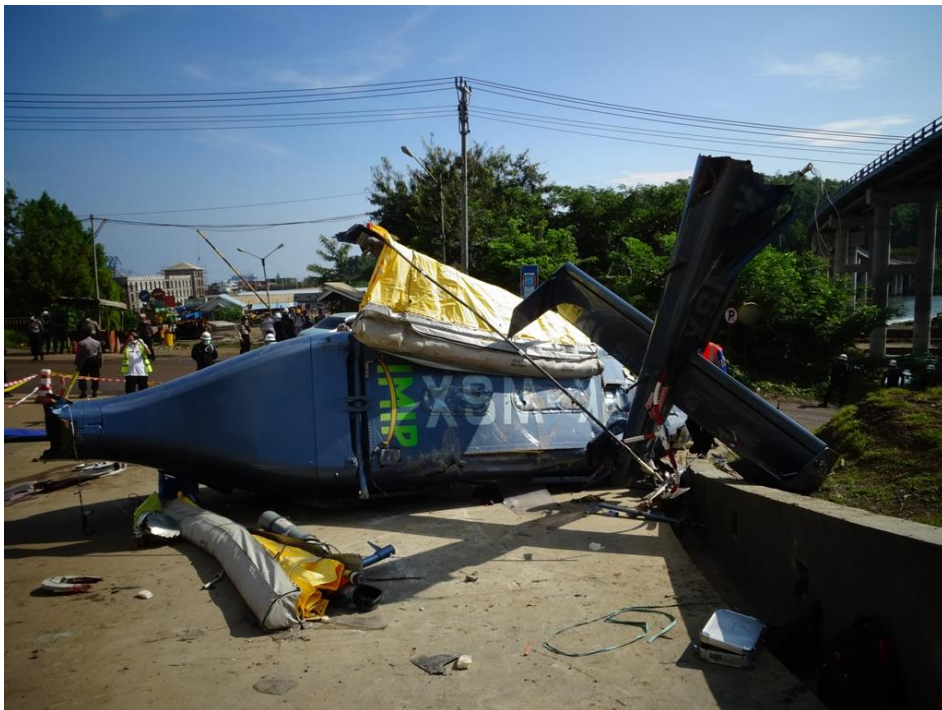
Figure 2: the wreckage of the helicopter

All main rotor blades were broken and detached from the main rotor hub. The tail boom broken and laid on the right of the helicopter and all the tail rotor blades were still intact.

The left landing gear skid was broken and laid on the right of the helicopter while floatation device was slightly open but not expanded. The right landing gear skid was still intact and the floatation device was unfurled but not expanded.
