**KOMITE NASIONAL KESELAMATAN TRANSPORTASI
REPUBLIC OF INDONESIA**

KNKT.19.05.10.04

Aircraft Accident Investigation Report

Airbus A320; PK-LZJ

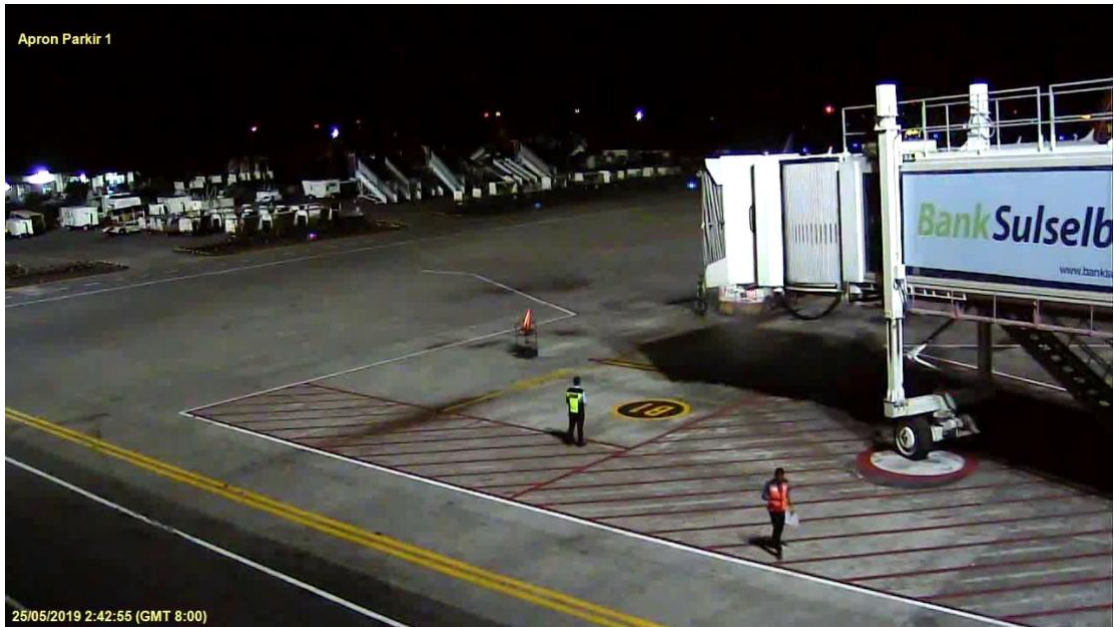
Figure 4: The blocked view of parking stand B1 CCTV

The CCTV camera located on the parking stand B1 was unable to provide clear view of the pushback maneuver as the view was blocked by the passenger boarding bridge (figure 4).

The view to the parking stand B1 on the CCTV system that was blocked by the passenger boarding bridge resulted in the pushback maneuver did not completely visible by the AMC officer. This condition might have made the AMC officer never noticed pushback maneuvers on the parking stand B1 that were not follow the available guidance lines. Without any incident, the pushback maneuvers on the parking stand B1 that were conducted deviating from the guideline was unnoticed.

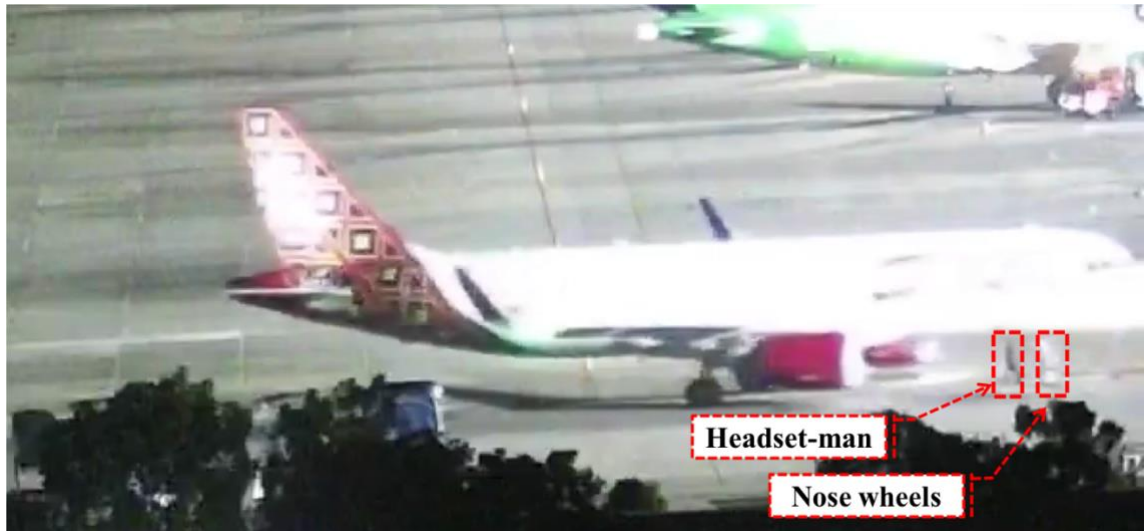
Figure 6: The zoomed-in view of the ATS provider CCTV display showed the headset-man position during pushback

The Air Traffic Services (ATS) provider also utilized CCTV system for security purposes. One of the CCTV cameras located outside the tower building facing to the apron recorded the push back maneuver. Based on the CCTV record, throughout the pushback maneuver, the headset-man position as such that the nose wheels were behind him (figure 6).

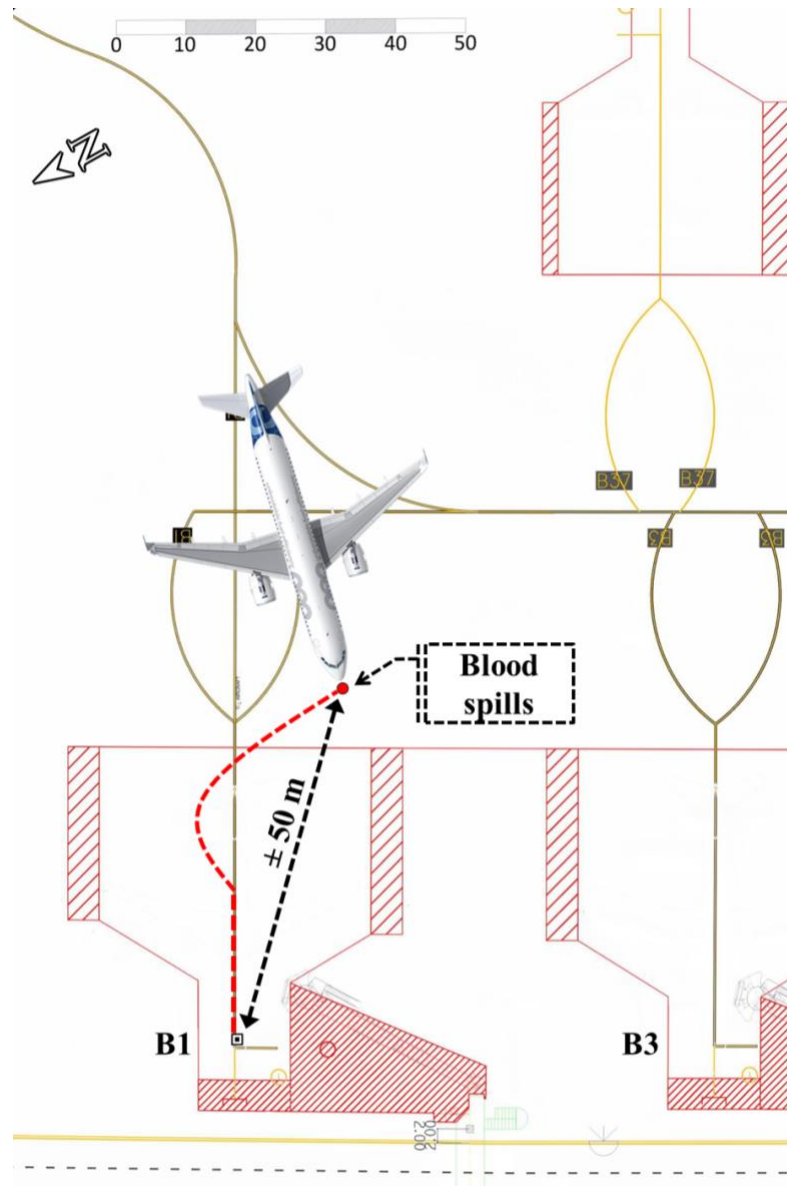
Figure 10: The illustration of the nosewheels movement during pushback maneuverer (red dot line)

The location of the blood spills on coordinate 5°4'32.86"S; 119°32'55.67"E, about 50 meters from the beginning of parking stand B1, was considered as the location when the nose wheel passed over the headset-man right foot.

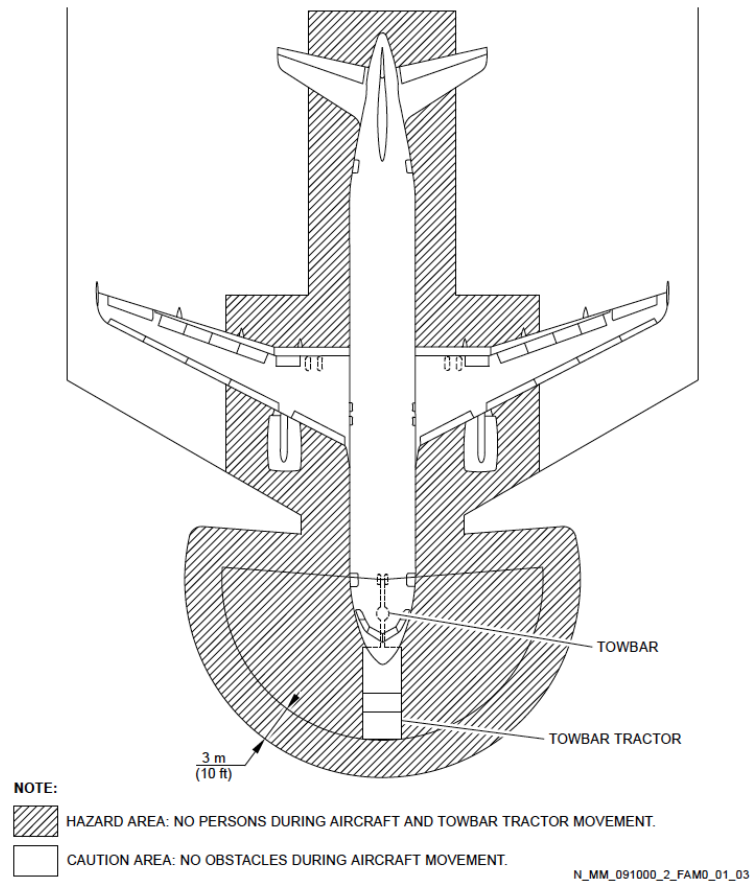
Figure 11: The hazard area during towing operation as describes in the Batik Air AMM for Airbus A318/A319/A320/A321

The towing procedure on subtask 09-10-00-584-064-A described that during the towing operations, while the aircraft moves, all persons must be at a minimum distance of 3 meters or 10 feet from the wheels and the tractor. The hazard area during towing operations were illustrated on the following figure:

The Batik Air Aircraft Maintenance Manual (AMM) for Airbus A318/A319/A320/A321 described hazard area during towing operation, which required all person must be at a minimum distance of 3 meters from the wheels and the tractor when the aircraft moved.
