**KOMITE NASIONAL KESELAMATAN TRANSPORTASI
REPUBLIC OF INDONESIA**

Aircraft Accident Investigation Report

PT. Batik Air Indonesia

Airbus A320; PK-LZJ

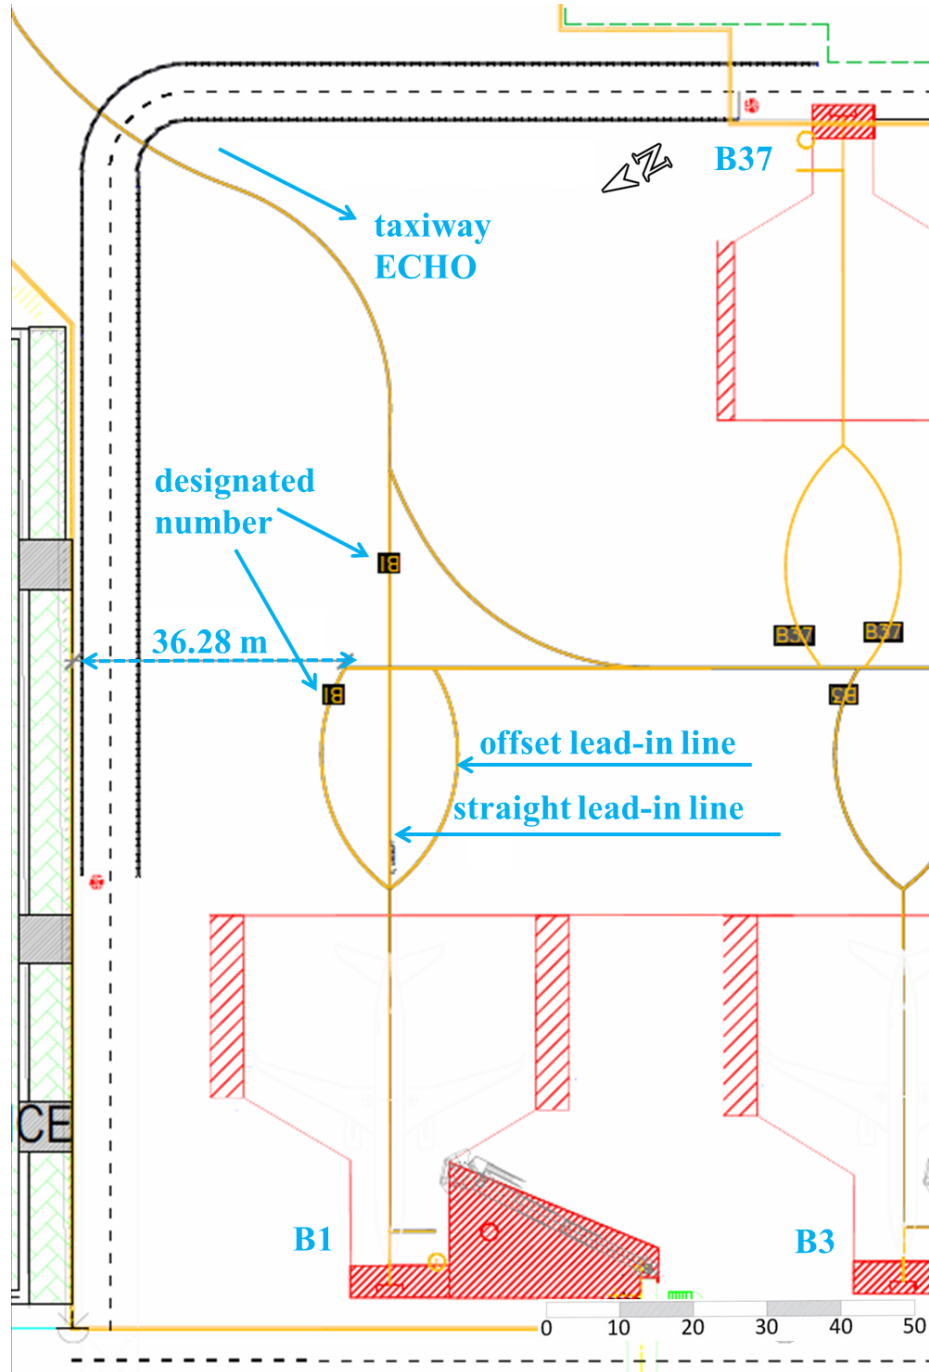
Figure 2: Parking stand B1 layout

The parking stand B1 is a nose-in parking stand that has two offset nose-wheel lead-in line and one straight lead-in line. The lead-in lines also use for guidance during the pushback maneuver. One of the offset nose-wheel lead-in line could not be used since there was no taxi route from north east direction and the other is used for aircraft which taxied from taxiway FOXTROT (south-west direction). The straight lead-in line is used for aircraft which taxied from taxiway ECHO (south-east direction). Therefore, the designated number of parking stand B1 only painted in one offset nose-wheel lead-in line and straight lead-in line.

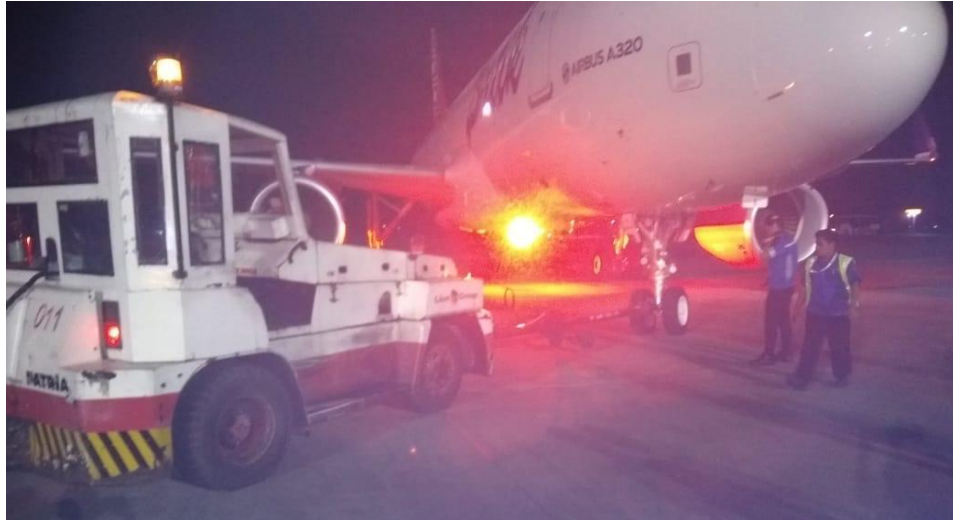
Figure 3: The position of the towing tractor and the aircraft after the accident

After the bump, the towing tractor driver stopped the towing tractor and the aircraft stopped by facing south east. The aircraft was undamaged.

The location of the blood spills on coordinate $5^{\circ}4'32.86''\text{S}$; $119^{\circ}32'55.67''\text{E}$, about 50 meters from the beginning of parking stand B1 was considered as the location when the nose wheel passed over the right headset-man foot.

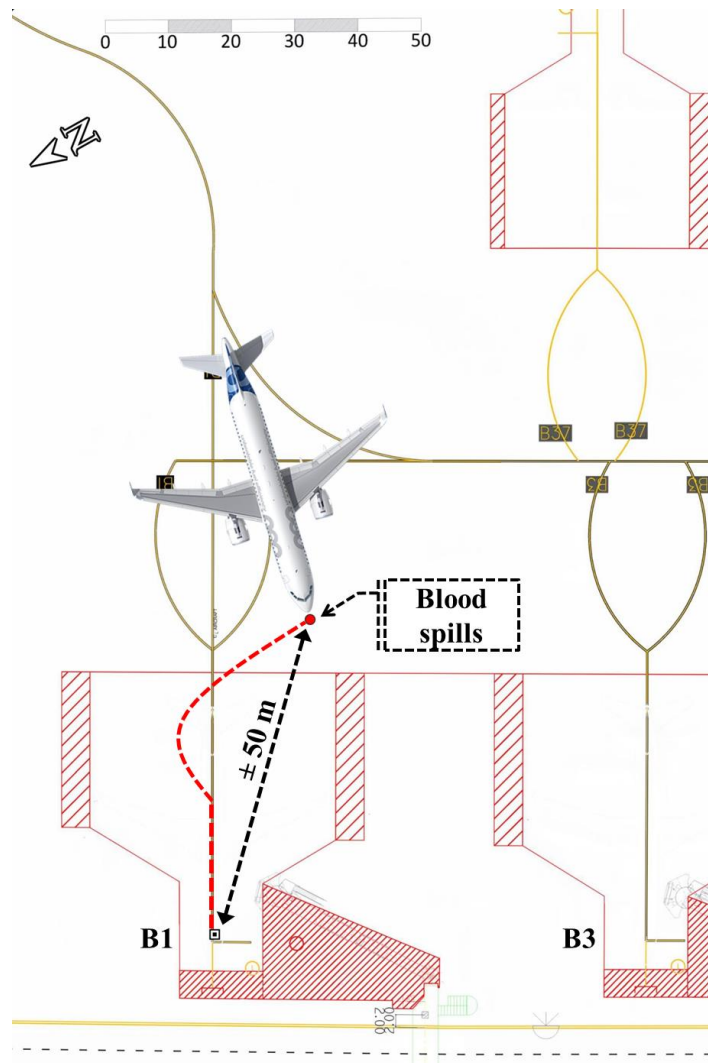
Figure 4: The illustration of the aircraft maneuverer (red dot line)

A few meters after following the straight lead-in line, the towing tractor driver maneuvered the towing tractor to the left in order to turn the aircraft facing north. This maneuver made the aircraft out of the straight lead-in line provided with intention to maneuver aircraft to face south west. The towing tractor driver considered that if the offset lead-in line was followed, the aircraft maneuver would be too close to the service road (see subchapter 1.10 for the detail apron layout).

Therefore, the KNKT recommend the Angkasa Aviasi Servis to ensure towing tractor drivers follow the available guidance line and/or conduct briefing for any plan of deviation maneuver from the guidance line.

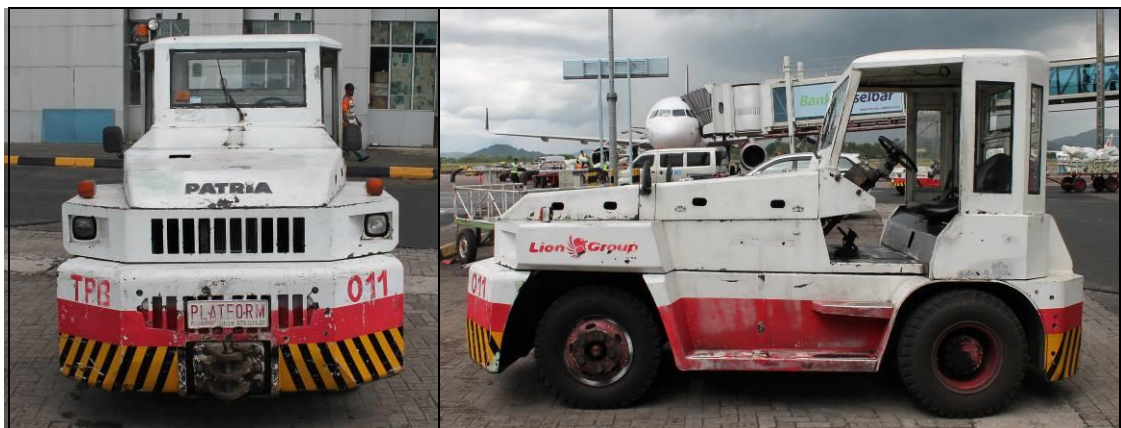
Figure 5: The towing tractor

The towing tractor manufactured by PT. United Tractors Pandu Engineering (PATRiA), Indonesia and the model PTD 50 is capable to tow Airbus A320. According to the product specification, the maximum speed for PTD 50 with forward-1 clutch is 12 km/hour and forward-2 clutch is 32 km/hour. The steering wheel of the PTD 50 is left hand drive which the steering wheel is on the left side.

Prior to the accident, there was no report or record of towing tractor system malfunction.
