**KOMITE NASIONAL KESELAMATAN TRANSPORTASI
REPUBLIC OF INDONESIA**

KNKT.19.07.14.04

Aircraft Accident Investigation Report

Cessna 172S; PK-WUG

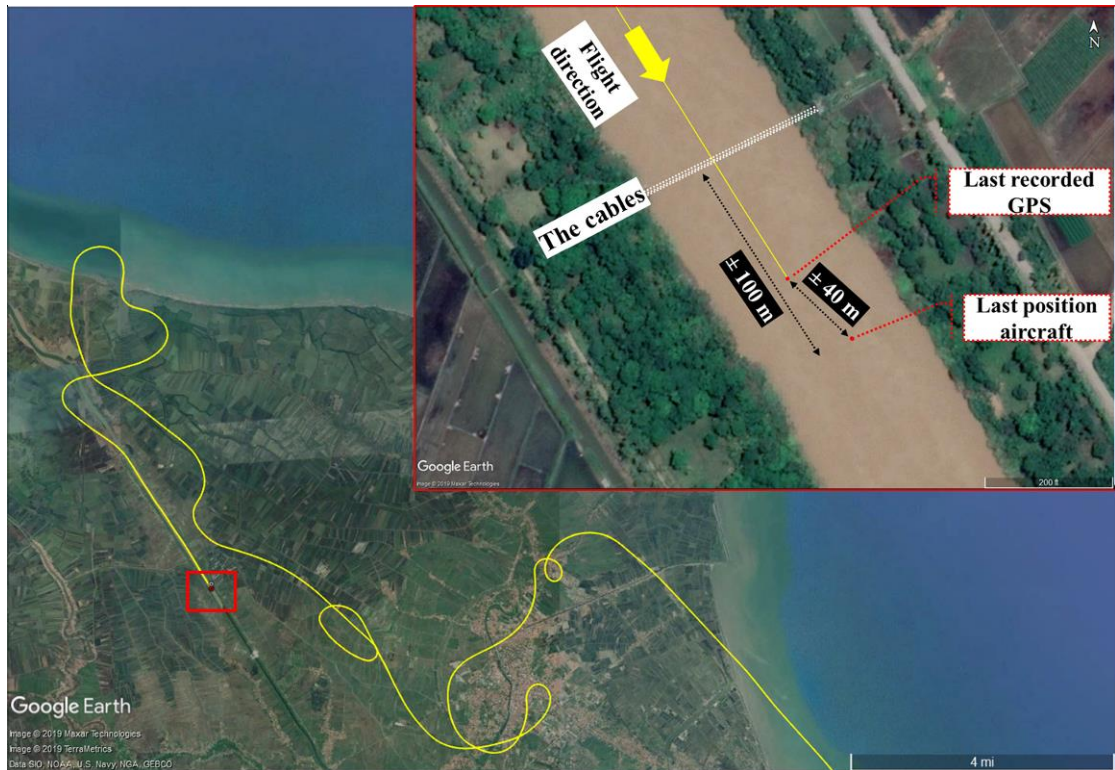
Figure 3: The aircraft flight profile and accident site information

The aircraft struck three power line cables that ran across the river from North-East to South-West direction on height of 10 meters (32 feet). All three power line cables broken and one of the cables got caught in the main landing gear struts.

The aircraft was found about 100 meters from the power line on South-East direction and tilted to the left with the left part of the aircraft was sunk into the river. A few moments later, the aircraft completely sunk into the river. The river depth was about 15 meters.

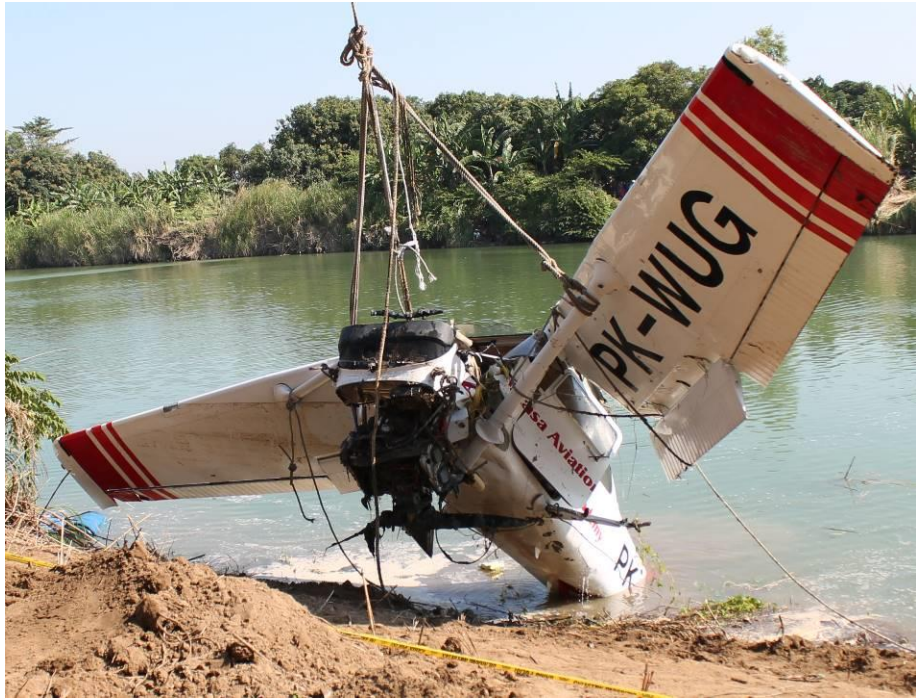
Figure 4: The aircraft condition after recovered from the river

One day after the accident, the aircraft heading changed to the South direction most likely due to river current. The diver who recovered the aircraft informed that the engine section folded down, the windshield cracked, and all the wheels detached. During the recovery process, the aircraft sustained additional damages.

18. The diver who recovered the aircraft informed that the engine section folded down, the windshield cracked, and all the wheels were detached. During the recovery process, the aircraft sustained additional damages.

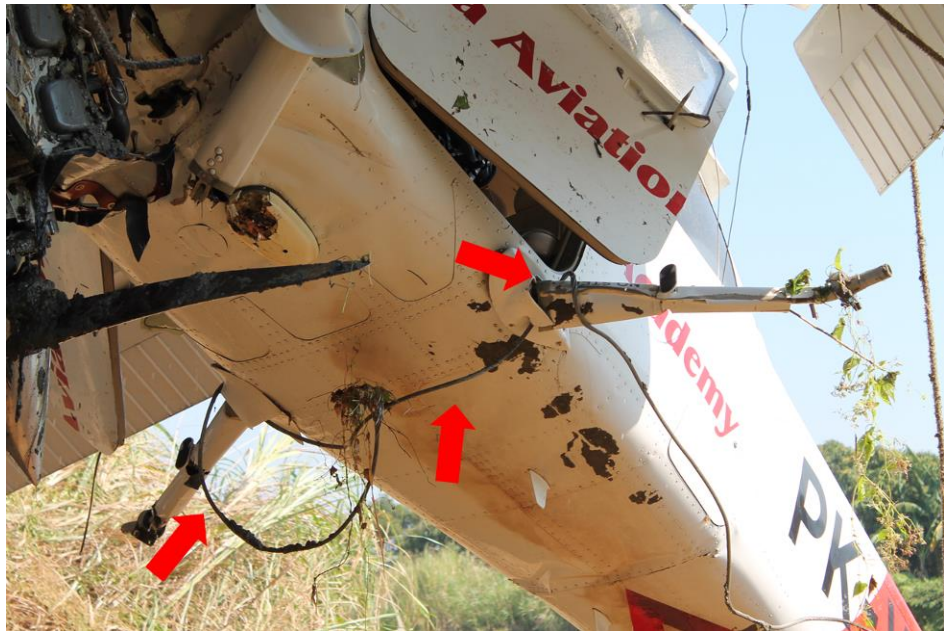
Figure 5: The power line cable caught in the main landing gear struts (red arrows)

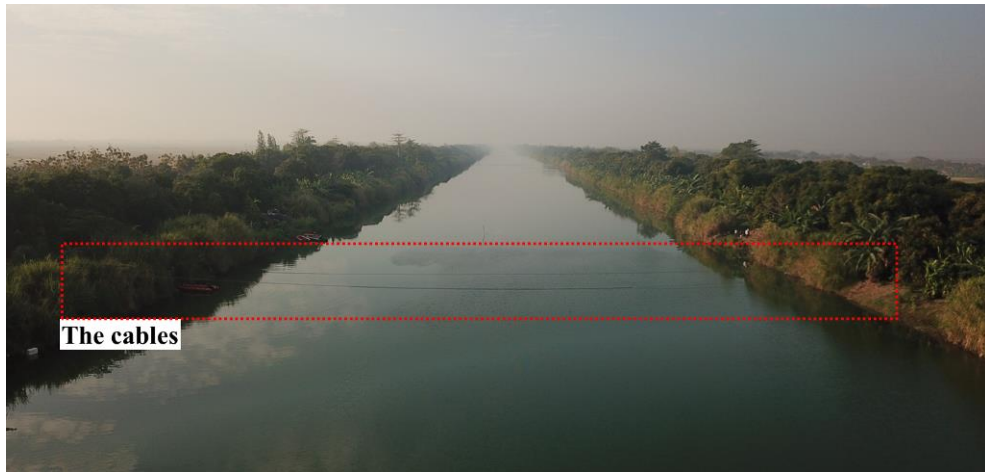
Figure 6: The cables across the river (in the red-doted square)

The figure 6 showed the cables condition after repaired. The photo was taken using drone at GPS altitude of 22 feet about 42 meters from the cables.

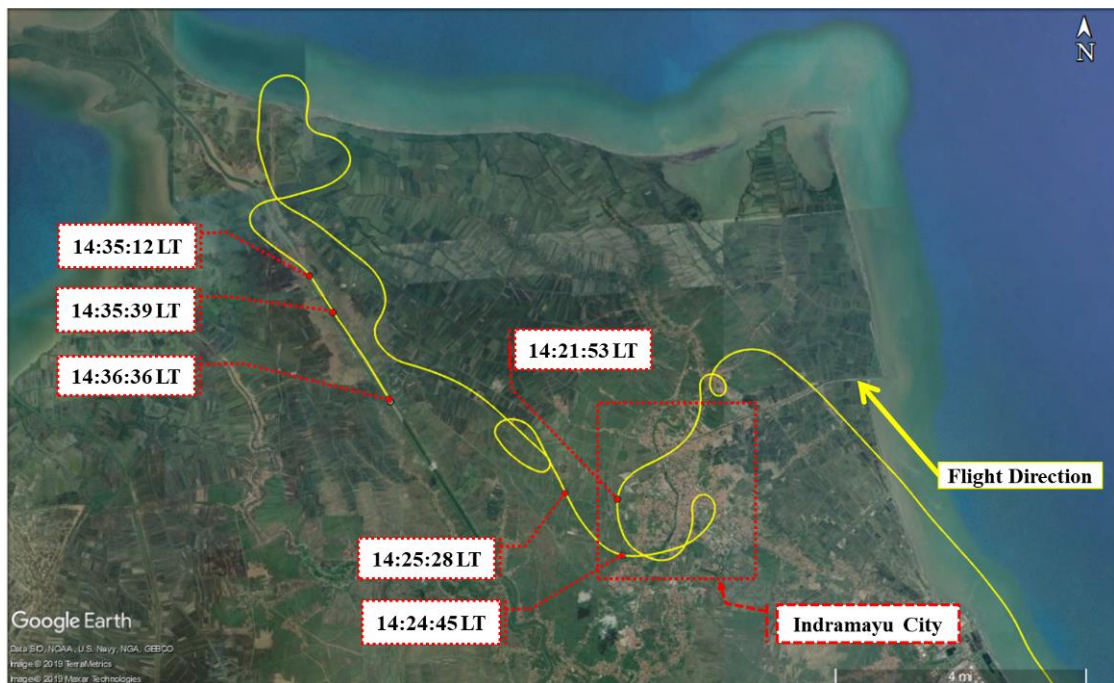
Figure 7: The GPS flight data log superimposed with Google Earth

The investigation retrieved 139 files that had been downloaded from the PK-WUG before the accident and 198 files from PK-WUJ aircraft since April 2019. The data indicated that 17 flight training exercises over training area descended below 500 feet MSL which consisted of 11 dual flights (student fly with flight instructor) and 6 mutual flights (student fly with another student)⁸. The detail of those 17 flights can be found in the appendix.

The AAA downloaded the Garmin G1000 flight data log every three days. As there was no procedure to utilize the recorded data, the downloaded data was stored in the engineering server have not been utilized for any purpose. The KNKT utilized the Garmin G1000 recorded data of two aircraft within four months prior the PK-WUG accident and found 17 training flights were flying below the minimum safe altitude.

Therefore, KNKT recommends the AAA develop system to monitor the training activity using the available means to detect flight training activity that deviate from the requirement standard and to enable immediate corrective action.

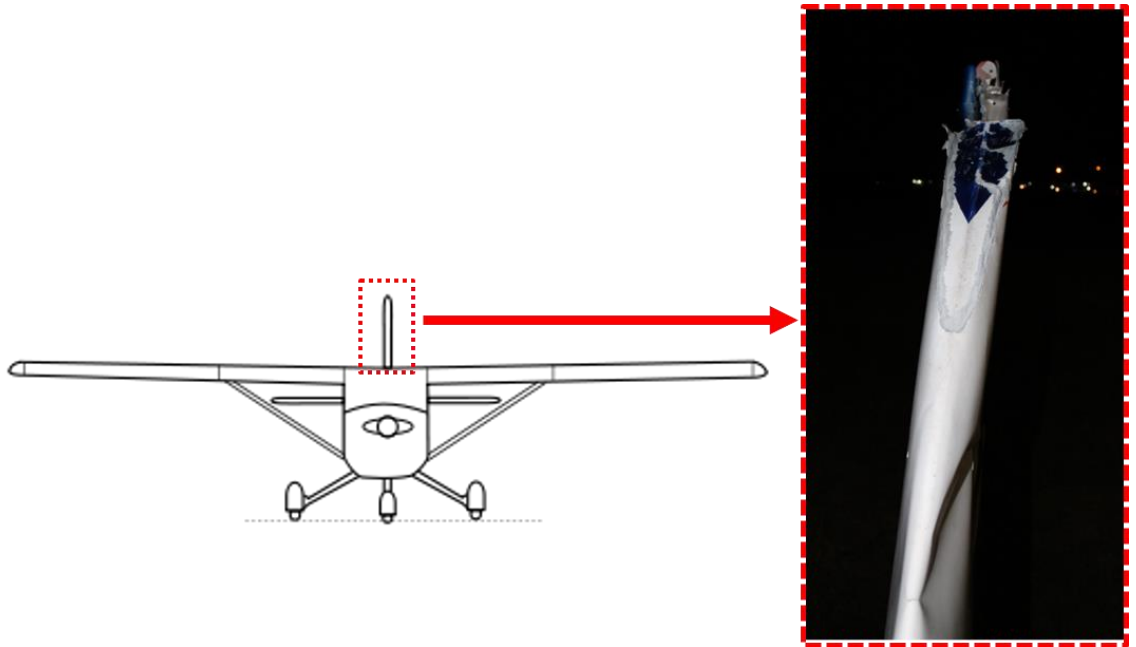
KNKT inspect to the aircraft involved and found damages on the aircraft vertical stabilizer that most likely was caused by impact to power line cable (figure 8). The electrical power company also reported broken cables on the Losari Area.

Figure 8: The damaged aircraft vertical stabilizer (in the red-dotted square)

21. On the day of the accident, there was another Cessna 172 from different flying school departed from Cirebon experienced cable strike on the Losari Training Area which indicated by the damages found on the aircraft vertical stabilizer. The electrical power company also reported broke cables on the Losari area. The flying school had not established a system to monitor the movement of aircraft in real time.
