**KOMITE NASIONAL KESELAMATAN TRANSPORTASI
REPUBLIC OF INDONESIA**

Aircraft Serious Incident Investigation Report

PT. ASI Pudjiastuti Aviation (Susi Air)

Cessna C208B, PK-BVN

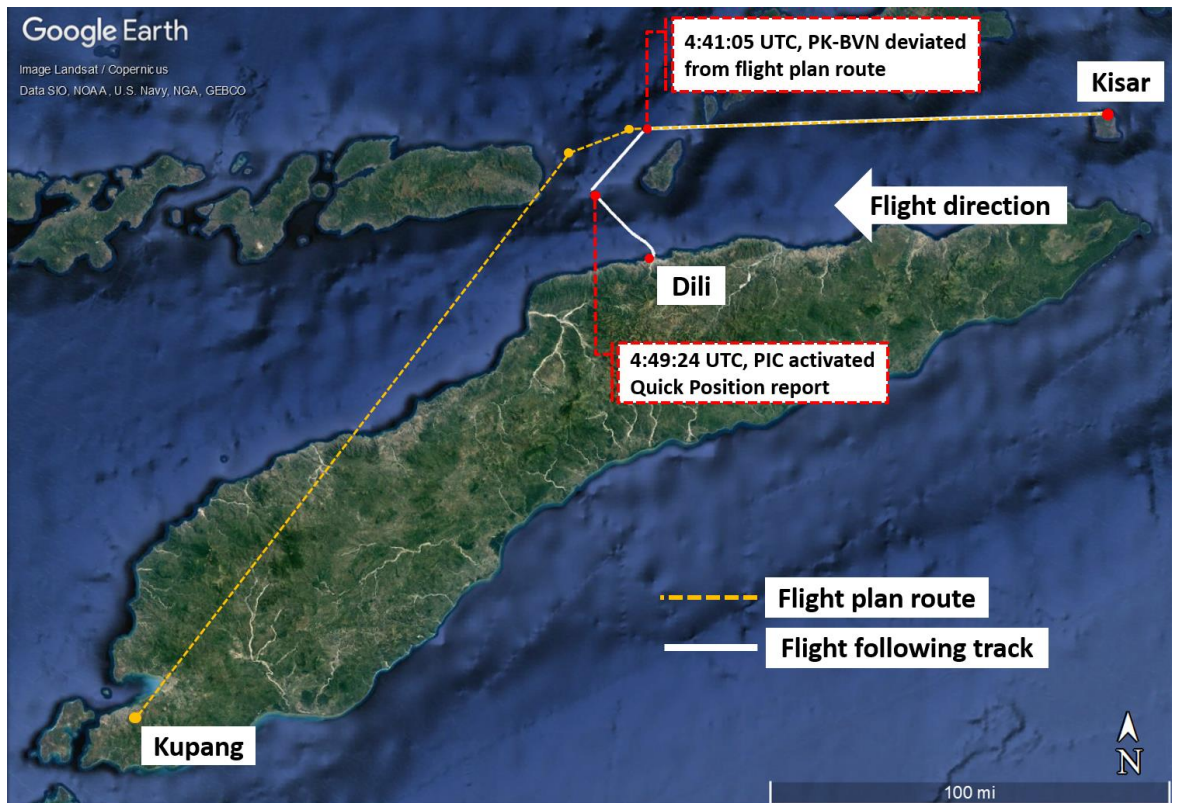
Figure 1: The flight profile based on flight following data

At 0449 UTC, when the aircraft passed altitude of 6,000 feet the PIC activated the Quick Position report⁶ of the flight following system installed in the aircraft.
