**Aircraft Serious Incident Investigation Report**

**PT Sinar Mas Super Air**

**Pacific Aerospace FU 24-950 Fletcher; PK-PNZ**

**Mambruk Airstrip, Lereh, Papua**

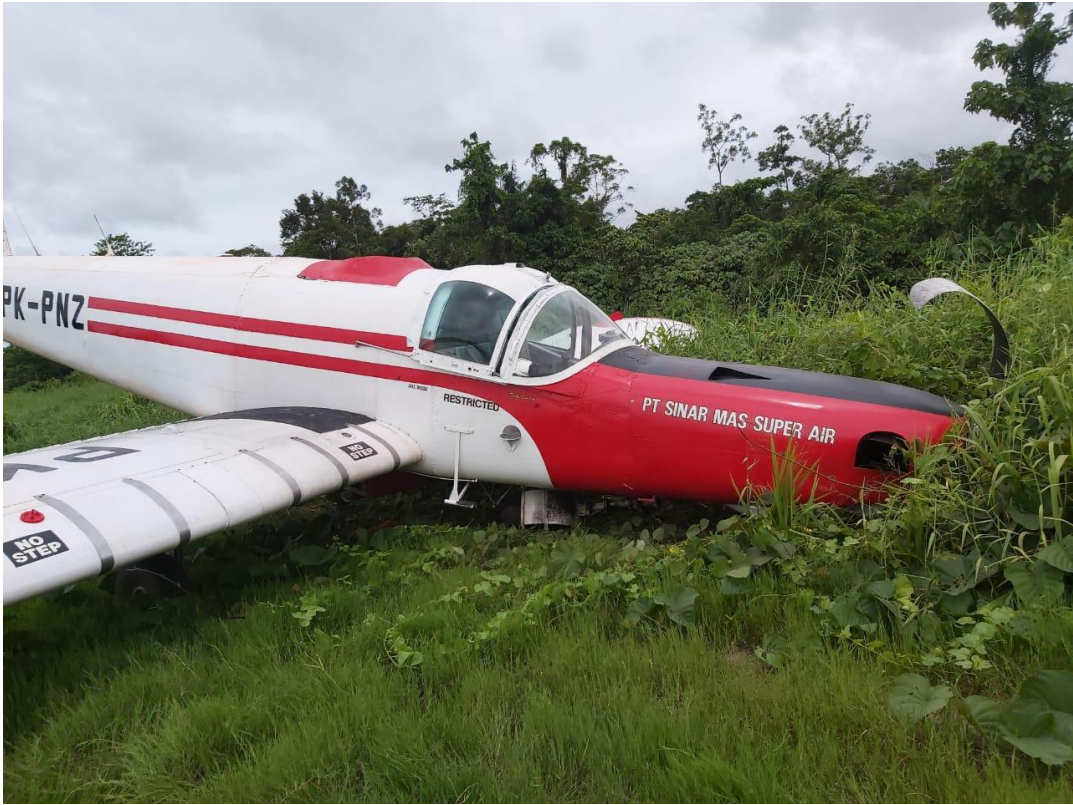
The aircraft veered to the left side of runway 36 and stopped on the grass area on runway shoulder.

The pilot conducted shutdown engine procedure and disembarked the aircraft. The pilot observed the aircraft condition and found that the aircraft nose wheel collapsed and propeller blades were bent.

**Figure 1: Aircraft After Occurrence**

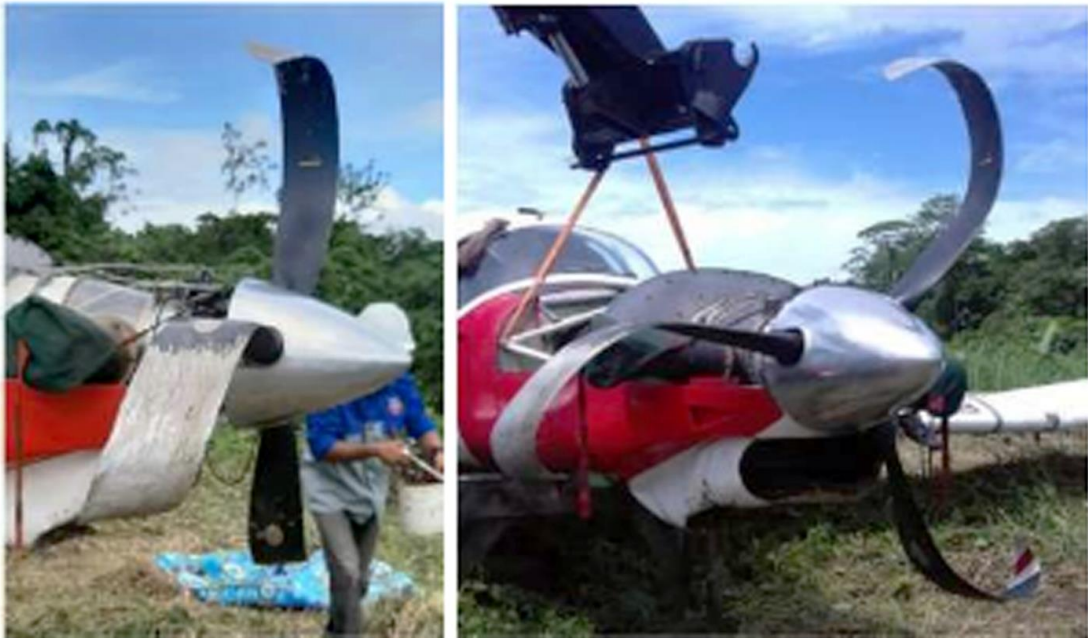
- Nose gear cylinder fractured.
- Aircraft fuselage skin on lower attachment bracket crack;
- All three propeller blades bent,
- Engine air intake area damage,
- Engine starter generator fractured.

**Figure 2: Damage to the propeller blades**

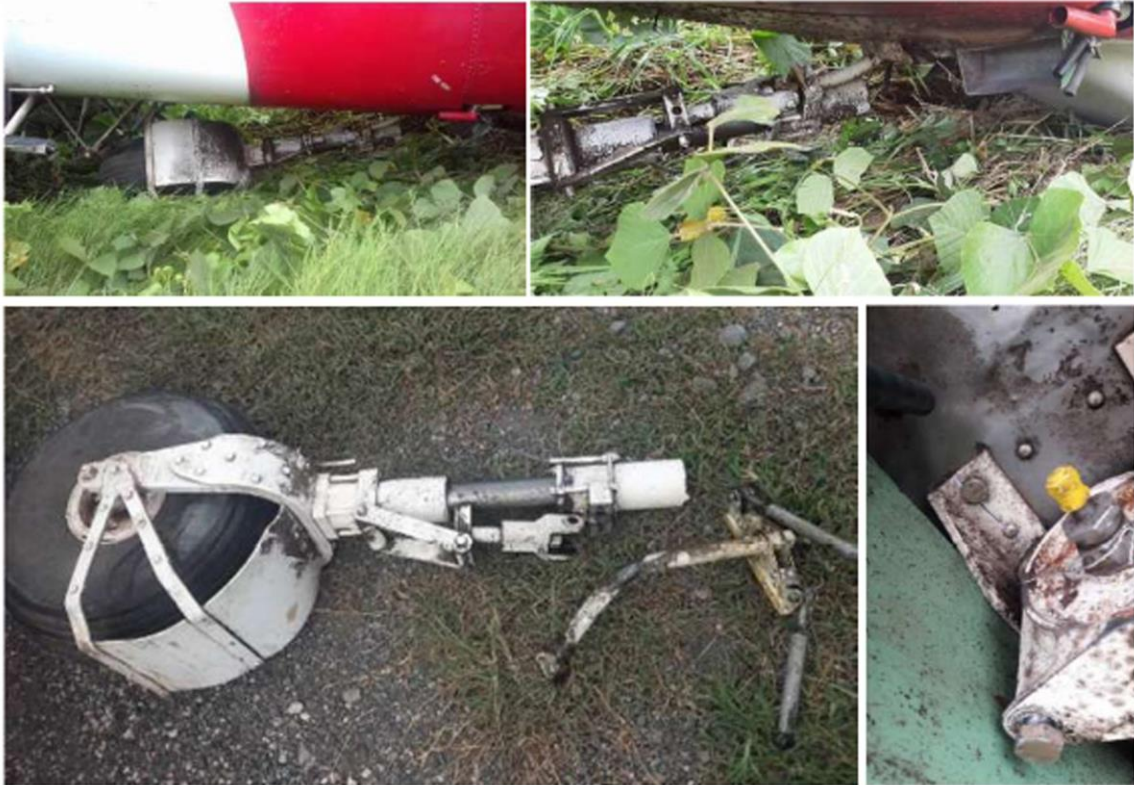
**Figure 3: Damage to the nose wheel**

Stuck position of the dead pig on the nose wheel mudguard (fender) probably created braking effect on aircraft nose wheel. This braking effect on a movement aircraft resulting to excessive stress, and nose wheel cylinder was fractured caused the aircraft became uncontrollable and the aircraft veered to the left.

- The airstrip operator built 2 security posts at the end of runway 36 and runway 18 and would be guarded 24 hours by palm company personnel.
2. PT. Sinar Mas Super Air issued Quality Notice Number FU24-950-QN/21/VIII/32-00/2020, dated 11 August 2020 regarding the prohibition of nose wheel mudguard (fender) installation on Fletcher Fu29-950 fleet.

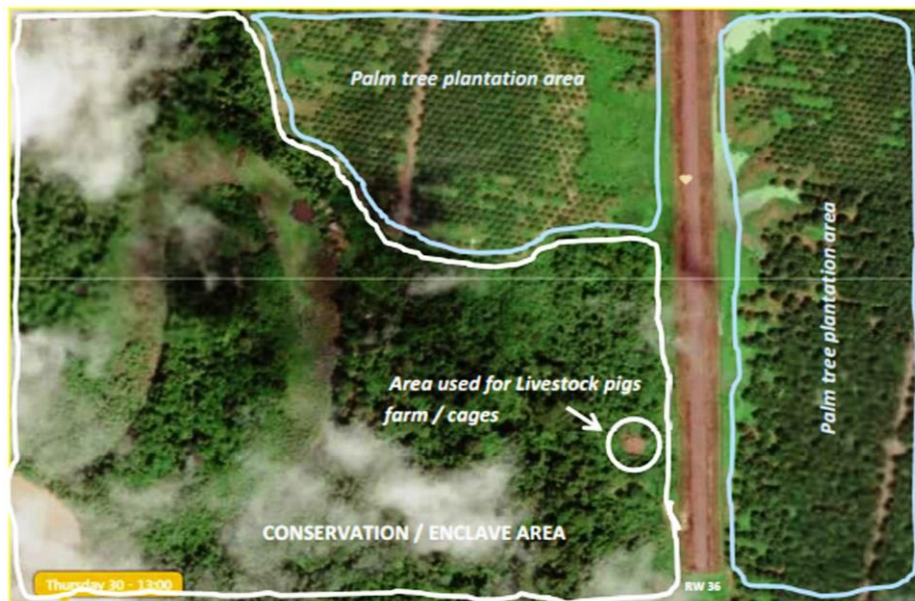
The east side area of Mambruk airstrip was palm plantation area while the west side was area dedicated as conservation. No activity allowed within the conservation area as it may disturbed the environment and the wild life. However, some local people utilized the conservation area on the left side of threshold runway 36 as livestock boar farming.

Figure 5: Airstrip, Plantation and Conservation Area

The airstrip management has put fences and gutter to prevent animal to enter the airstrip. The investigation found that some segments of the fence and gutter were not in a proper condition which allowed small size of boar or animals to pass and entering the airstrip. The fence and gutter inspection program did not monitor the fence and gutter condition.

- The palm plantation company, as airstrip operator, has cleaned and improved the gutter condition around airstrip;
  - The palm plantation company, as airstrip operator, has repaired the fence condition around airstrip;

- Coordinate with airstrip operator to held a meeting with local community. The result of meeting was the farming area would be relocated to Nawa riverside area, about 6 km from Mambruk Airstrip;

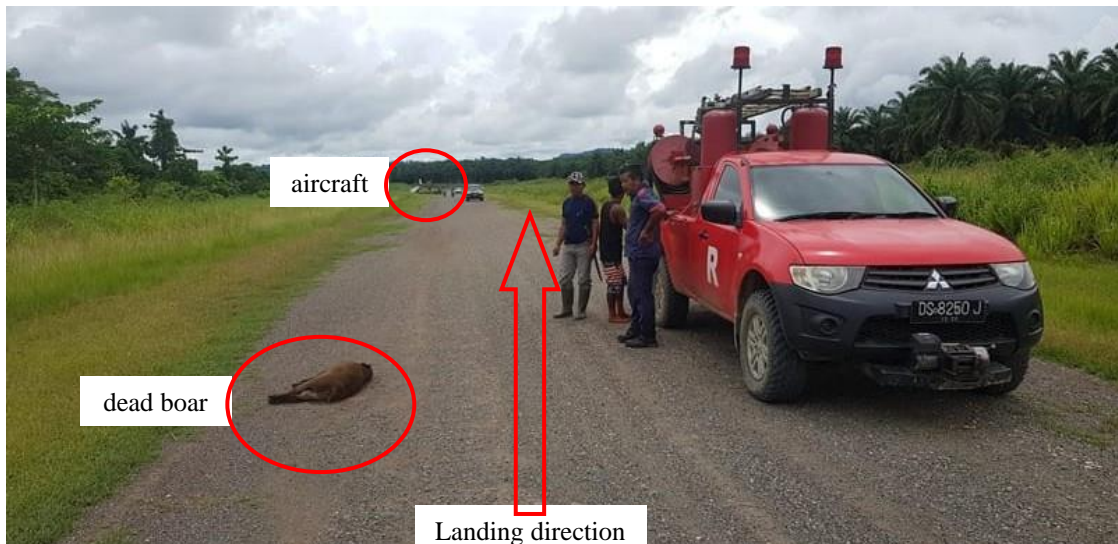
The ground support team conducted inspection on the runway and found a dead boar, about 120 meters from the beginning of the runway 36. The dead boar height was approximately 45 cm and the weight was approximately 15 kg. Some boar furs were found on the area around the aircraft nose wheel fork and the mudguard (fender). The wound pattern on dead boar shoulder was similar with wheel mudguard corner pattern.

**Figure 6: Occurrence picture**

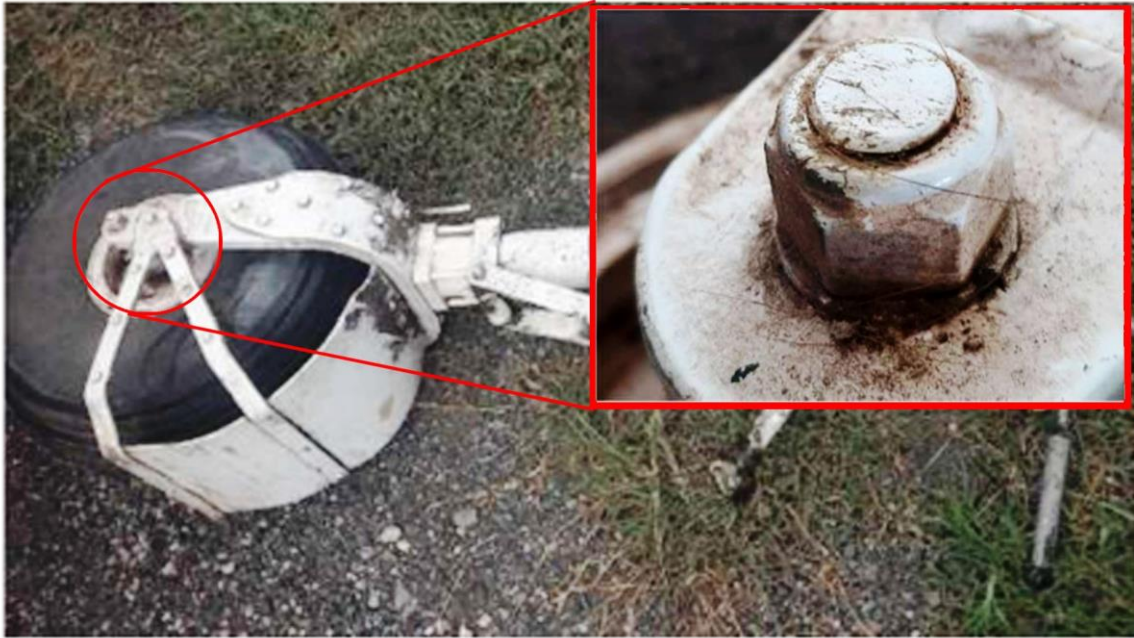
**Figure 7: Boar's Furs found in the Nose Wheel Fork**

Most probably, after impact with the nose landing gear, the boar was run over the nose wheel and stuck on the nose wheel mudguard (fender). The wound pattern in dead boar shoulder was similar with nose wheel mudguard (fender) corner pattern.
