**KOMITE NASIONAL KESELAMATAN TRANSPORTASI
REPUBLIC OF INDONESIA**

Aircraft Accident Investigation Report

Airbus MBB BK117 D-2 Helicopter; PK-JBX

Bersujud Airport, Batulicin

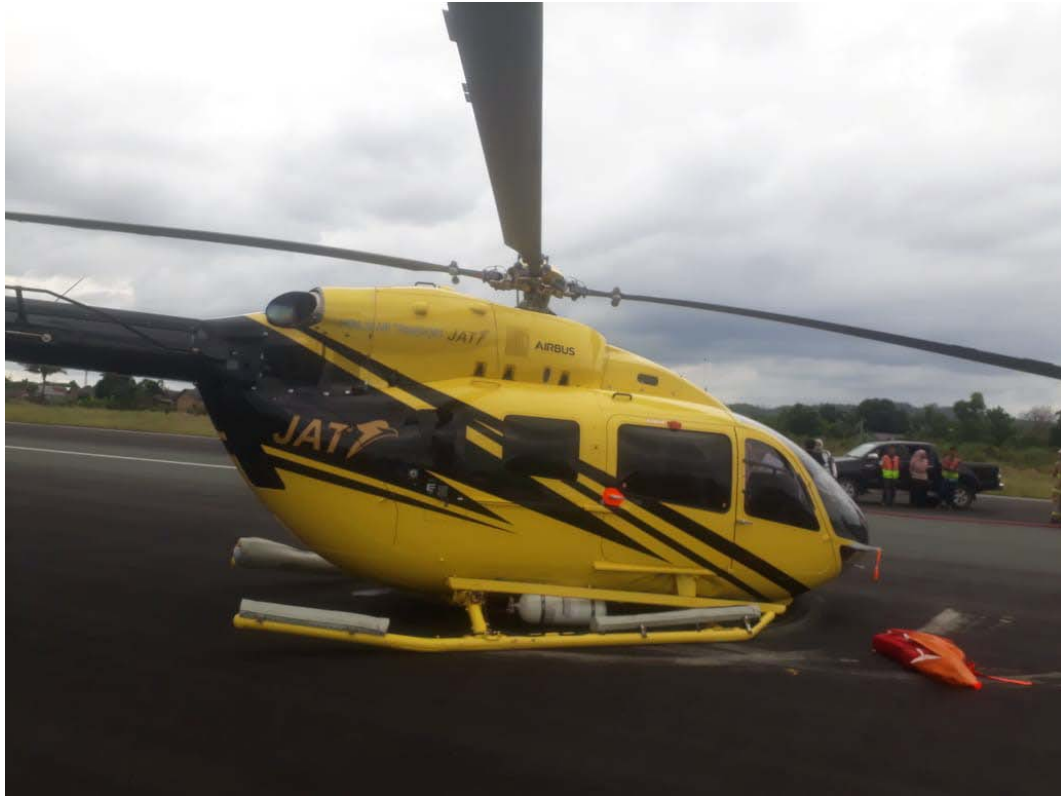
Figure 1: The helicopter after stopped on the runway

The helicopter substantially damaged. The damage mainly on the lower fuselage skin and the cross tube and the detail are as follow:

- Right forward lower fuselage skin dent with dimension about 12 inches wide and 24 inches long with approximately 4 inches deep,
- Right forward lower fuselage skin teared off approximately 11 inches at forward landing cross tube attachment,
- Right mid (between aft and forward) lower fuselage skin dent approximately 0.5 inches deep, 2 inches wide, and 2 inches long,
- Right landing cross tube to fuselage fairing teared off 11 inches long,
- Left forward lower fuselage skin dent approximately 1 inch deep, 7 inches wide, and 15 inches long,
- Left aft lower fuselage skin dent approximately 1 inch deep, 21 inches wide, and 7 inches long,
- Left and right landing cross tube bent,
- Lower center fuselage to landing cross tube attachment teared off approximately 2 inches long,

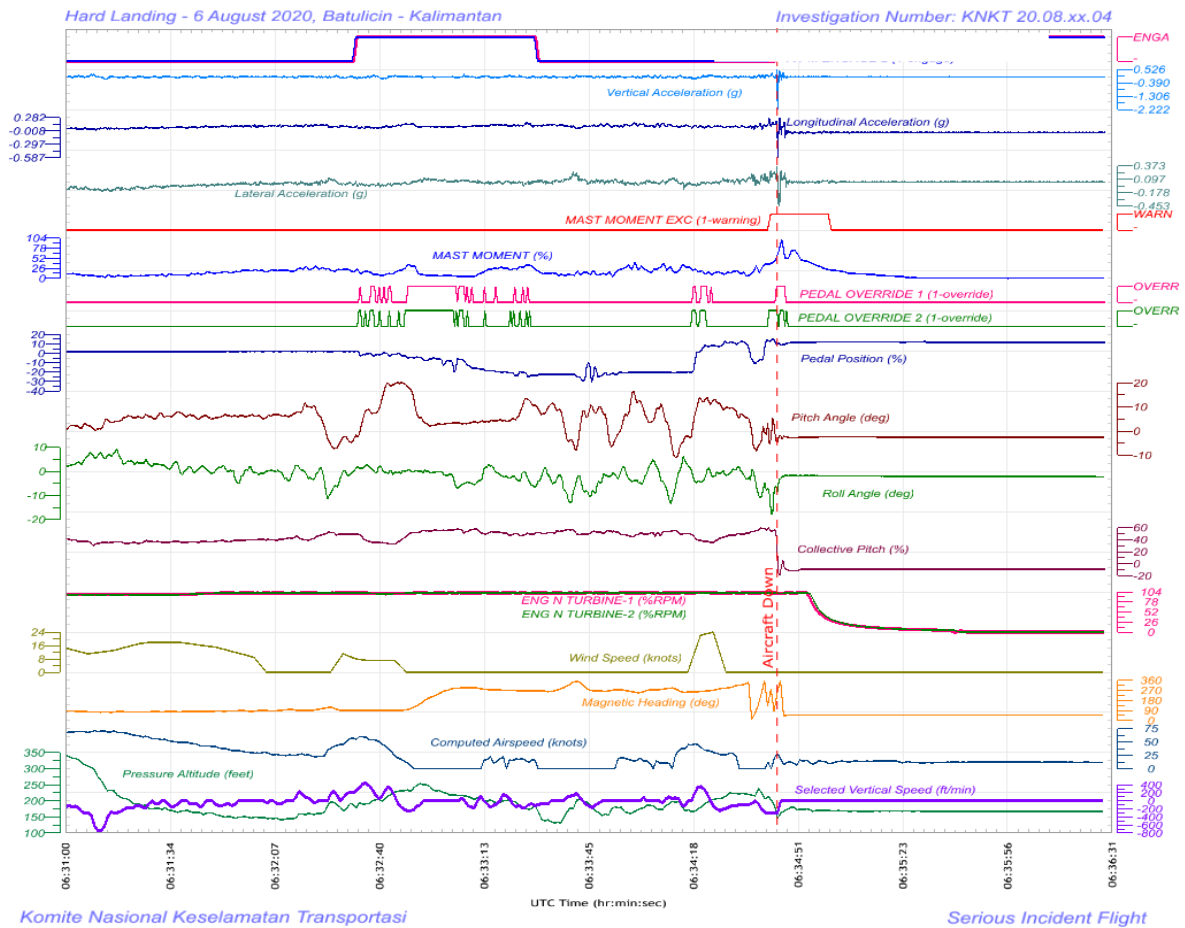
Figure 3: Significant parameter recorded by the CVDR

The significant parameters recorded by the CVDR indicated as follows:

1. At 14:34:20 LT wind direction was from 169 and speed 22 knot, at 14:34:28 LT wind direction was from 169 and speed 24 knot, then back to calm;
2. At 14:34:26 LT, helicopter magnetic heading started to change from 270° to 360°, 360° to 270°, 270° to 360°, 360° to 270° and the last heading was 048°;
3. At 14:34:45 LT, collective pitch relatively manipulated between 40% to 60 % than changed to -20%.

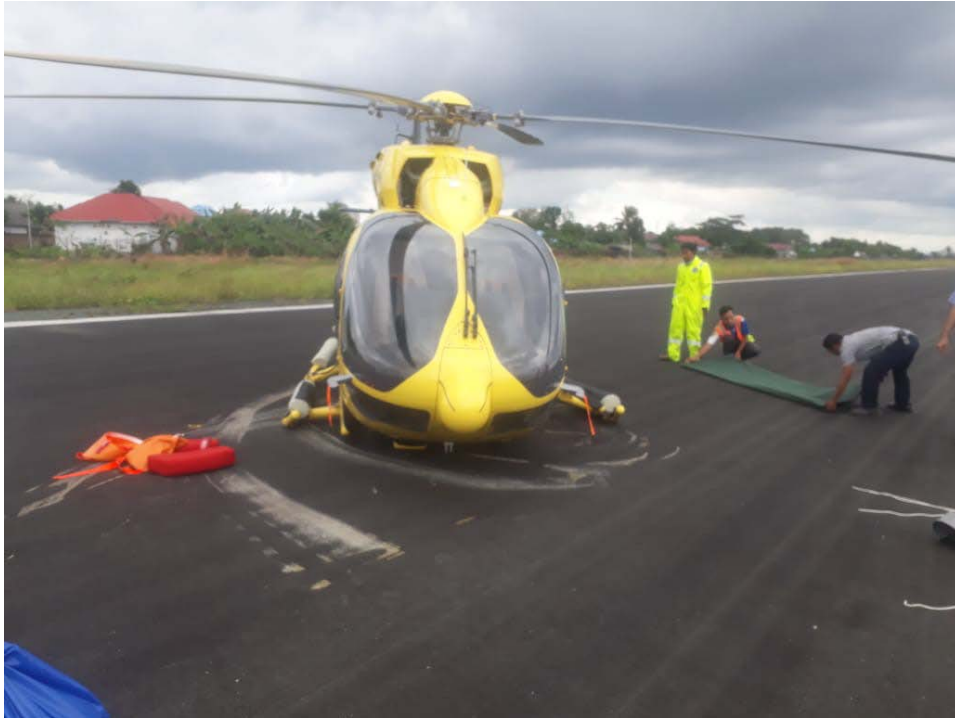
Figure 5: The helicopter position and the scratch marks

Circle scratch marks were found about 730 metres from the beginning of runway 09. The circle scratch mark had diameter of 5.8 metres and 1 cm depth. No fuel smell or evidence of fuel spillage found.
