**KOMITE NASIONAL KESELAMATAN TRANSPORTASI
REPUBLIC OF INDONESIA**

PRELIMINARY

Aircraft Serious Incident Investigation Report

Airbus A330; PK-LEG

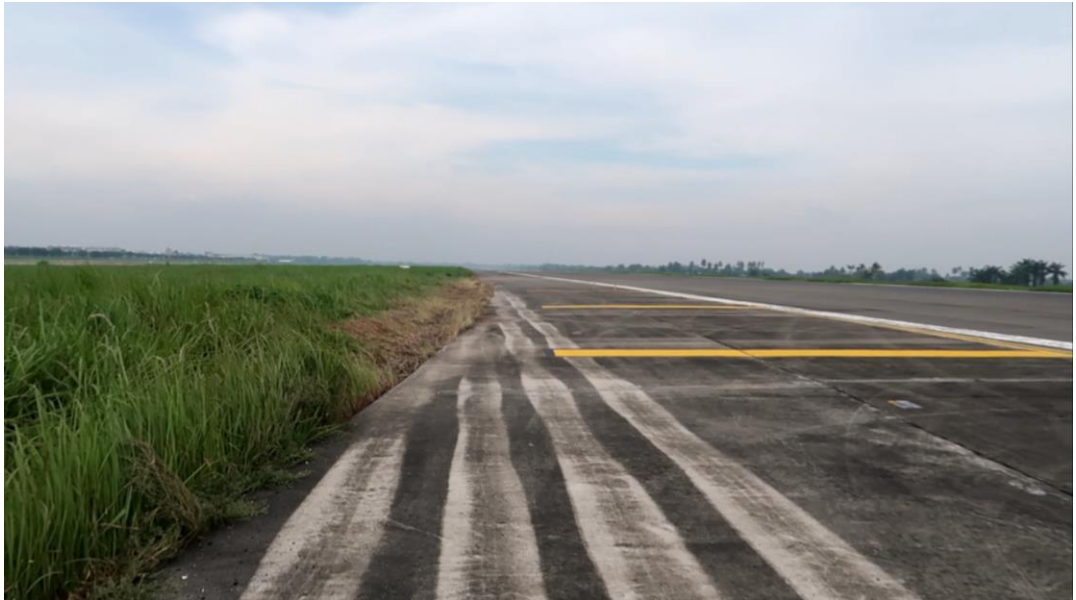
The tire marks consisted of 4 strips which consistent with the left main landing gear, found on runway from approximately 370 meters from the threshold runway 23 and continued along the aircraft path. The aircraft touchdown point could not be identified.

The marks deviated to the left from the initial marks and travelled out of runway. After passed the taxiway D, the marks continued travel outside the runway for approximately 30 meters then back to the runway centerline at taxiway Echo or approximately 1,500 meters from runway threshold.

Figure 1: The left main landing gear tire marks before the aircraft out of runway.

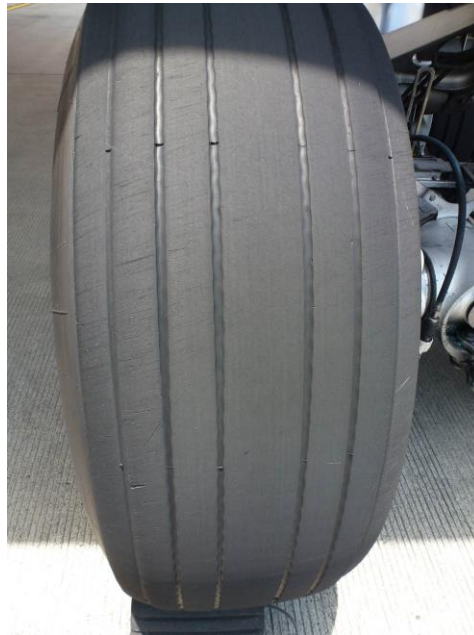
The tyre marks have striation in perpendicular direction to the aircrfat movement. The striation also found in the left main landing gear tires which were perpendicular to the normal tire movement.

Post-occurrence inspections on the aircraft tires did not find evidence of reverted rubber hydroplaning.

Figure 2: Striation mark in lateral direction on tire surface.

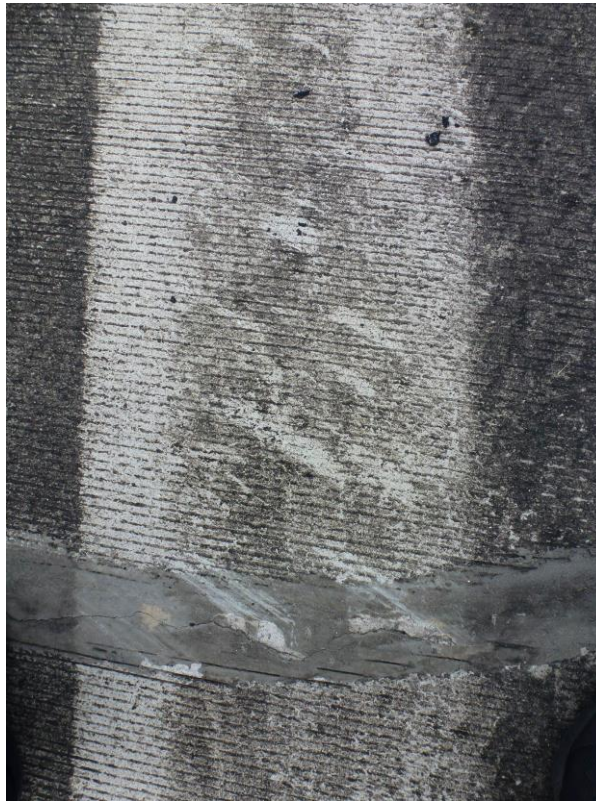
Figure 3: The striation mark on runway surface.
