Aircraft Accident Investigation Report

Quest Kodiak 100; PK-MEC

Sentani Lake, Jayapura, Papua

12 May 2020

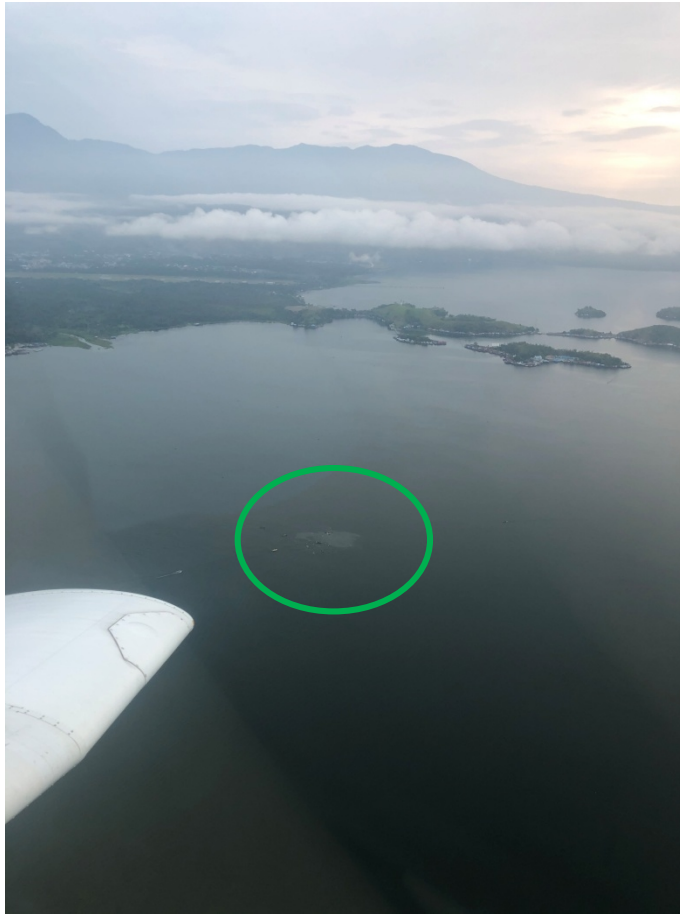
The pilot of PK-RCE reported to Jayapura Radar controller that some debris could be seen on Sentani Lake and some boats were moving toward the debris location. The pilot of PK-RCE assumed that PK-MEC aircraft had crashed to the lake.

Figure 1: The PK-MEC aircraft wreckage location taken by the pilot of PK-RCE

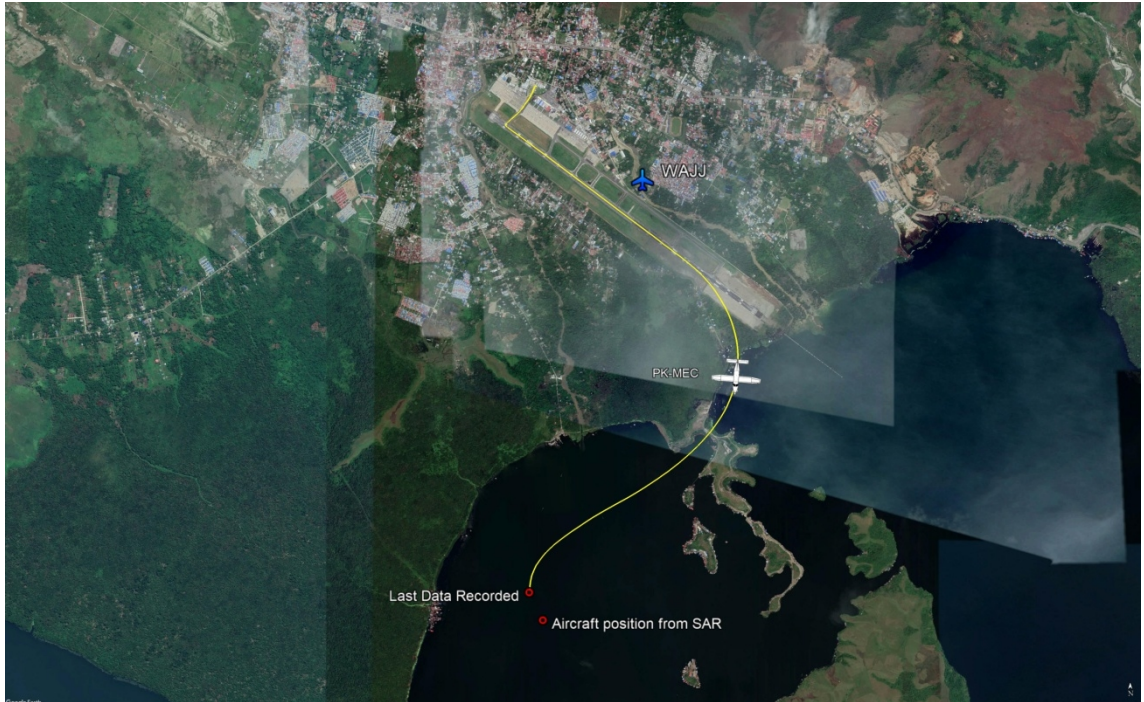
Figure 2: The aircraft flight profile based on Garmin G1000 data and the location of the main wreckage

The aircraft wreckage was found in Sentani Lake, at coordinate 2°36'44.77" S; 140°30'46.84" E or approximately 3,300 metres from the end of runway 30 Sentani Airport.

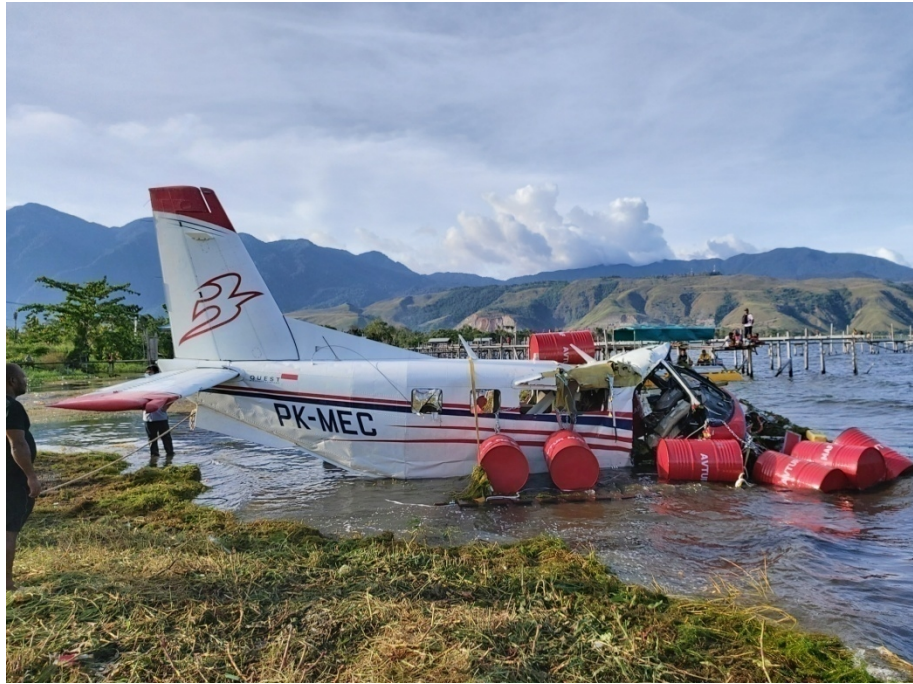
The aircraft was substantially damage.

Figure 3: The aircraft after recovered from Sentani Lake (taken from right side)

The aircraft main wreckage recovered from the lake bed. The right wing from the root to the tip and the left outer wing were detached. The engine forward section from flange B up to the propeller detached.

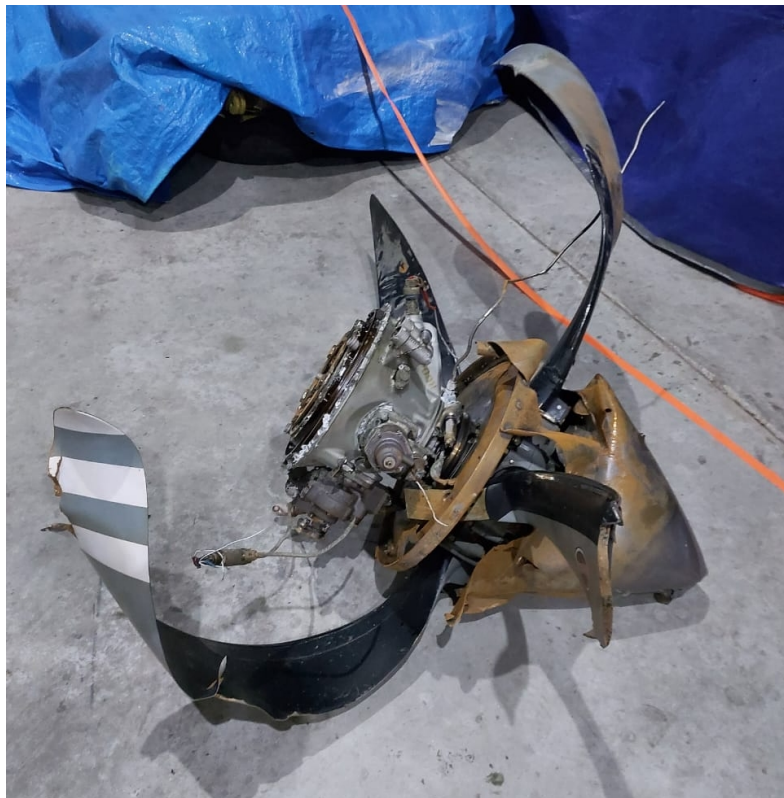
Figure 4: The propeller

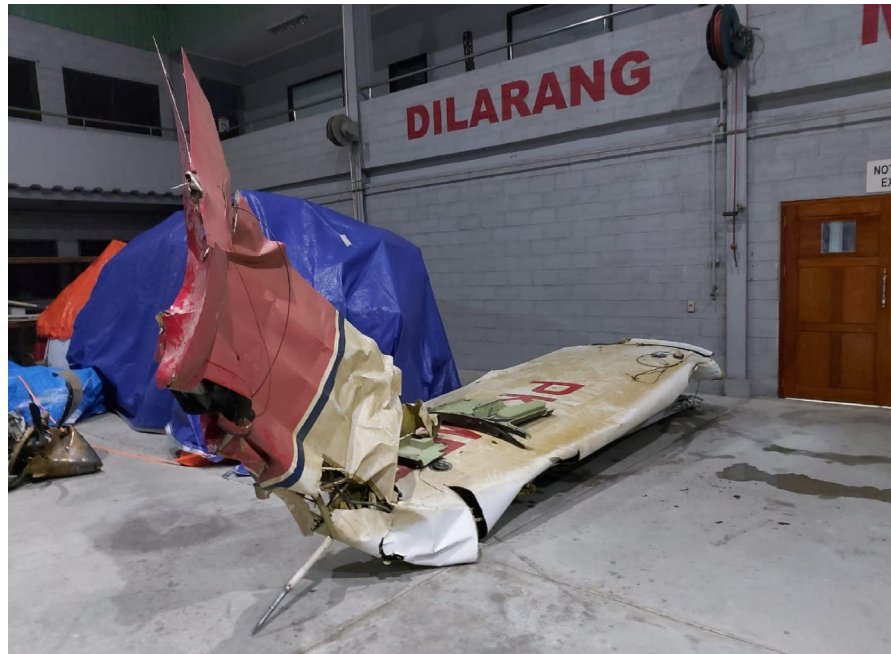
Figure 5: The right wing
