**KOMITE NASIONAL KESELAMATAN TRANSPORTASI
REPUBLIC OF INDONESIA**

KNKT.20.06.10.04

Aircraft Serious Incident Investigation Report

AT-802A; PK-PAG

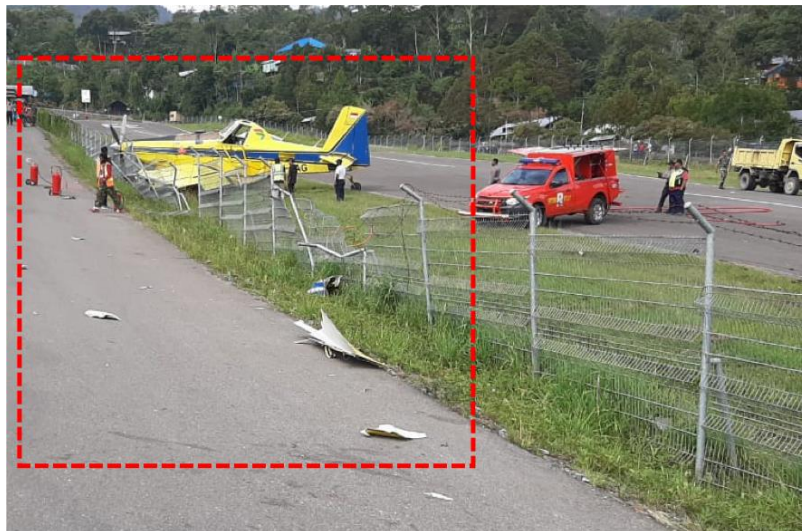
The airport fence was damaged.

Figure 1: The aircraft last position and the damaged airport fence (inside the red-dotted square)

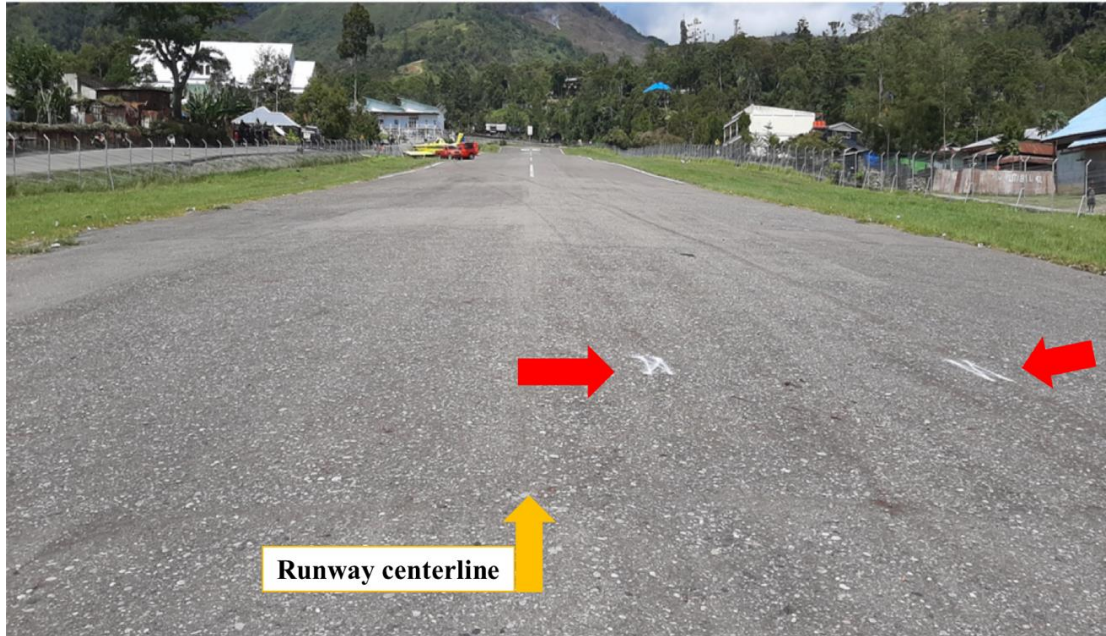
Based on the site measurement conducted by the airport operator personnel, there were braking marks of the left and right wheels started about 200 meters from the beginning runway until the aircraft travelled out from the runway.

Figure 4: The beginning of braking marks on the runway (red arrows)

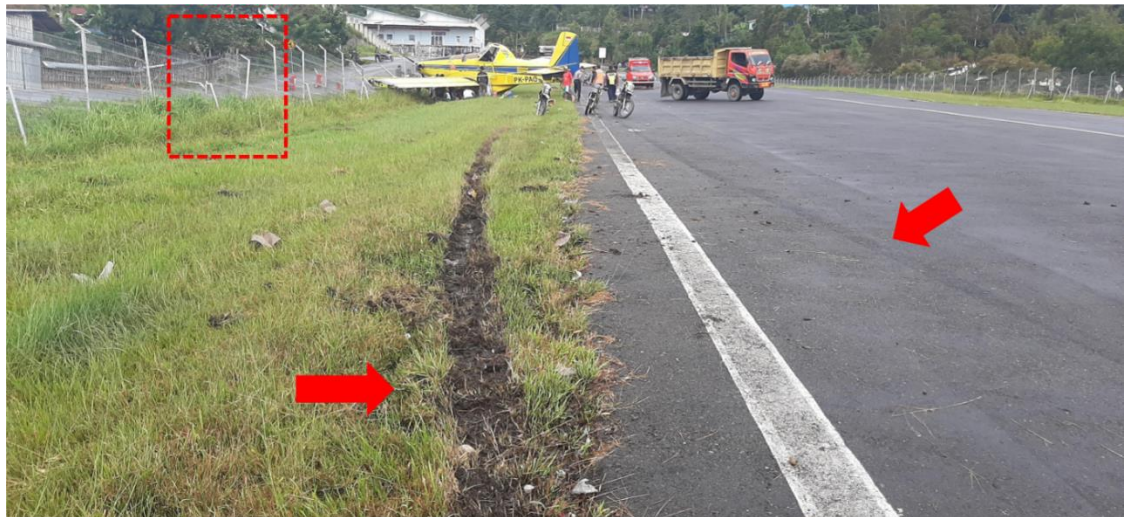
About 480 meters from the beginning runway 17, the left main wheel travelled out from runway (figure 5) and the braking mark of the right wheel on the runway still visible.

Figure 5: The wheel marks (red arrows) and the first damaged fence (red dotted square)

The first broken airport fence was found about 500 meters from beginning runway 17 or about 30 meters from the last aircraft stopped position. The distance from the left runway edge to the airport fence was 8.7 meters. The aircraft stopped about 530 meters from beginning runway 17 on heading about 110°. The right main wheel entered a ditch and the aircraft tilted to the left.

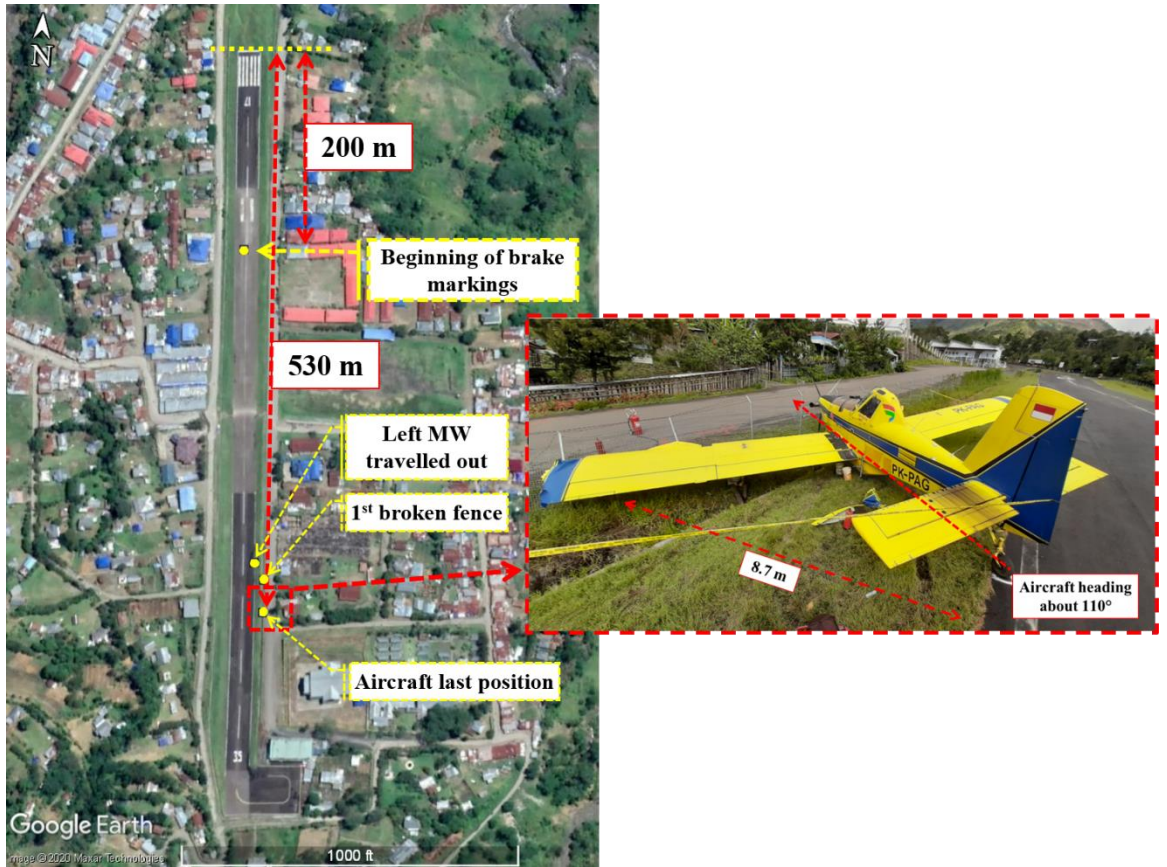
Figure 6: The sketch of the occurrence site

19. The first broken airport fence was about 500 meters from the beginning runway 17 or about 30 meters from the last aircraft stopped position. The aircraft stopped about 750 meters from beginning runway 17 on heading about 110°. The right main wheel entered a ditch and the aircraft tilted to the left.

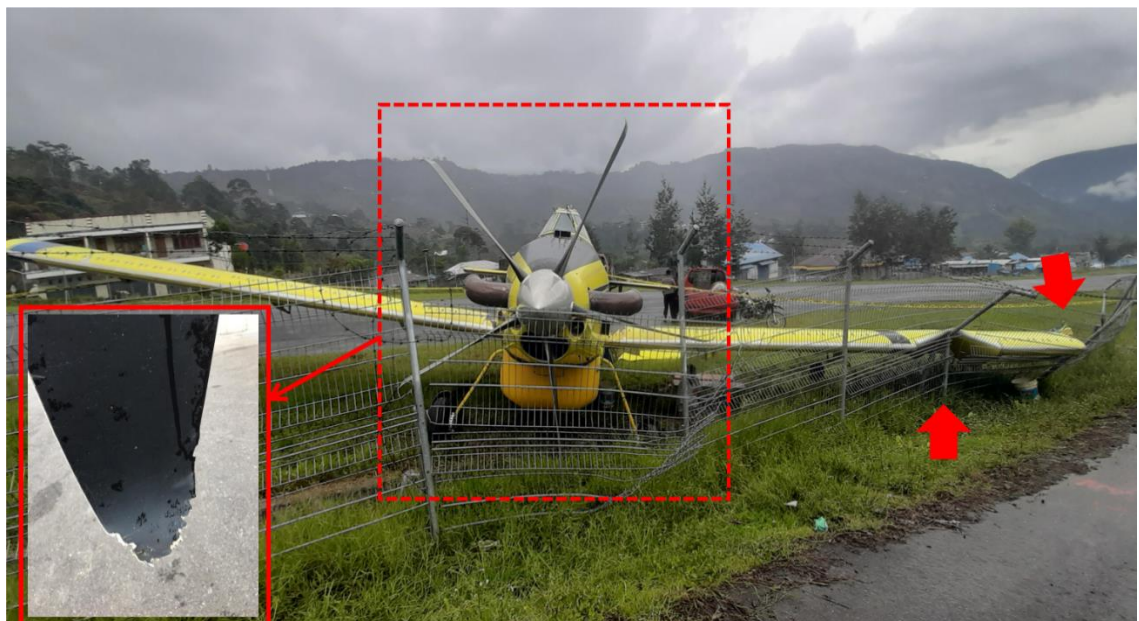
All propeller blades were bent and abraded as result of the impact to the airport fence and there were no propeller marks found on the ground.

Figure 7: The damaged propeller blades, left-wing leading edge and the left-wing

tip

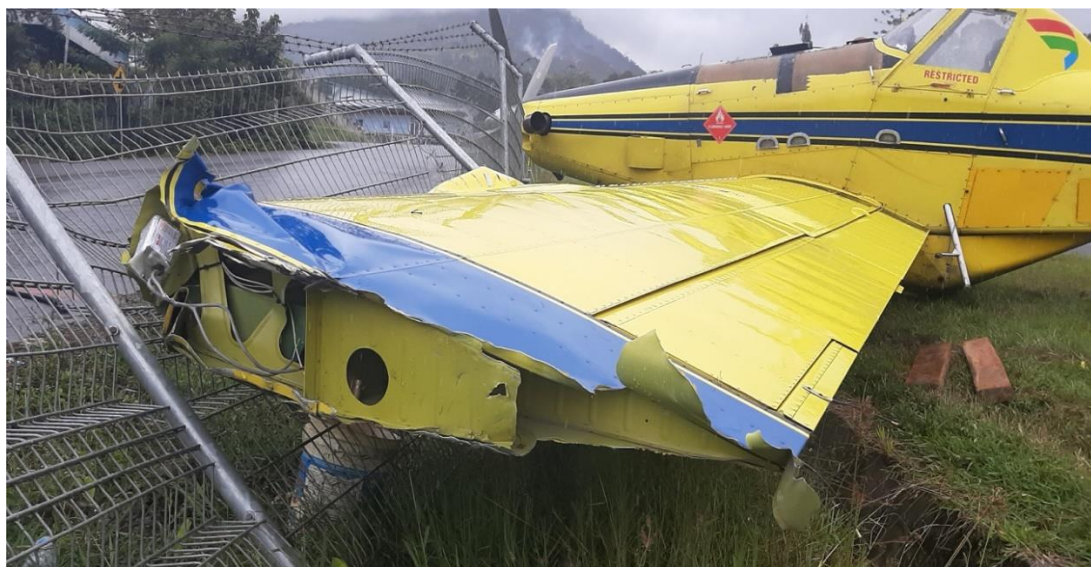
Figure 8: The damaged left-wing tip

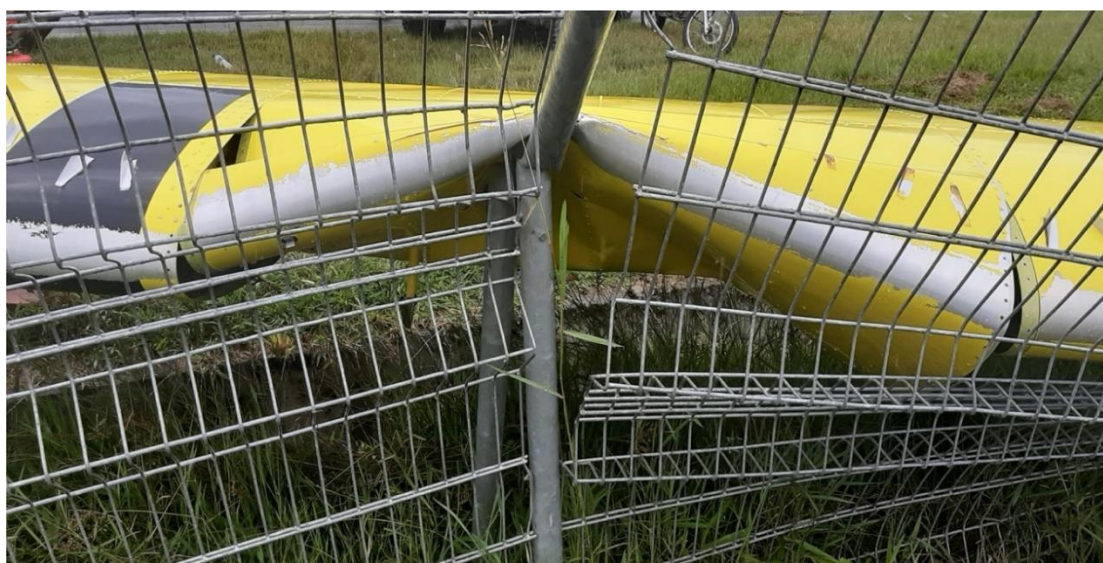
Figure 9: The damaged left-wing leading edge
