Aircraft Accident Investigation Report

PAC 750 XL; PK-RWR

Bayabiru Airstrip, Paniai, Papua

15 October 2020

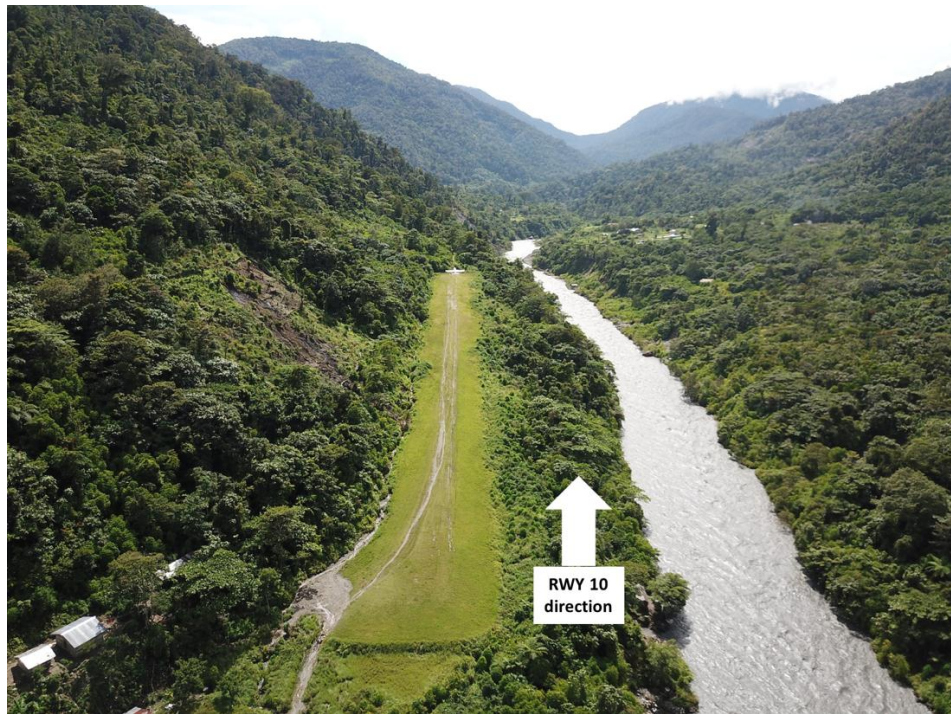
Figure 4: The airstrip condition

During the on-site investigation, the KNKT measured the runway length which both ends of runway were marked by bushes and higher ground. The measurement result was about 330 meters. The KNKT also retrieved the Bayabiru airstrip information from the other aircraft operator which described the runway length of the Bayabiru was 330 meters.

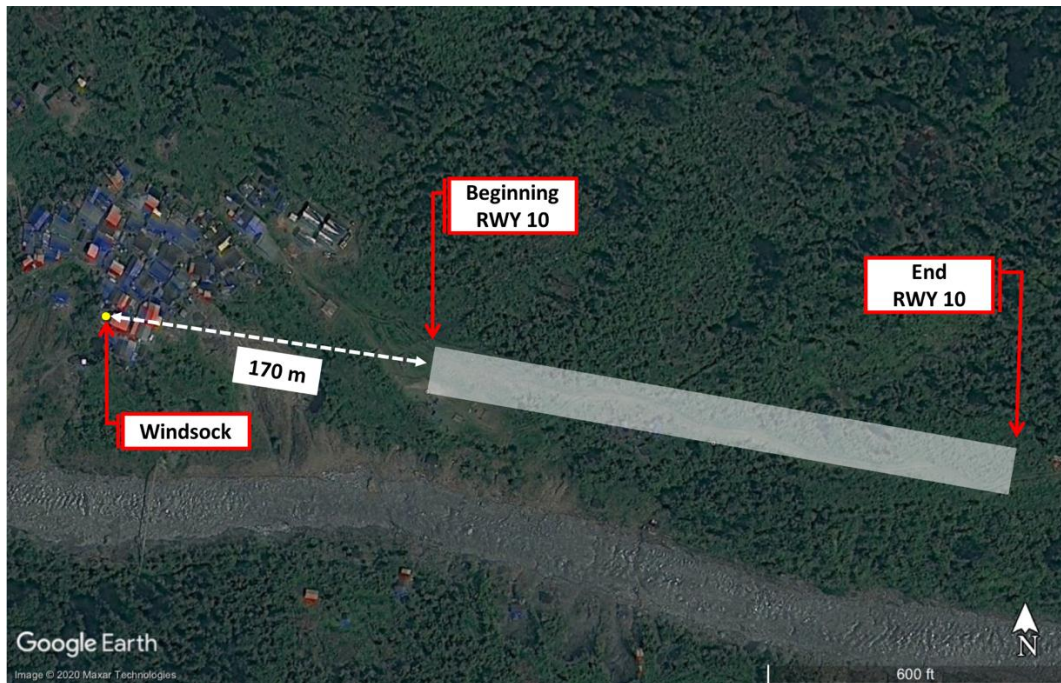
The airstrip was equipped with wind sock, located on the settlements near the airstrip about 170 meters from beginning runway 10 on bearing 275°.

Figure 5: The windsock location (yellow dot) and the airstrip

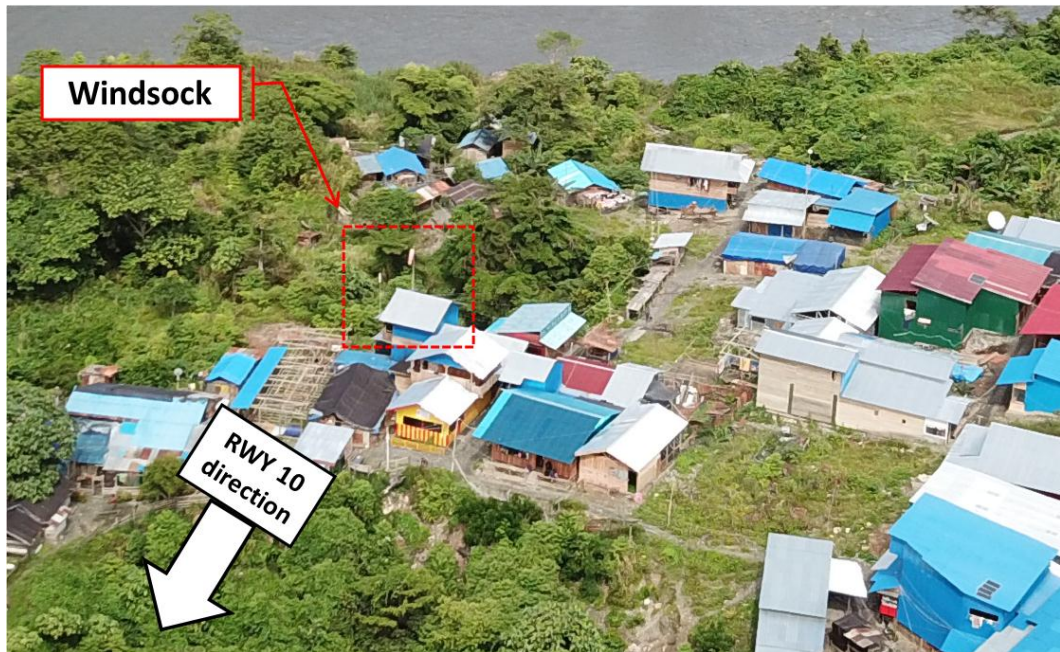
Figure 6: The windsock location (inside red-dotted square)

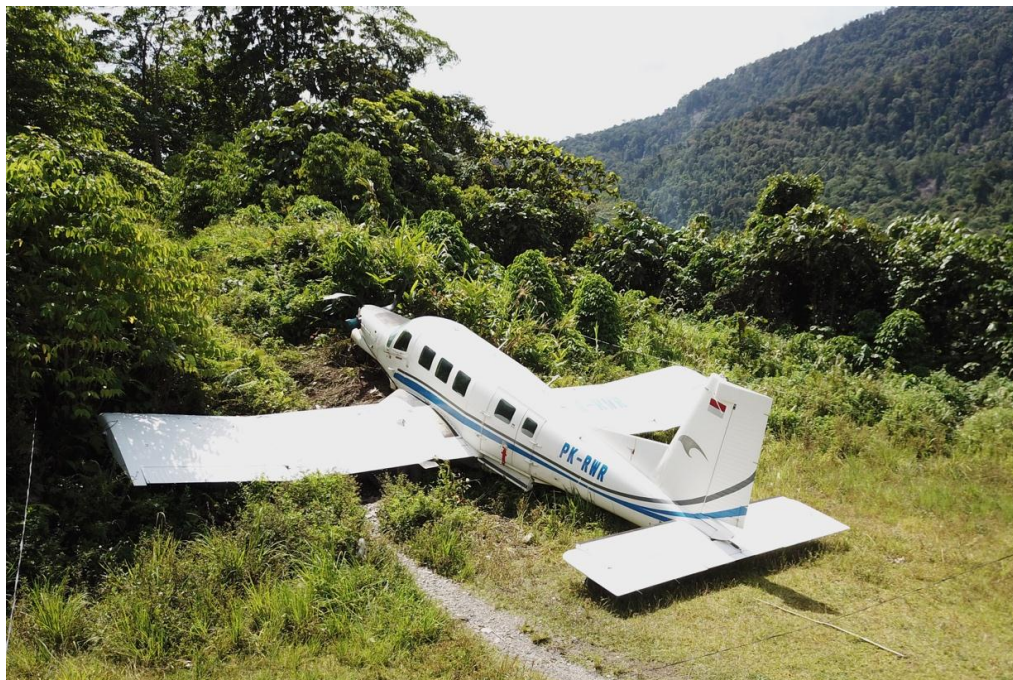
Figure 7: The aircraft last position

The aircraft touched down marks found on runway 10 about 15 meters from the beginning runway and stopped by impacting higher ground at the end of the runway. The aircraft last position was about 315 meters from the location of the aircraft touched down.

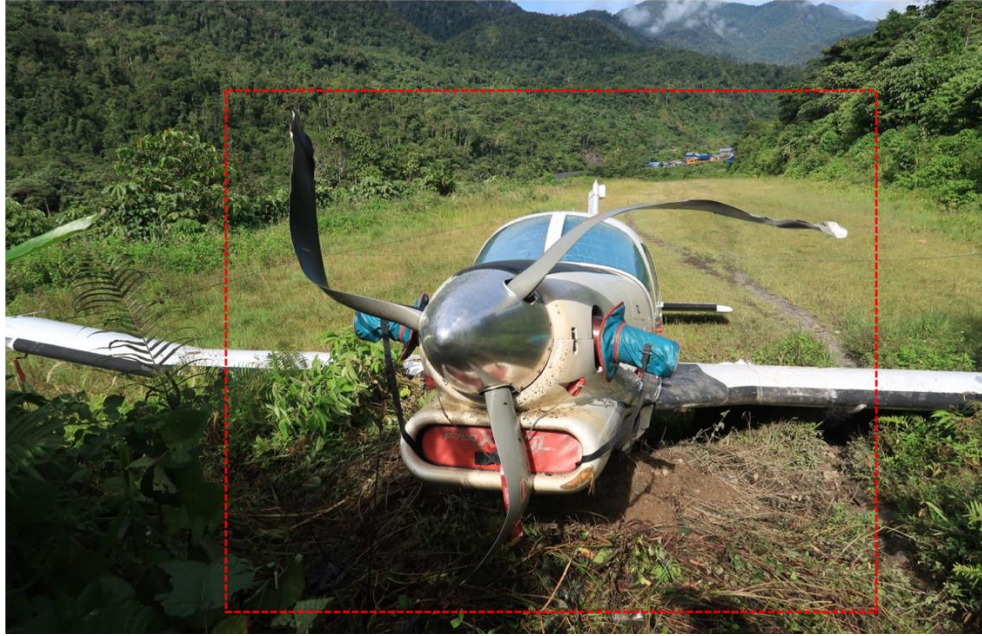
- propeller blades were damaged;
- nose gear was bent backward;
- front section of cargo pod was damaged;
- left landing gear strut was broken and punctured the left wing;
- left flap was torn;
- aft section of the aircraft was damaged.

Figure 8: The damaged propeller blades

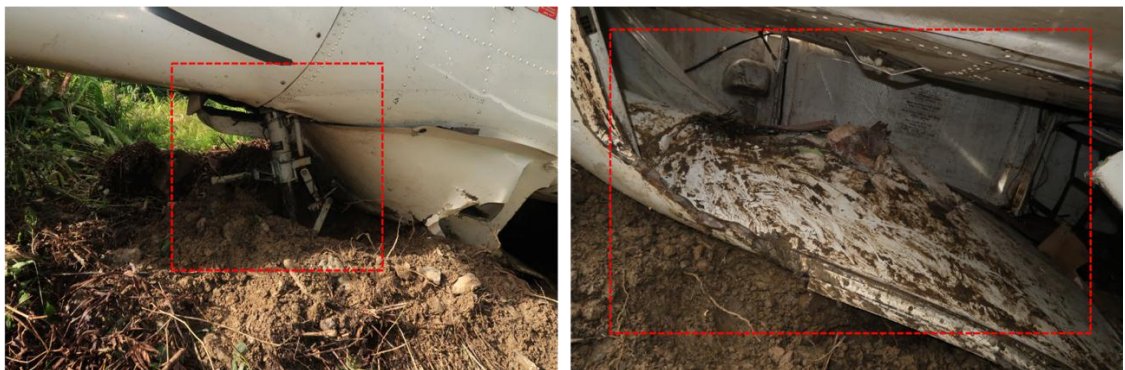
Figure 9: The bent of nose landing gear strut (left picture) and the damaged of cargo pod (right picture)

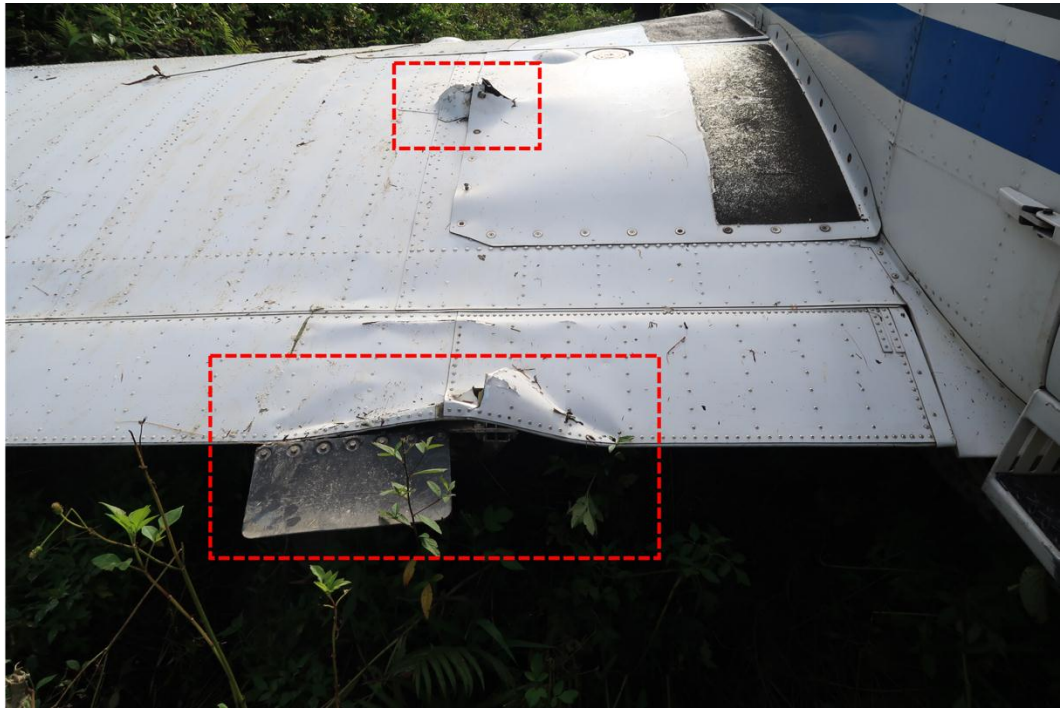
Figure 10: The damaged of left wing

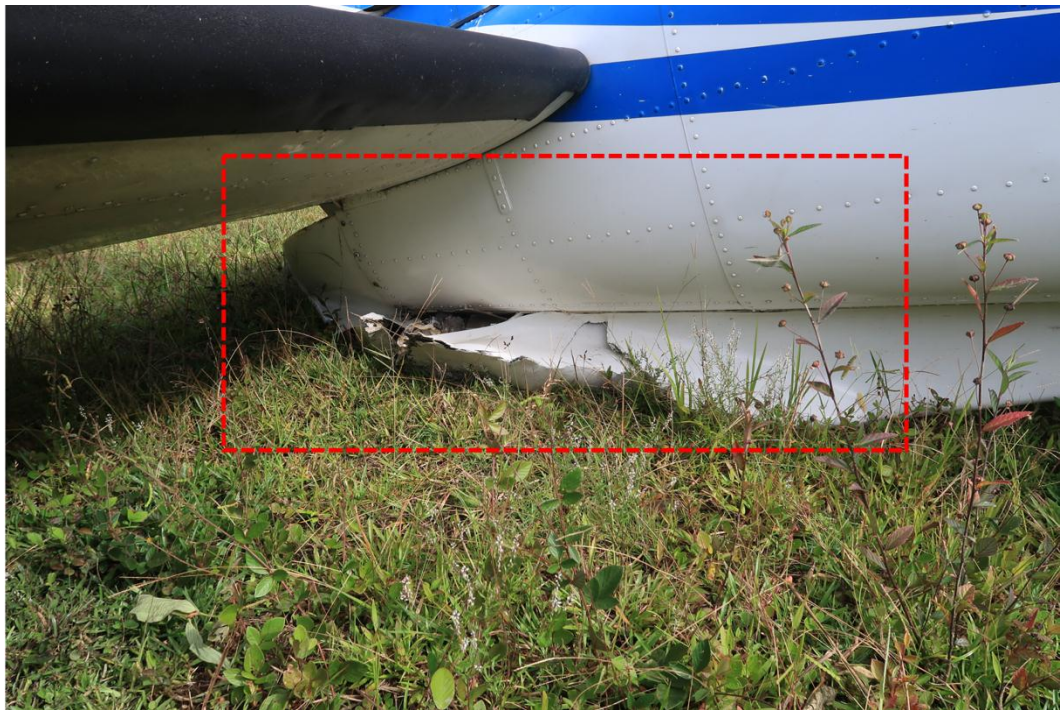
Figure 11: The damaged on the aft section
