**KOMITE NASIONAL KESELAMATAN TRANSPORTASI
REPUBLIC OF INDONESIA**

KNKT.20.01.02.04

Aircraft Serious Incident Investigation Report

PK-SNP, Cessna 208B (EX)

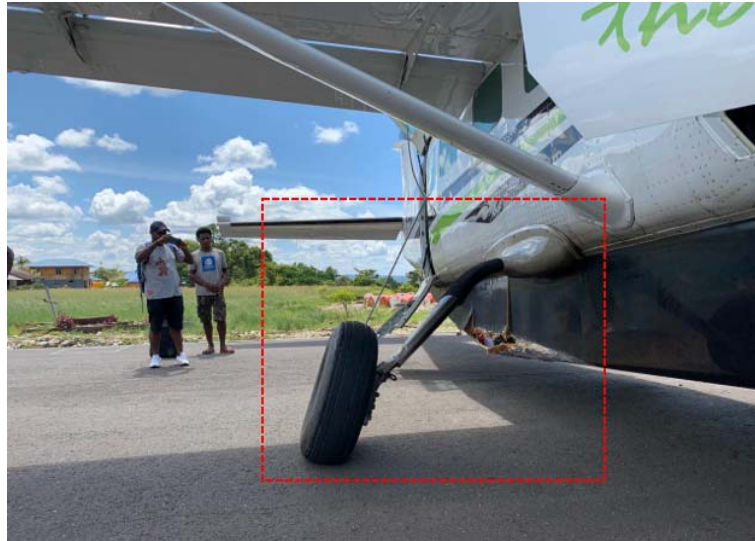
- left and right main landing gear struts were bent;
- left and right main wheel sidewall crack;
- cargo pod compartment C and D were damaged;
- tail cone bottom skin rivet was damaged;
- rear tail cone bottom bulkhead was damaged; and
- bottom panel center spring deformed.

Figure 1: The bent of the right main landing gear strut

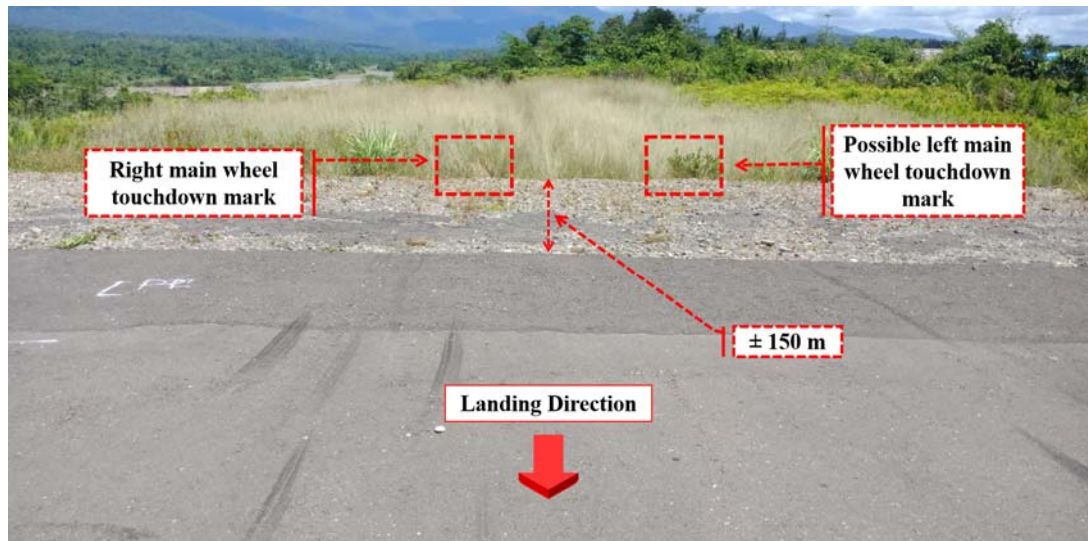
The aircraft touched down outside the runway pavement, about 150 meters before beginning runway 22.

Figure 2: The touchdown location
