**KOMITE NASIONAL KESELAMATAN TRANSPORTASI
REPUBLIC OF INDONESIA**

KNKT.20.12.27.04

Aircraft Serious Incident Investigation Report

PK-SNR, Cessna 208B

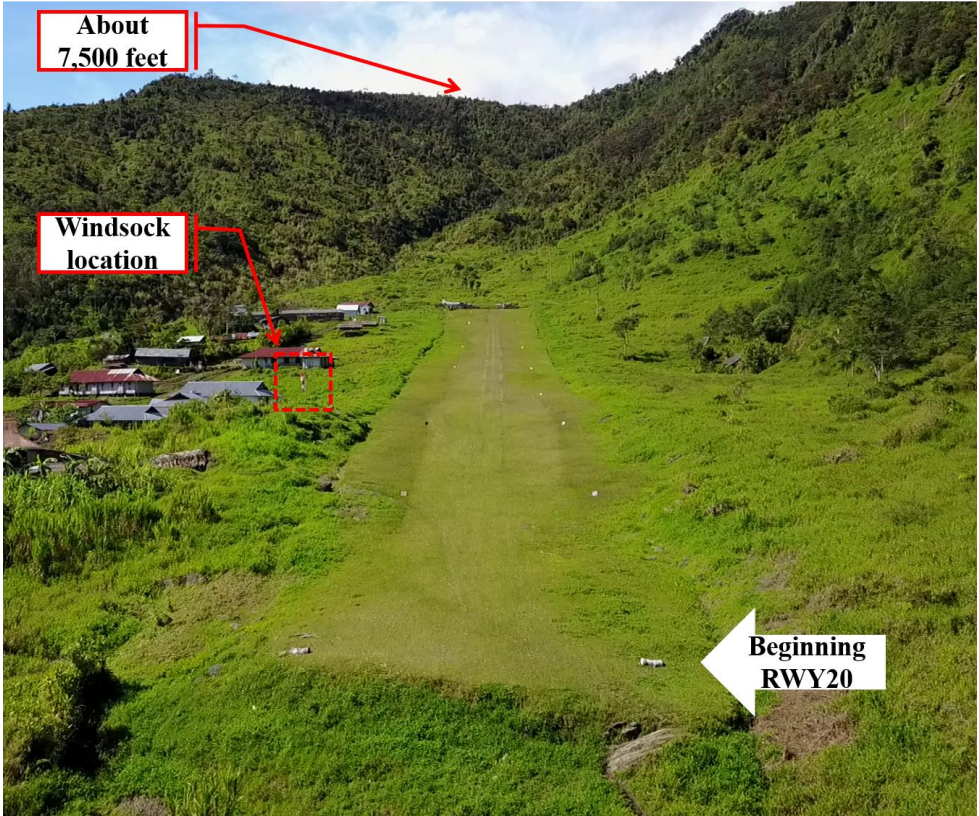
Sela was located on mountainous area and the runway was located on a mountain slope. The runway was a one-way runway which means the landing only can be made from the Runway 20 and the takeoff only can be made from Runway 02. On the final area of the Runway 20 there was a hill with height about 6,200 feet (about 250 feet above threshold Runway 20). The airstrip was equipped with windsock located on the left side of Runway 20.

Figure 3: The runway 20 and the location of the windsock (red square)

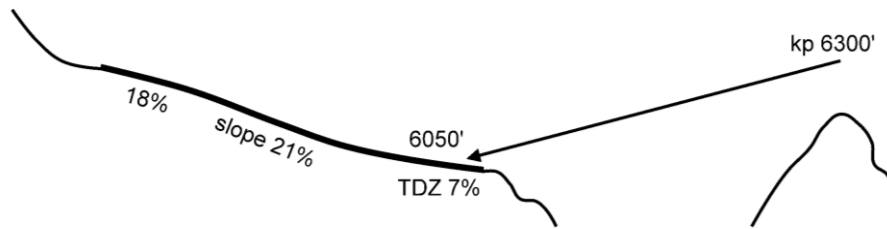
length	: 415 meters
width	: 18 meters
touch down slope	: 7%
surface	: grass

Figure 4: The runway illustration provided in the airport information of other aircraft operator

Therefore, KNKT recommends the DGCA to review the aerodrome information provided in the AIP Volume IV to ensure the information is correct and accurate.

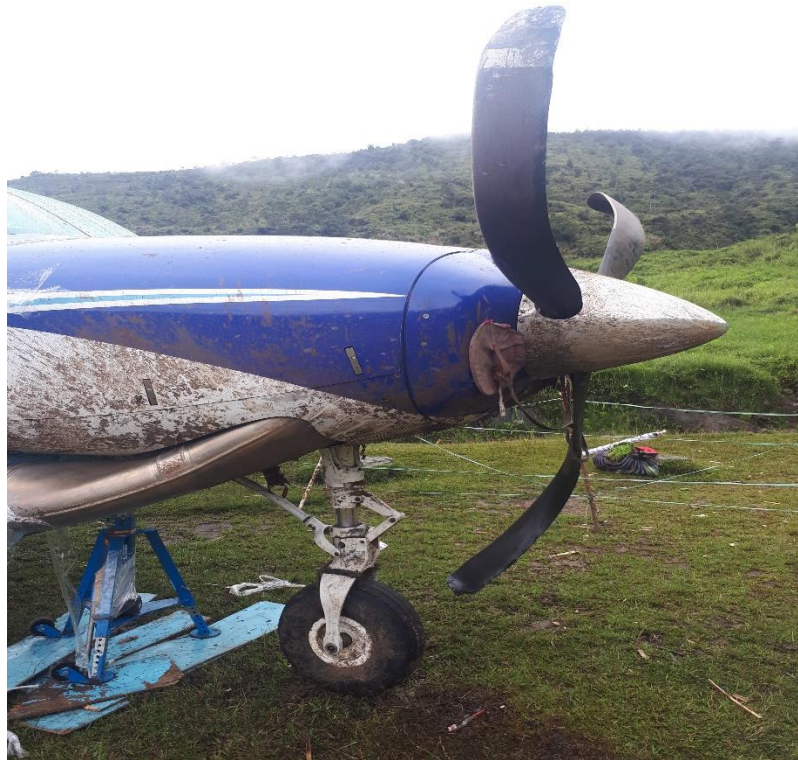
Based on the CVDR, the aircraft touched down about 160 meters from the beginning runway. The investigation could not identify the touchdown mark on the runway. The aircraft stopped after impacting higher ground at the end of the runway, about 260 meters from the location of the aircraft touched down. The propeller blades bent as the result of the impact with the higher ground.

Figure 5: The damaged of the propeller blades
