KNKT.20.07.14.04

Aircraft Serious Incident Investigation Report

ATR72-212A 600 Series; PK-WHY

03 July 2020

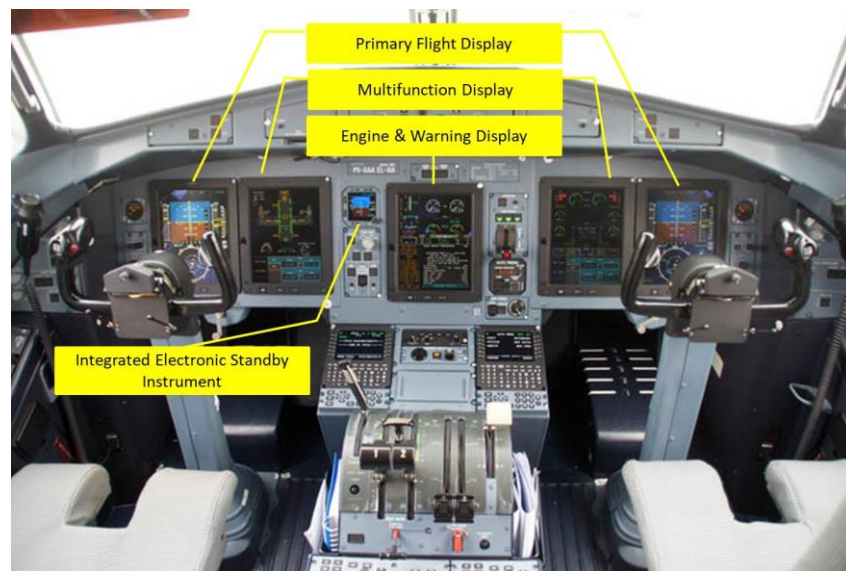
Figure 1: ATR 72-212A 600 Series Glass Cockpit

The starting process of both engines was normal then the aircraft taxied and line up runway 22 of Ambon. At 0400 UTC² (1300 LT³) the aircraft took off and after airborne the pilot verified the Idle Gate lever engaged. Suddenly all 5 Display Units (DU) and the Integrated Electronic Standby Instrument (IESI) went blank and all of the Very High Frequency (VHF) radios were off. The landing gear could not be selected to up.

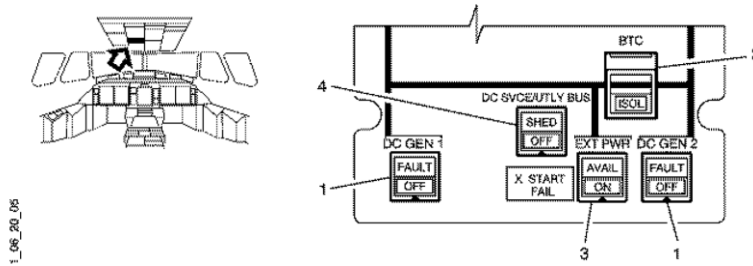
Figure 2: DC Service/Utility Bus and External Power push button

The pilot glanced to the overhead panel and saw several lights illuminated consisted of the SHED light on the DC SVCE/UTLY BUS⁴, the AVAIL (available) light on the EXT PWR (external power) push buttons, pack, lavatory detection and engine boost.

4 DC SVCE/UTLY BUS (DC service and utility bus) push button is a controls connection or disconnection of DC SVCE BUS (DC service bus) and both UTLY BUSSES (utility bus) to associated main DC BUSSES. The SHED illuminates amber and the Flight Warning System (FWS) will active when a load shed condition controlled by the BPCU is present and at least one UTLY BUS is disconnected from associated main DC BUS.

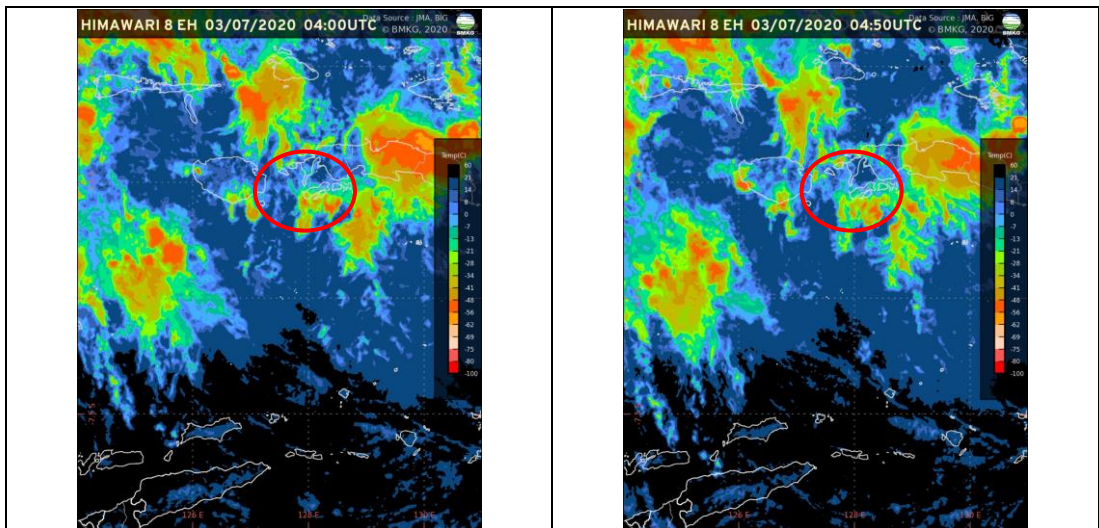
Figure 3: The cloud temperature at the area occurrence

The *Badan Meteorologi Klimatologi dan Geofisika* (BMKG – Bureau of Meteorology, Climatology and Geophysics) provided enhanced infrared satellite images. The enhanced infrared satellite images at 0400 UTC (1200 LT) up to 0450 UTC (1250 LT) indicated that the cloud top temperature at the area (red circle) was from -21 up to -41°C as shown below.

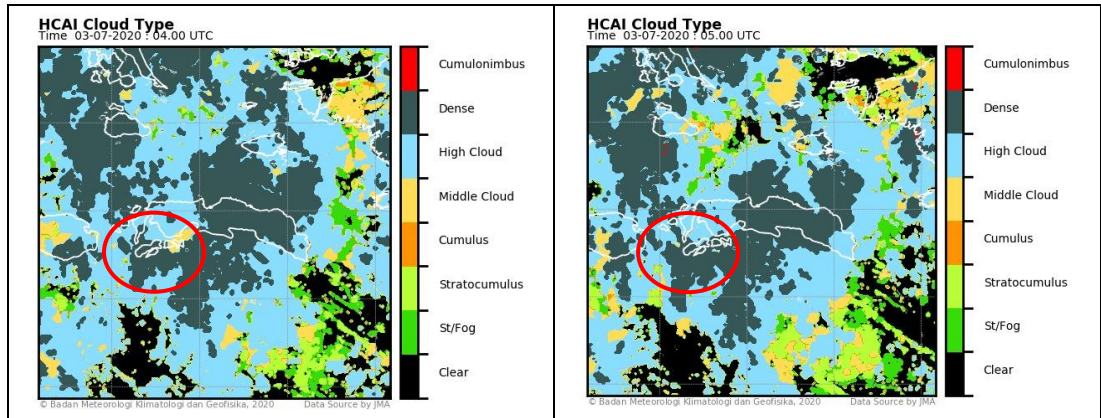
Figure 4: The cloud type at the area of occurrence

The cloud type at 0400 UTC (1200 LT) up to 0500 UTC (1300 LT) as shown in the figure below (red circle), indicated that the low cloud with the potential of rain over the area.
