**KOMITE NASIONAL KESELAMATAN TRANSPORTASI  
REPUBLIC OF INDONESIA**

# **PRELIMINARY**

**Aircraft Accident Investigation Report**

**PT. Trigana Air Service  
Boeing B737-300; PK-YSG  
Sentani International Airport, Jayapura  
Republic of Indonesia  
25 February 2020**

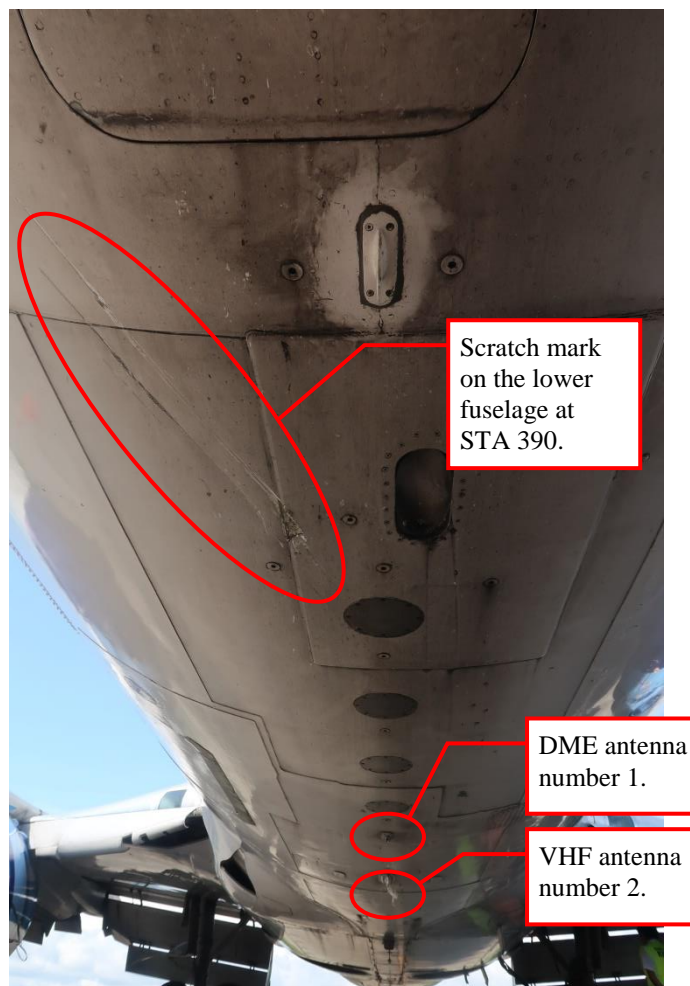
**Figure 1: Scratch marks on the lower fuselage**

The aircraft was substantially damage. The lower fuselage was damage at the station 390 (between the electronic equipment bay to the first radio altimeter antenna) identified by two scratch mark about 0.5 meter. See figure below.

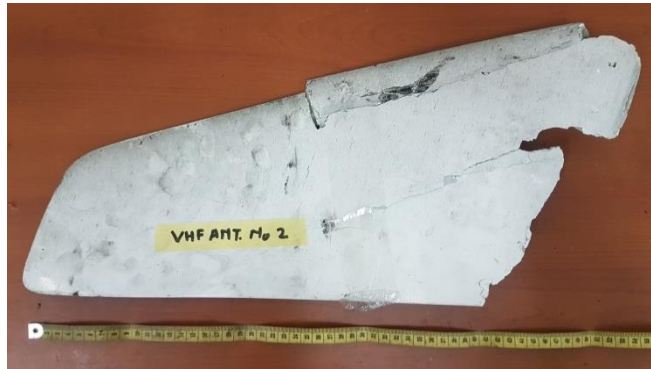
**Figure 2: The broken VHF antenna number 2**

The Very High Frequency (VHF) antenna number 2 (located behind the DME antenna number 1) at station 511 was broken as shown in the figure below.

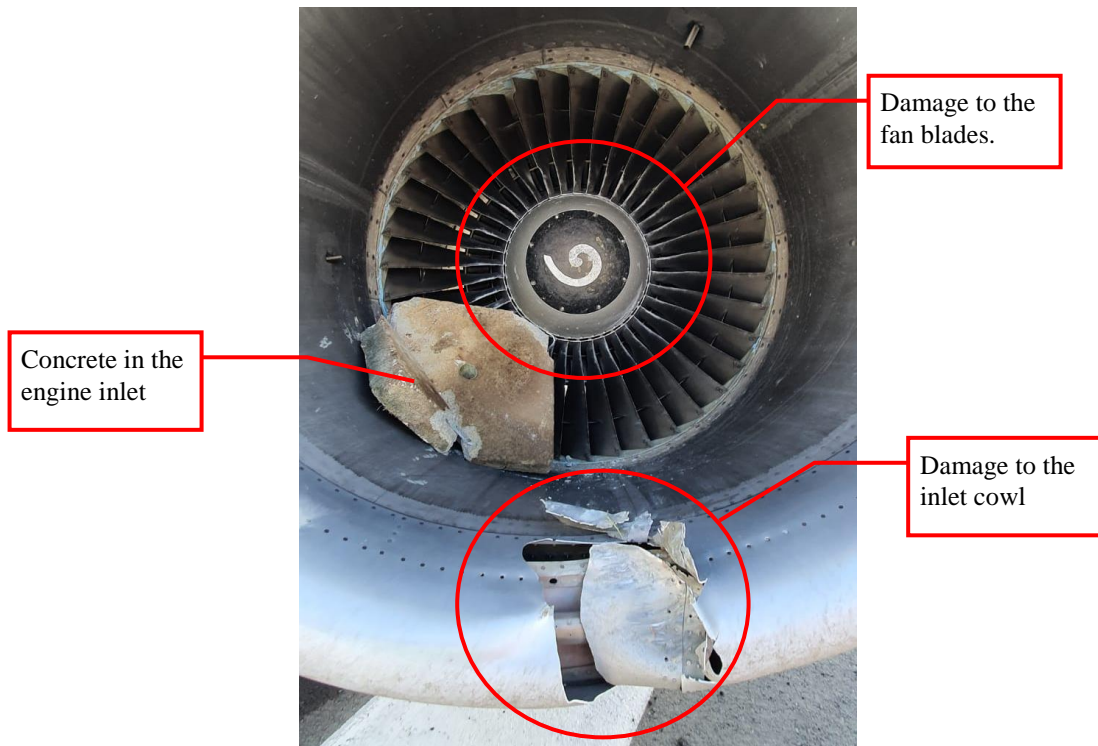
**Figure 3: The concrete in the left engine inlet cowl**

A triangle concrete pavement with the dimension approximately  $40 \times 40 \times 50$  centimeters with the thickness of approximately 15 centimeters was found in the left engine inlet. The concrete most likely damaged the lower engine inlet cowl with the dimension about  $20 \times 20$  centimeters and also damaged several engine fan blades as shown in the figure below.

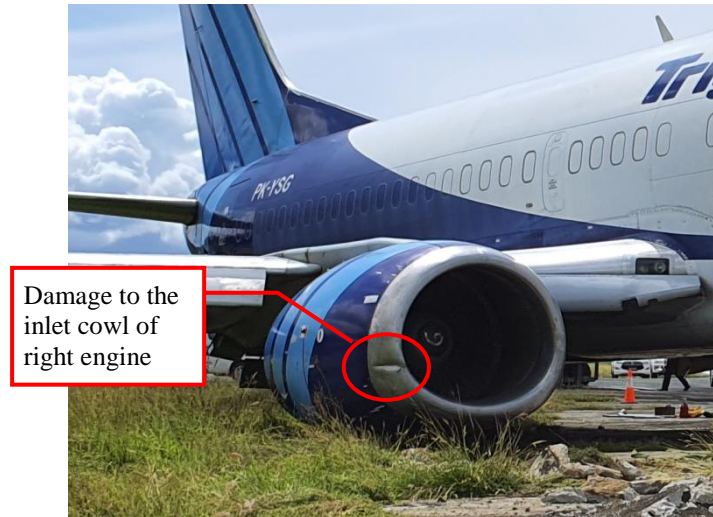
**Figure 4: Dent on the right engine inlet cowl**

The right engine fan inlet cowl was damage approximately at the position 9 o'clock (looking aft to the engine) identified by dent mark about 10 centimeters long with the depth about 2 centimeters as shown in the figure below.

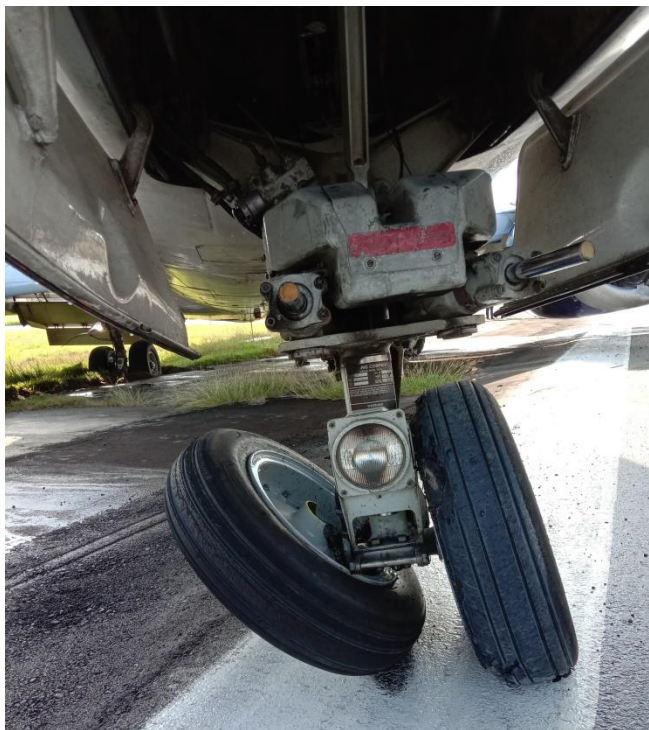
**Figure 5: The Nose wheel condition**

The nose wheels were broken at the wheel hub. There was no significant damage to the aircraft nose area and the nose landing gear assembly including the torsion link and steering assembly.

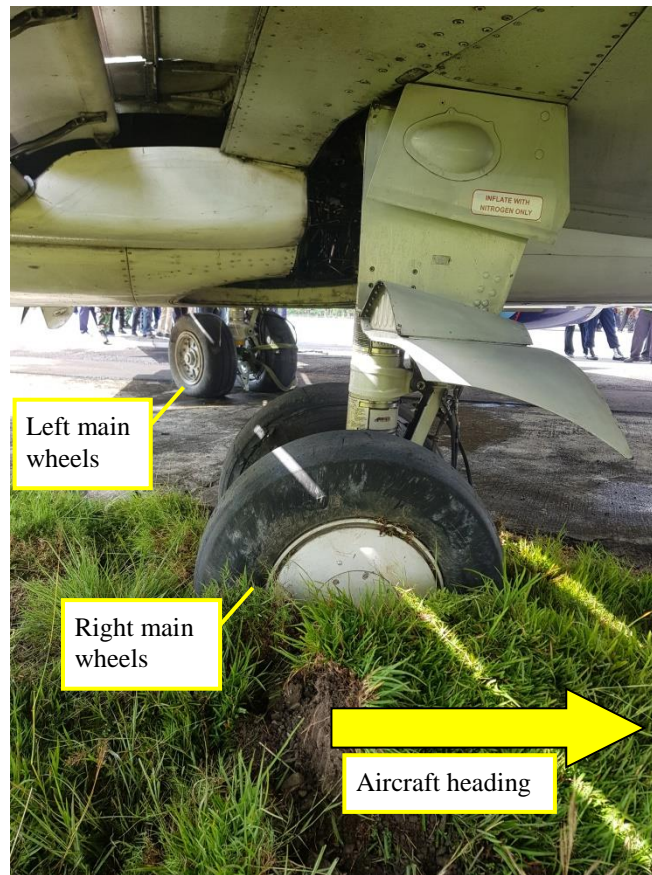
**Figure 6: The position of left and right main wheels**

The left and right Main Landing Gears (MLG) were still intact. The left main landing gear was on the pavement of the runway shoulder and the right main landing gear was on the grass of the runway shoulder. All of the torsion links of the MLG were broken.

The main wheel number 1 and 2 were intact to the left Main Landing Gear (MLG) axle and faced almost 90° relative from the aircraft heading (see figure 6).

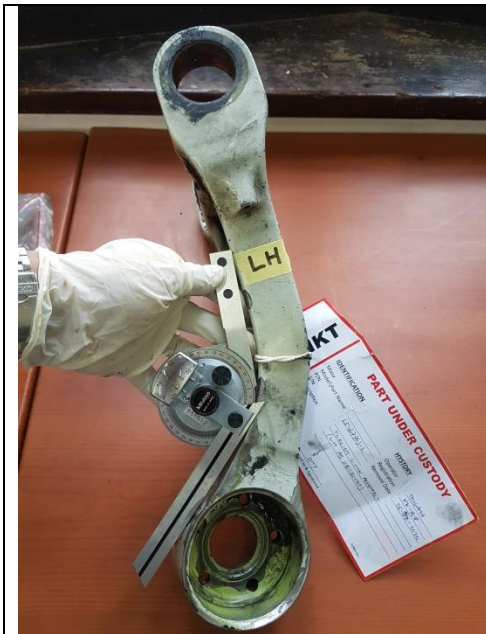
**Figure 7: Left upper torsion link**

The left MLG upper torsion link was separated from the lower torsion link. The left upper torsion link bent about 45° and twisted to the right (relative to the forward movement of the aircraft).

7. The upper torsion link and lower torsion link of both main landing gears were separated. Both upper torsion links bent and twisted to the right. The left lower torsion link was fracture while the right lower torsion link broken.

Therefore, KNKT recommend to implement the Boeing SL 737-SL-32-057-E (or the latest revision) requirement.

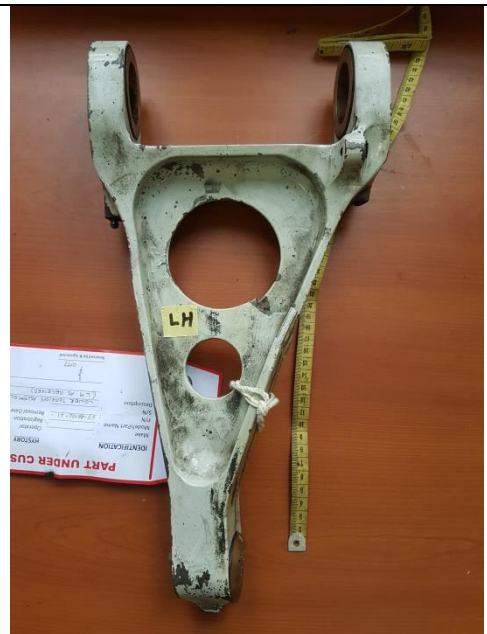
**Figure 8: Left lower torsion link**

The left MLG lower torsion was bent to the right and fractured about 19 centimeters from the torsion link joint (see figure 7 and figure 8).

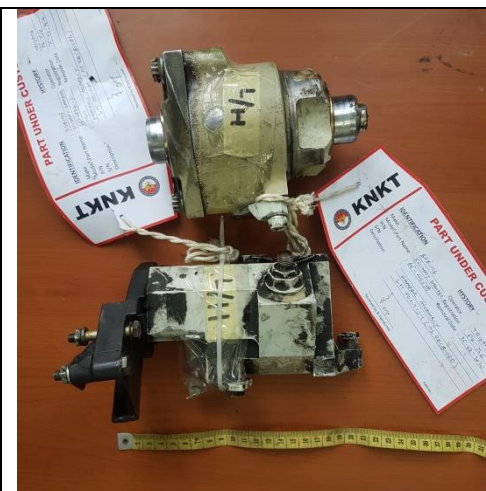
**Figure 9: Left shimmy damper manifold assembly and shimmy damper piston assembly**

The left shimmy damper manifold assembly was separated with the shimmy damper piston assembly. The left shimmy damper manifold assembly was found intact with the hydraulic hose of the left main landing gear.

The shimmy damper piston assembly was broken and found on the runway about 1,300 meters from the beginning runway 30 (300 meters from the final aircraft position). The piston was separated from the piston housing of the shimmy damper piston assembly.

8. Both left and right main landing gear shimmy damper assembly were broken and the shimmy damper manifold separated with the piston housing assembly. The broken part of the left piston has not been found.

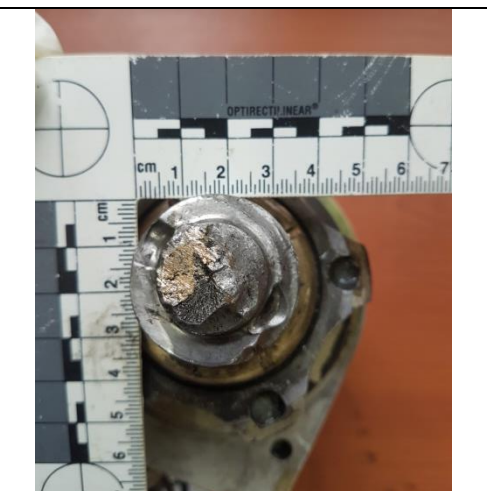
**Figure 10: Broken piston of left shimmy damper**

Until the publishing of this preliminary report, the piston with the apex nut has not been found. See the figure 9 and figure 10 below.

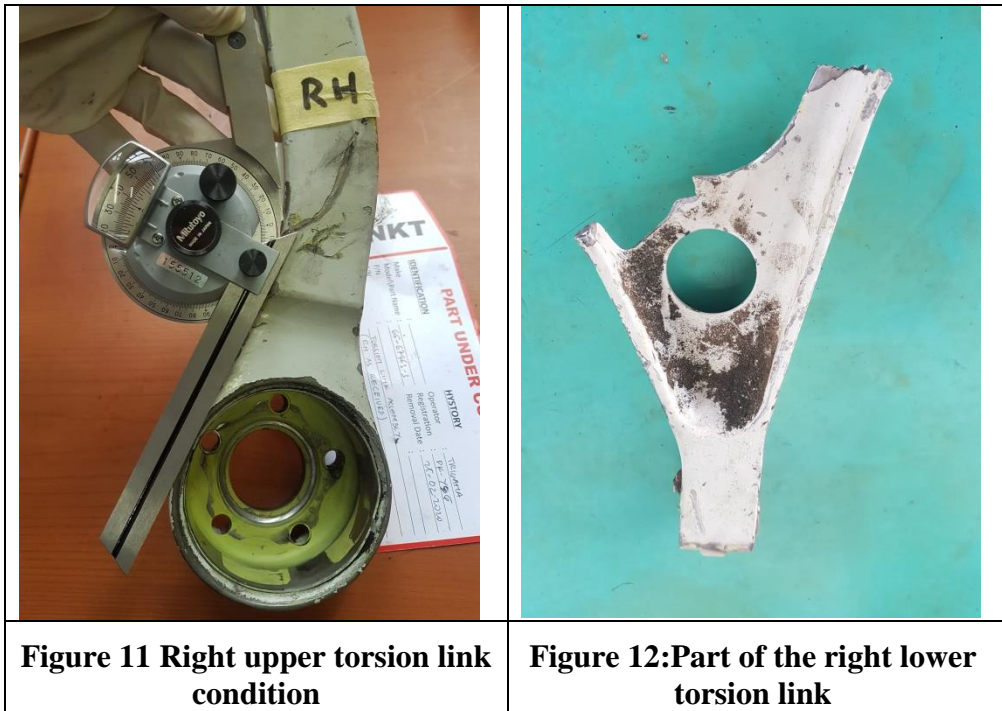
The right MLG upper torsion link was separated from the lower torsion link. The

right upper torsion link was bend about 35° and twisted to the right (relative to the forward movement of the aircraft). The lower torsion link was broken in two pieces. The broken lower torsion link was found on the runway about 1,600 meters from the beginning of runway 30 (near the final aircraft position).

**Figure 11 Right upper torsion link condition**

**Figure 12: Part of the right lower torsion link**

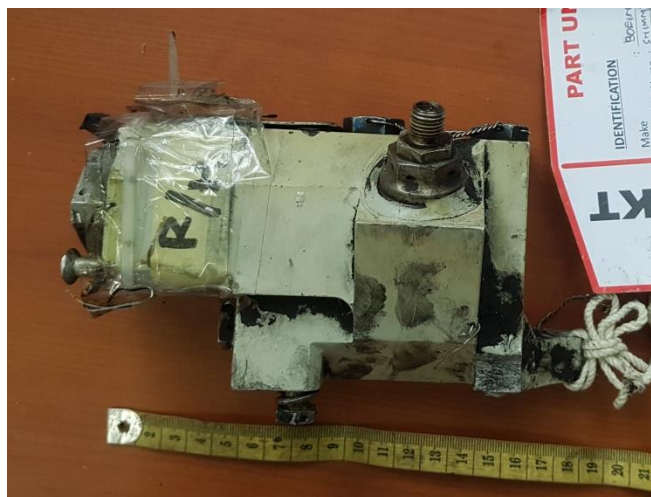
**Figure 13: The right manifold of shimmy damper assembly**

The right shimmy damper manifold assembly was separated with the shimmy damper piston assembly. The right shimmy damper manifold assembly was intact with the hydraulic hose of the right main landing gear.

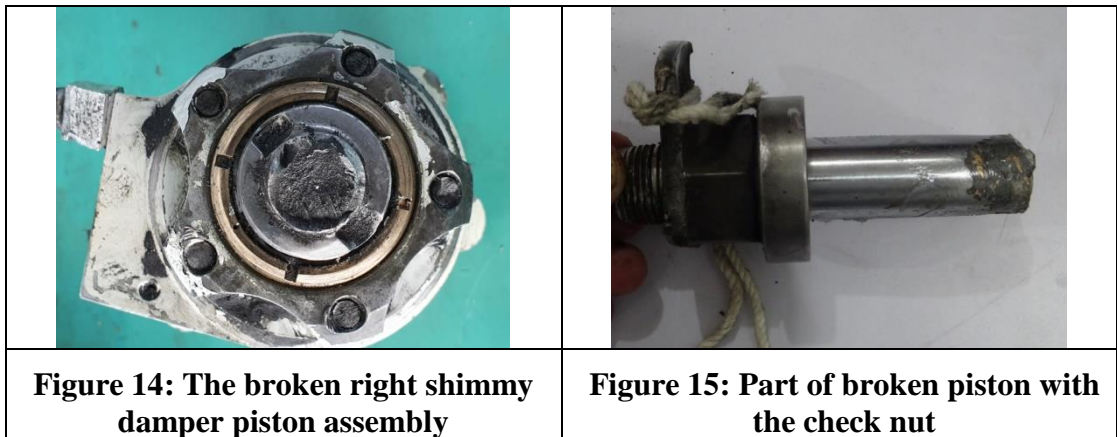
The right shimmy damper piston assembly was broken and found on the runway about 1,600 meters from the beginning runway 30 (see figure 14 and 15). Part of broken piston was found about 1,500 meters from the beginning of runway 30 (100 meters from the final aircraft position).

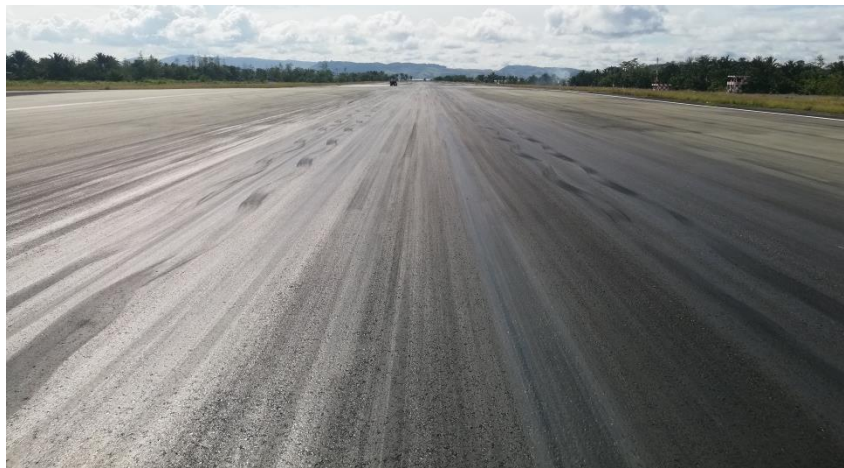
**Figure 18: The oscillation wheels marks**

The first oscillation wheels marks were found to since about 500 meters from the beginning runway 30 until the position of the aircraft stop. Part of the oscillation wheel marks is shown in the figure below.

4. Oscillation wheel marks of the both main landing gears were found on the runway since about 500 meters from the beginning runway 30 until the aircraft stop position.

Therefore, KNKT recommend to resolve the height variation on the runway.

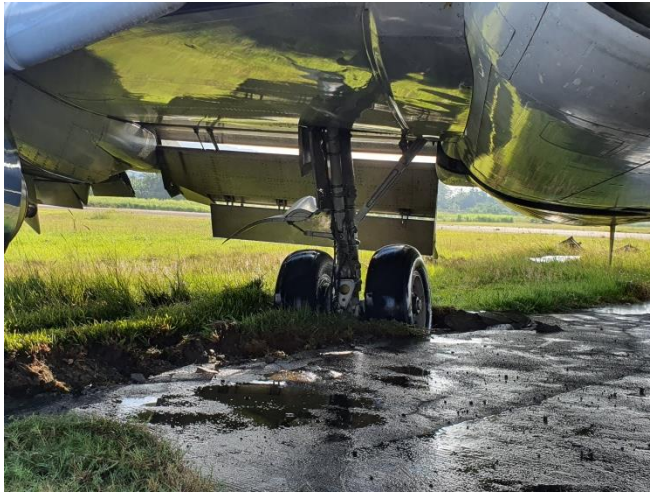
**Figure 19: The main wheel number 3 and 4 of the right MLG**

The left main landing gear was on the pavement runway shoulder about 1.5 meters from the runway edge mark and the right main landing gear was on the right runway shoulder and trapped in the soft surface. The right main landing gear torque link was broken.

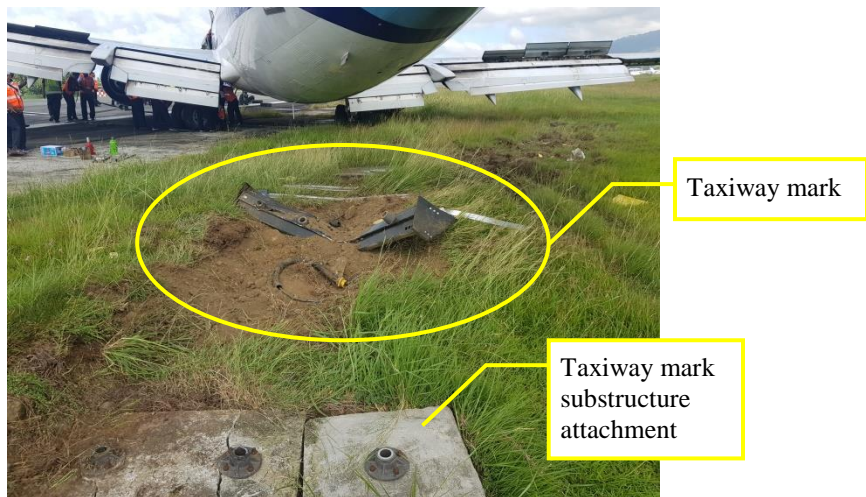
**Figure 20: The damage of the taxiway sign board**

The sign boards of taxi way C and D were broken.

The sign board of taxi way D was damage as shown in the figure below.

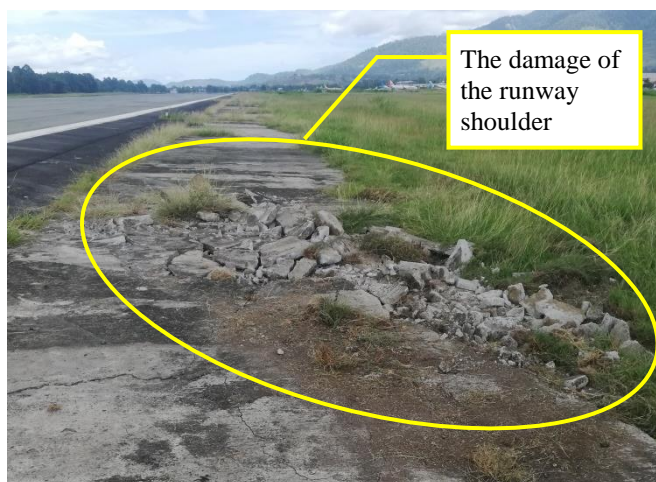
**Figure 21: The damage of the runway shoulder**

The runway shoulder at distance about 1,600 meters from the beginning runway 30 damaged with the dimension approximately 10 × 2 meters.

The damage of runway shoulder as result of the aircraft rotation is shown below.
