**KOMITE NASIONAL KESELAMATAN TRANSPORTASI
REPUBLIC OF INDONESIA**

1st INTERIM STATEMENT

Aircraft Serious Incident Investigation Report

Airbus A320; PK-LUT

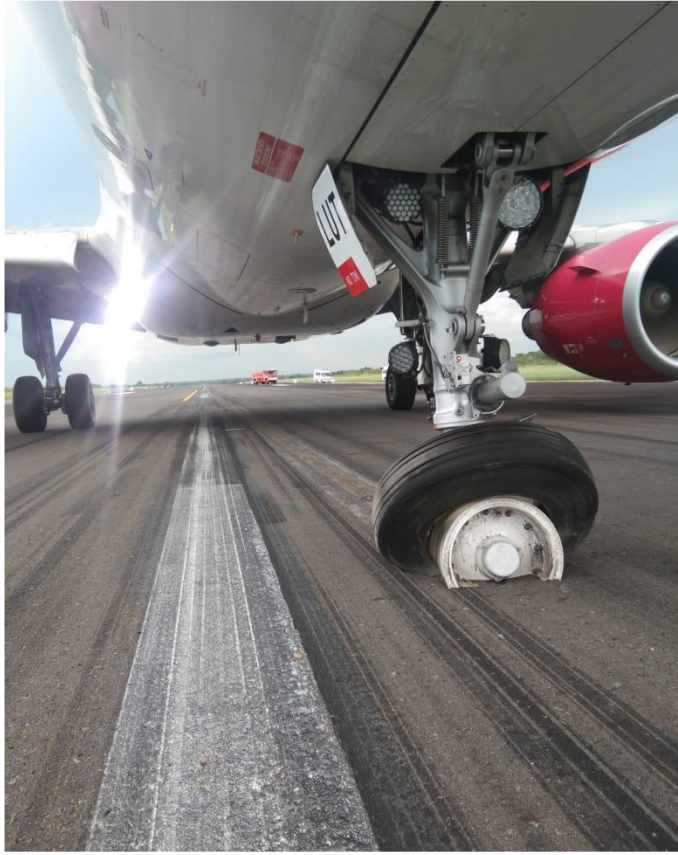
Figure 1. Nose landing gear damage

The nose wheel and tire were abraded due to contact with the runway and one nose landing gear tire detached.

Rubber tire mark from the nose wheel was found about one meter left of runway centerline, starting from 26 meters from the threshold marking runway 31 and continued about 800 meters along the runway. The nose wheel mark was the mark during the takeoff as recorded on the CCTV that the nose wheel was at tilted position during takeoff.

The first metal scratch mark was found near the runway centerline at about 1,100 meters from threshold runway 31 and the width of the scratch mark increasing until the aircraft stop position about 1,900 meters from the beginning of runway 31.

One of the nose wheel tire detached from the landing gear and found on the runway at about 1,300 meters from the beginning of the runway 31.
