**KOMITE NASIONAL KESELAMATAN TRANSPORTASI
REPUBLIC OF INDONESIA**

Aircraft Accident Investigation Report

PK-MAD, Cessna 208B

Angguruk Airstrip, Papua

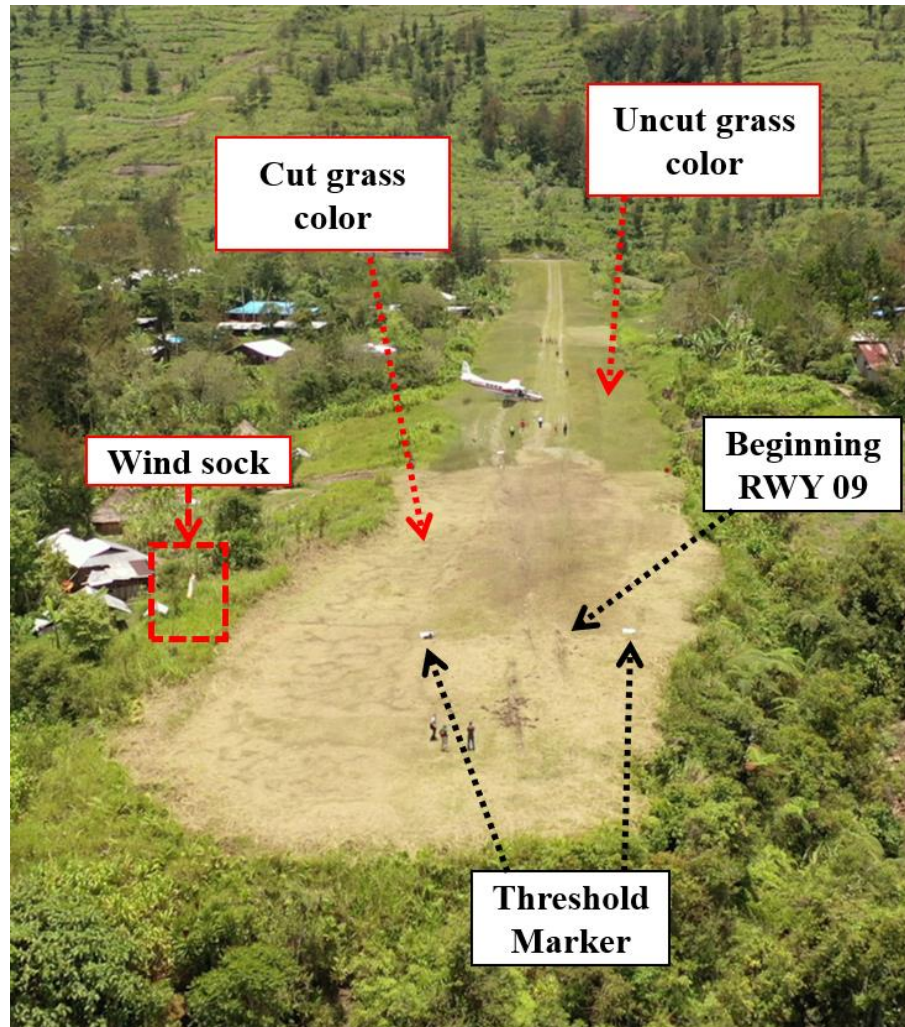
Figure 2: The threshold markers and wind sock location

Angguruk was located on mountainous area and the airspace over the airstrip was classified as Class G airspace. The airstrip was equipped with a windsock located on the left side of Runway 09. There were runway threshold markers painted with white paint on the beginning Runway 09. According to the local resident at Angguruk, the grass in the beginning of the airstrip was cut on 9 March 2021 or one day before the occurrence.

12. When the aircraft was on final, the pilot noticed that the runway threshold markers were visible. The pilot recalled that the markers were not stand out as usual due to the color were less contrast with the brighter color-grass.

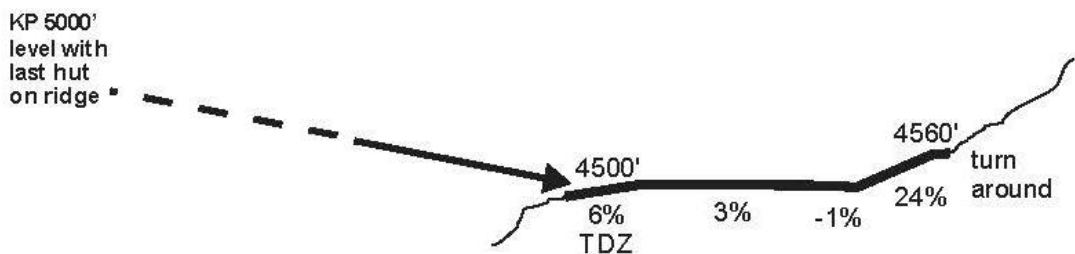
Figure 3: The runway illustration provided in the MAF Indonesia's airstrip information of Angguruk

The airstrip information developed by MAF Indonesia for internal use, described the airstrip elevation was 4,500 feet, and included runway information as follow:

direction : 09 – 27
length : 490 meters
width : 22 meters
slope : 5%
surface : Grass

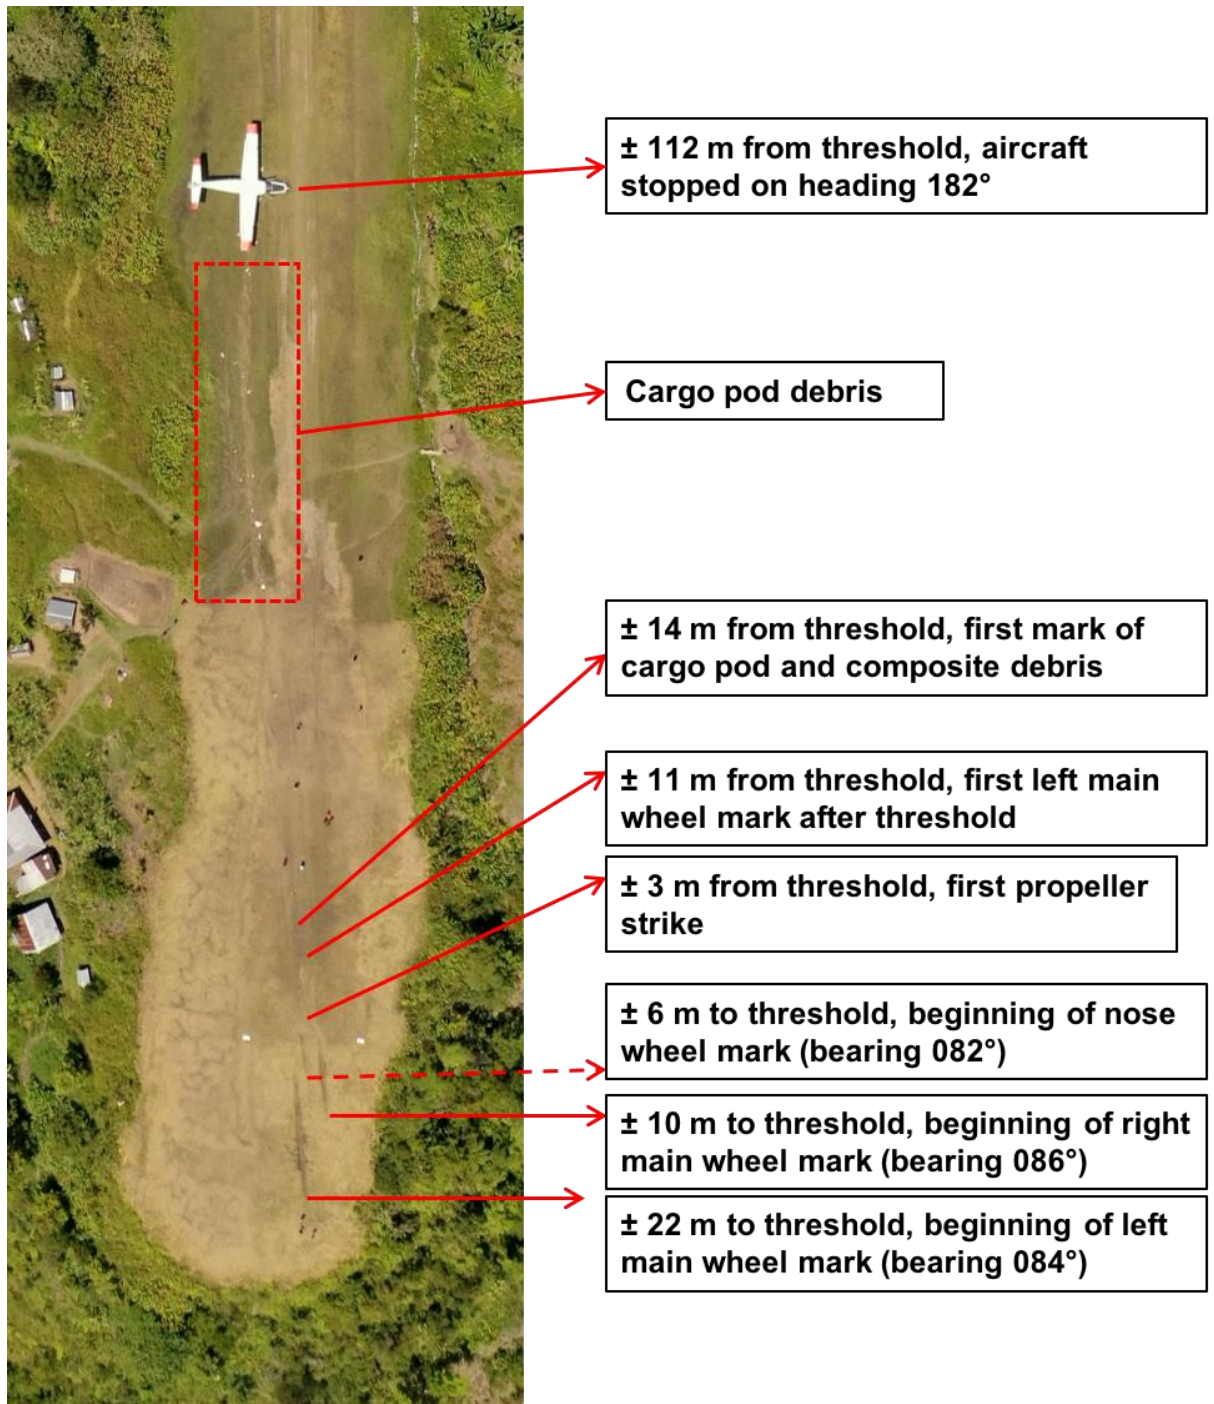
Figure 4: The damaged of the propeller blades

About 3 meters after the Runway 09 threshold, the first propeller strike mark was found and about 14 meters after, it was found composite debris and ground scratch mark of the cargo pod. The aircraft stopped on the left runway shoulder about 112 meters after the Runway 09 threshold on heading 182°.

- Bottom engine cowling including the engine exhaust damaged.
- Propeller blades bent.

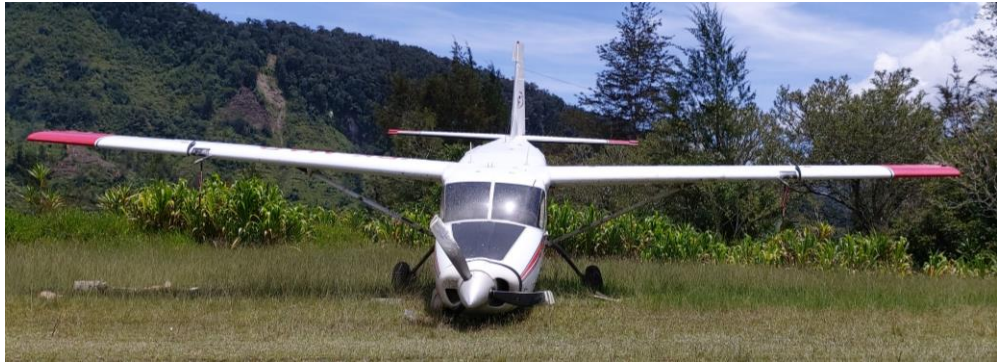
Figure 5: The aircraft condition after stop

- Left main gear spring bent aft ward.
- Nose gear drag link spring failed in two locations.
- Nose landing gear strut assembly and nose wheel damaged, found folded aft ward underneath the aircraft. The drag link spring attachment failed.
- Steer bungee/shimmy damper damaged.
- Engine truss frame bent.
